Inspection Report

Property Address:
16233 W Randell St
Manhattan IL 60442

SafeCheck Home Inspection

Date: 9/11/2024	Time: 02:00 PM	Report ID: 20240911-16015-W-Baker-Rd
Property: 16233 W Randell St Manhattan IL 60442	Customer: Joe Smith	Real Estate Professional:

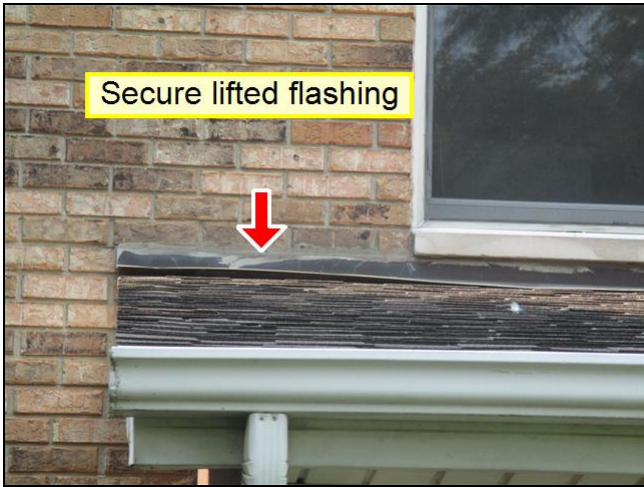
1.0 Item 1(Picture)

1.0 Lifted flashing was observed on the front of the home. This occurs when nails push up the flashing, or they are not properly secured. If not secured, moisture may enter and damage home. Contact a qualified roofer for correction.

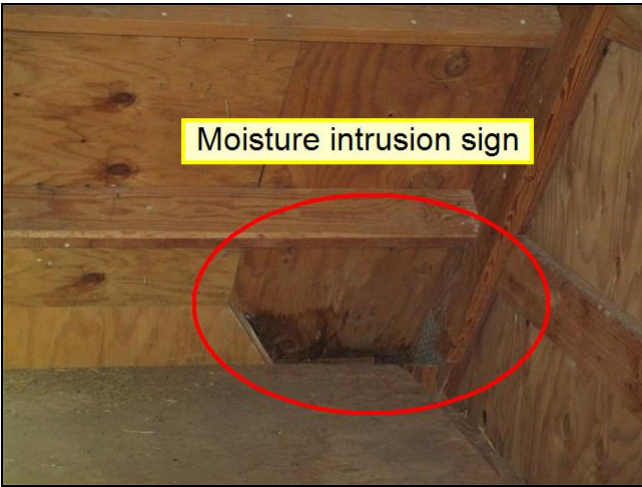
1.1 Item 10(Picture)

🏠 (3) A roof leak was observed in the attic of the outbuilding. The area was not wet at time of inspection. If not corrected, moisture related issues will develop and further damage will occur. Contact a qualified roofer for correction and further evaluation of the outbuilding roof.

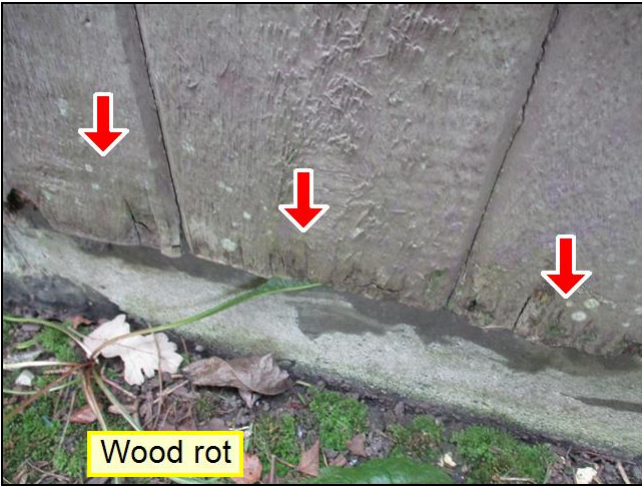
2.0 Item 3(Picture)

2.0 (2) Wood rot was observed on areas of the exterior of the home and outbuilding. If not corrected, further damage may occur. Contact a qualified contractor for further evaluation and repair. See pictures for details and locations.

NOTE: Possible mice entry.

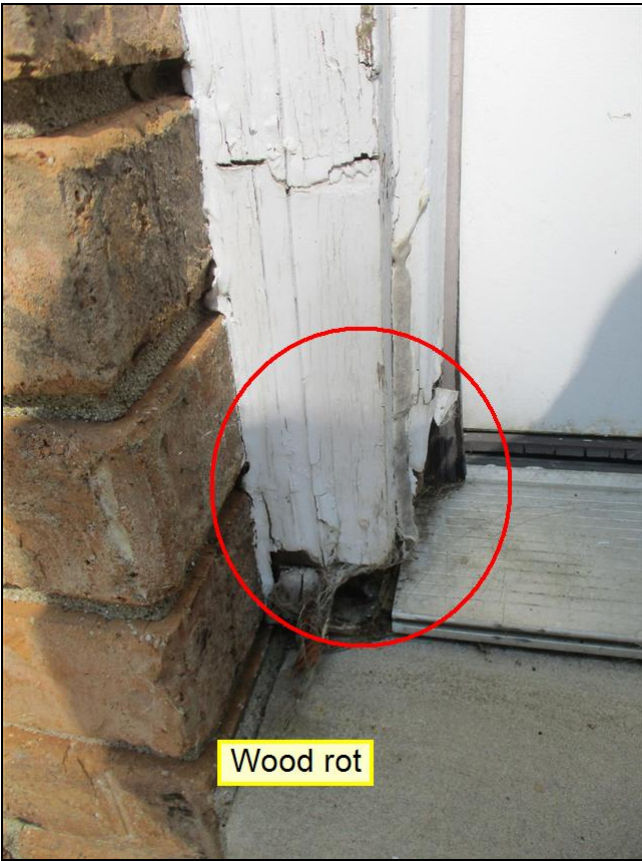
2.0 Item 5(Picture)

Wood rot

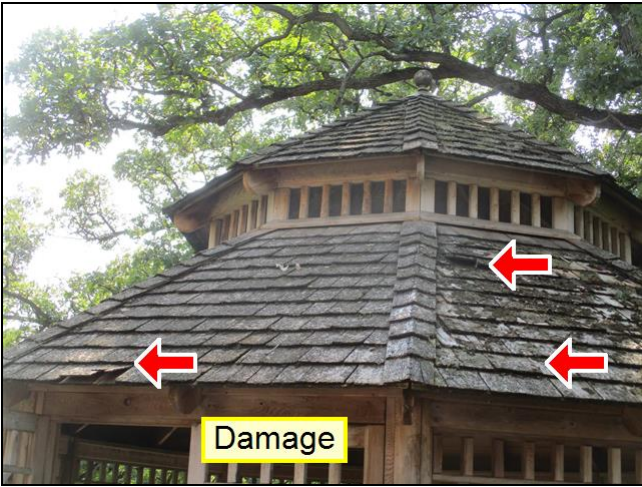
2.4 Item 1(Picture)

2.4 (1) The gazebo cedar shakes are showing damage and algae. If not repaired and maintained, leak may occur. Contact a qualified roofer for further evaluation.

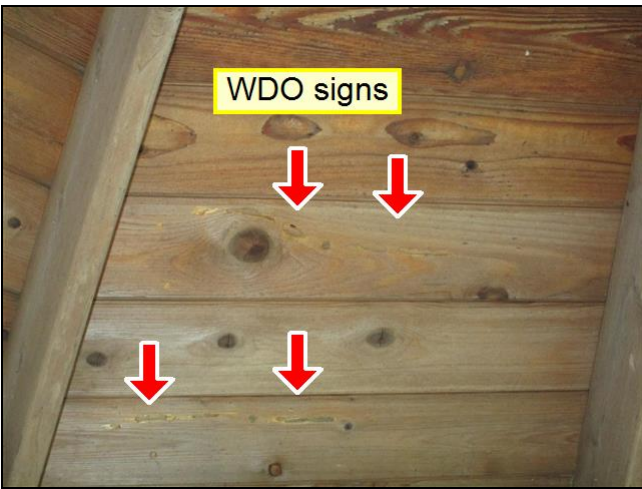
2.4 Item 2(Picture)

📍 (2) Signs of wood destroying organisms (WDOs) were observed in the gazebo ceiling. If not treated, damage to the gazebo and structure may occur. Contact a pest abatement company for further evaluation and treatment options.

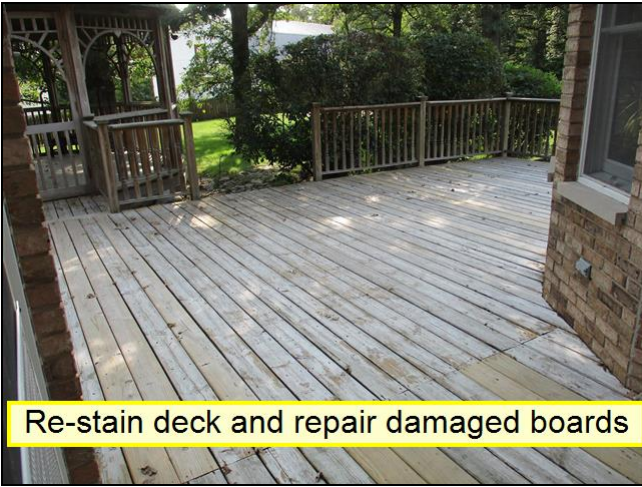
2.4 Item 4(Picture)

(3) The deck wood needs maintenance. I recommend re-staining the wood to prevent damage. Contact a qualified contractor to do so.

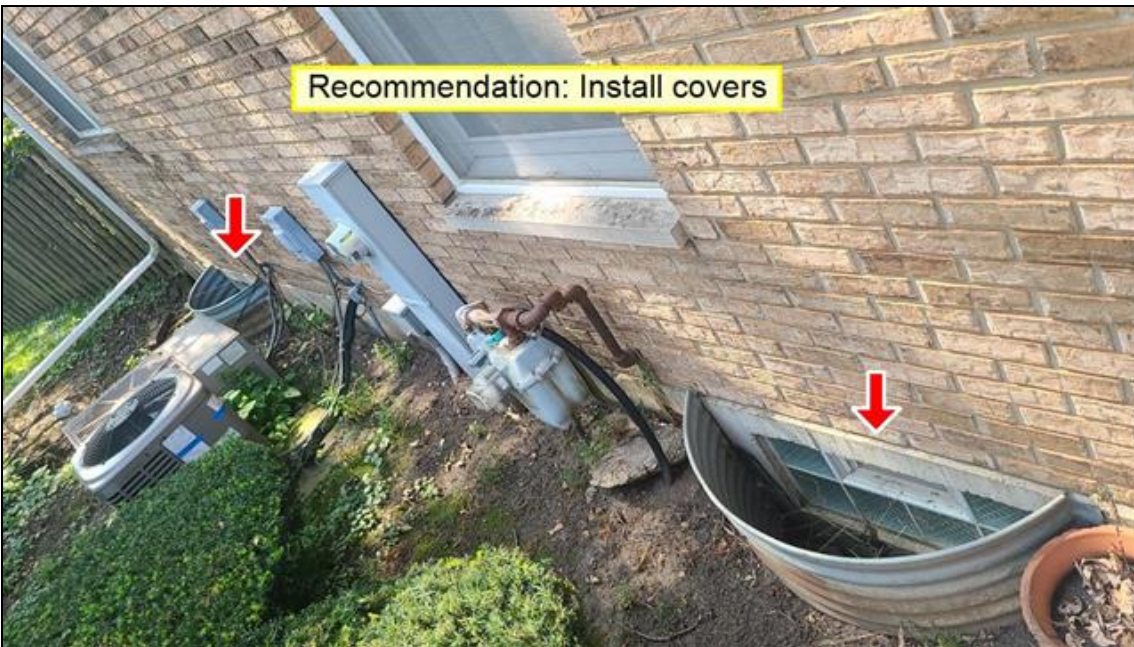
2.5 Item 1(Picture)

2.5 (1) RECOMMENDATION: I recommend installing window well covers on exterior of home. Window well covers prevent water, animals, or intruders from entering home.

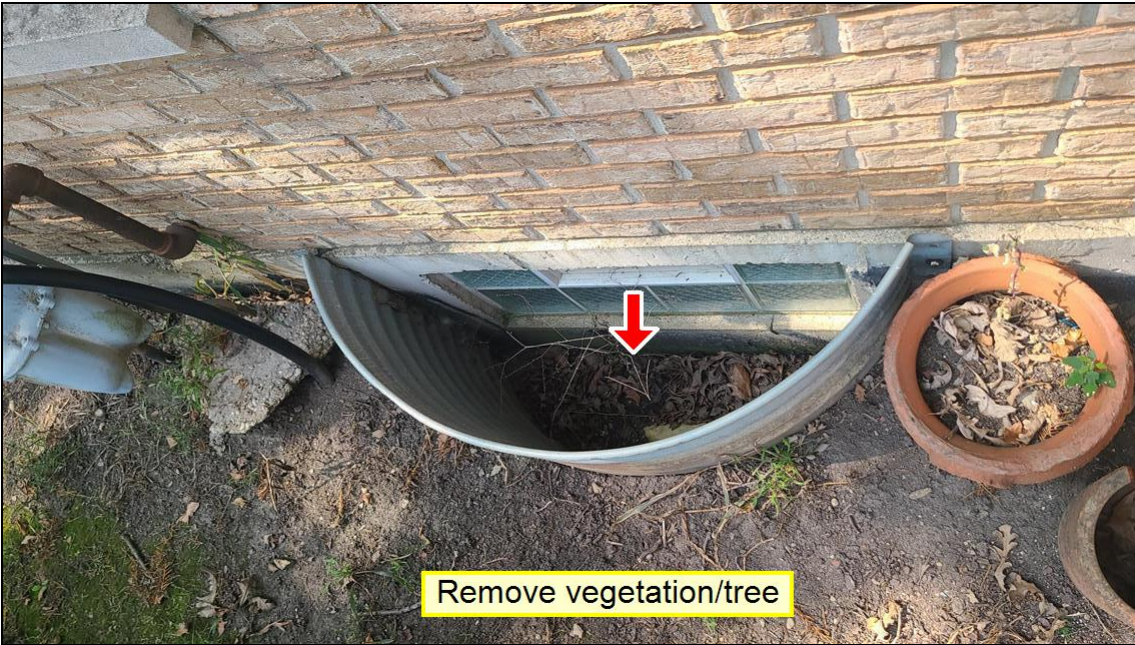
2.5 Item 2(Picture)

(2) Vegetation was observed in the rear window well. Vegetation can attract pests or clog the window well drain. Contact a qualified person to remove the vegetation from the window well.

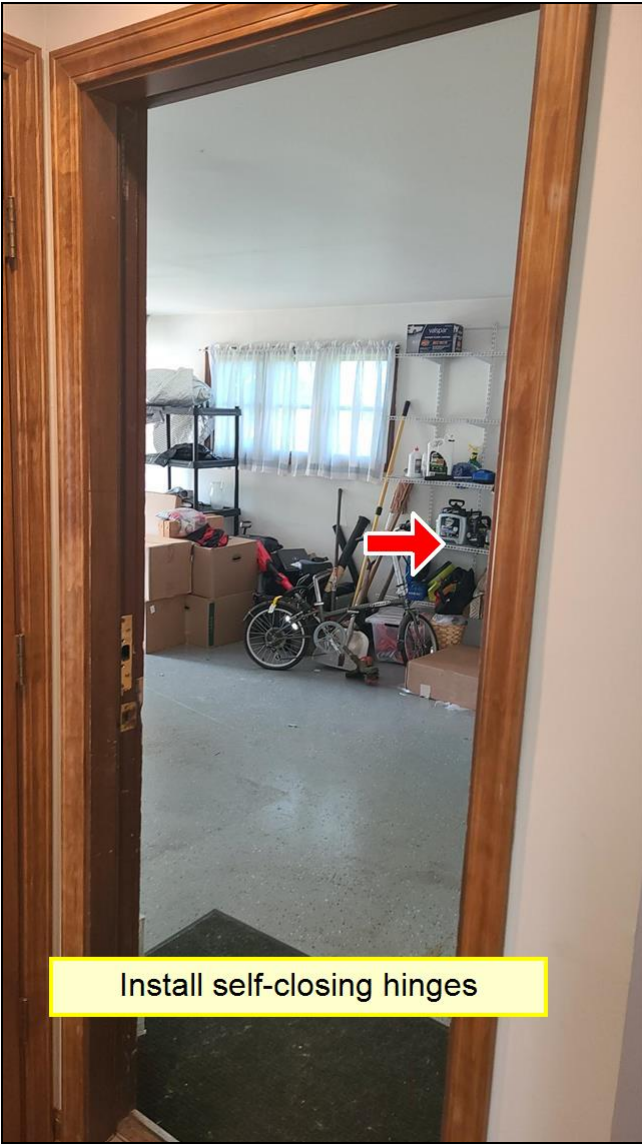
3.3 Item 1(Picture)

3.3 The occupant door to the garage, is not equipped with self closing hinges. Modern fire safety standards require the door between the home and garage, to have self closing hinges. Contact a qualified person to install self closing hinges on garage occupant door.

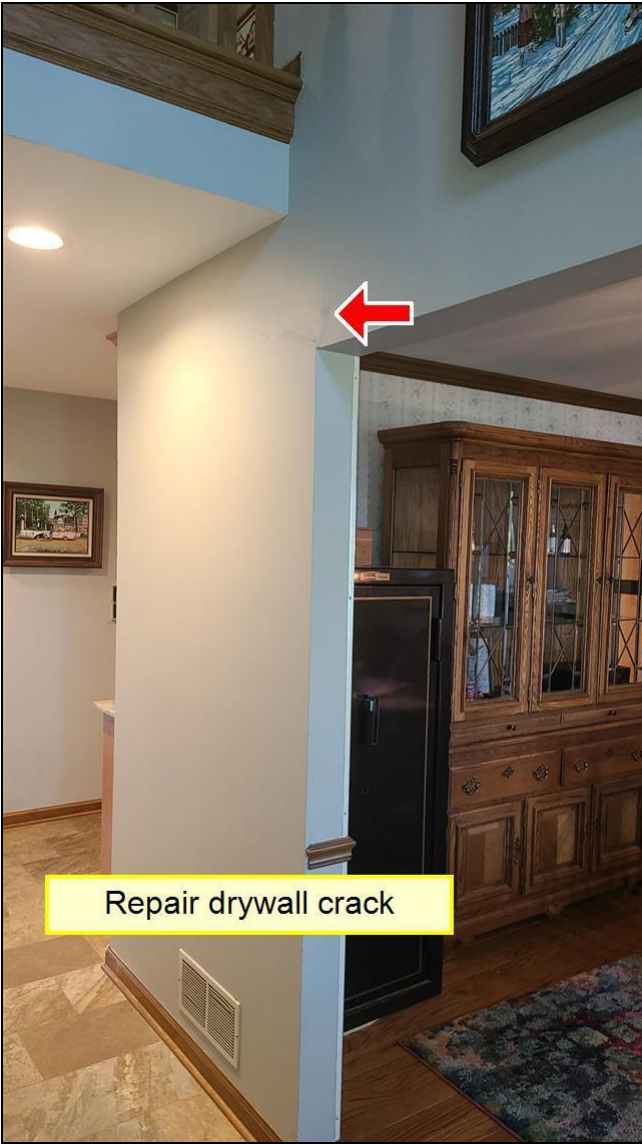
4.1 Item 1(Picture)

4.1 (1) Drywall cracks were observed by the main entrance wall. This is a cosmetic issue and for your information. Contact a qualified contractor to repair the cracks as needed.

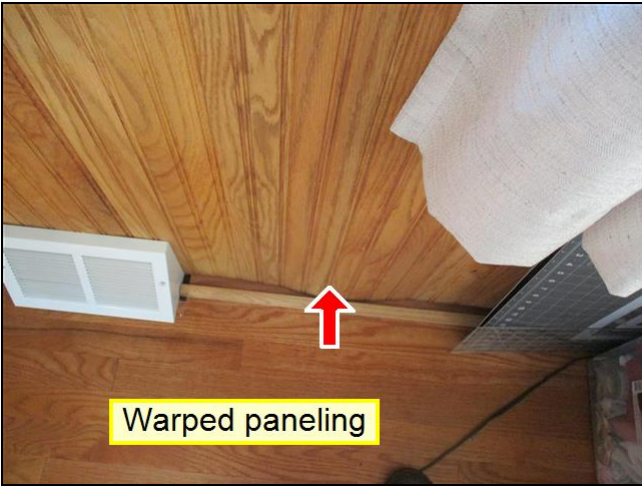
4.1 Item 2(Picture)

👉 (3) Water damage and stains were observed in paneling under the windows in the office room. Contact a qualified contractor for further evaluation and repair.

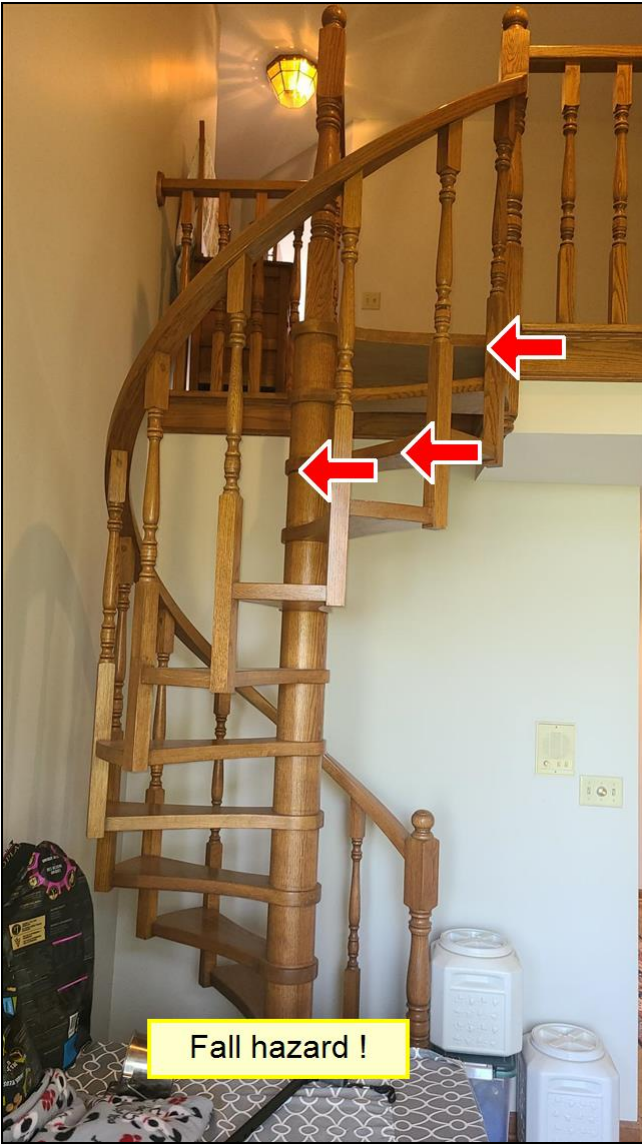
4.3 Item 1(Picture)

4.3 The staircase balusters are too far apart. Modern building standards require the opening to be 4" or less. When this home was built, this was not the requirement. This is a safety requirement to prevent children from falling through the openings. Contact a qualified contractor to install balusters that are 4" or less apart.

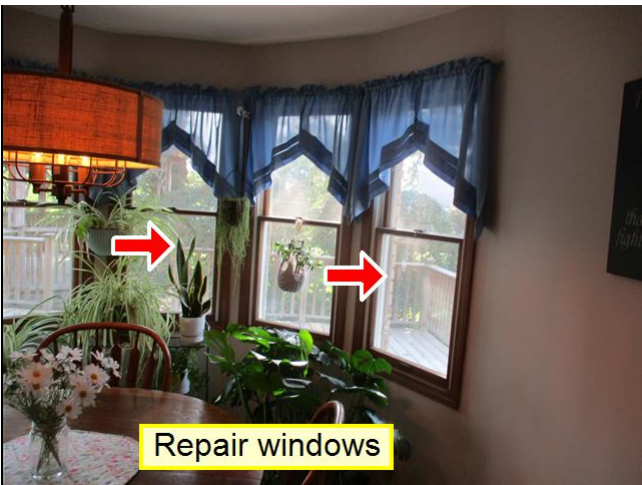
4.4 Item 4(Picture)

🏠 (4) Several of the main level windows would not stay in the open position when opened. The windows slams shut, which could cause injury to occupants. Contact a window repair company to repair the windows.

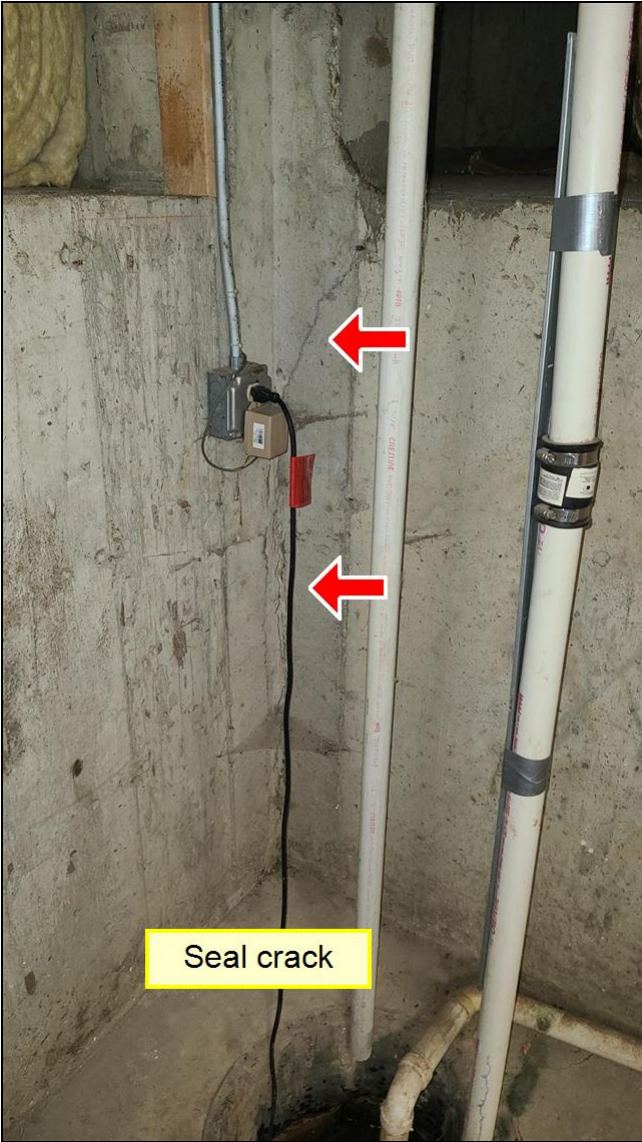
5.0 Item 2(Picture)

5.0 (2) There were several cracks in the basement foundation walls. This is not a structural issue, but cracks should be repaired to prevent further damage or water from entering. Contact a water proofing company to repair all cracks in basement foundation walls.

NOTE: Some of the cracks were not seeping water at the time of the inspection, but there are signs of water seepage. There are water stains and mineral deposits. Cracks may not seep water now, but WILL during heavy rains.

NOTE: The cracks that showed sign of seepage is the area that has low grading on the outside.

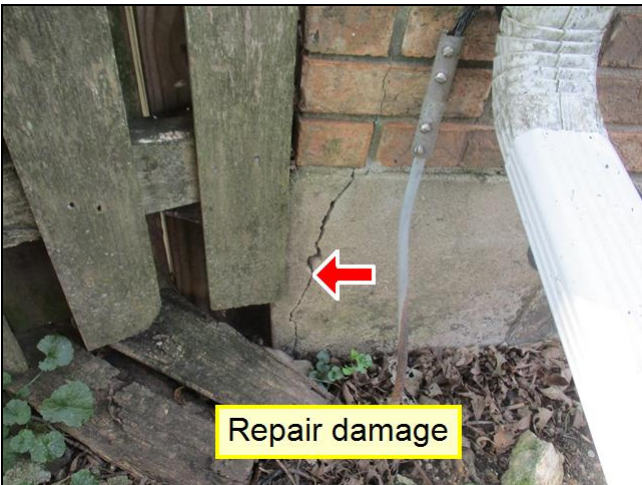
5.0 Item 11(Picture)

🏠 (4) Damage was observed on the corner of the foundation slab "Corner pop". This is not a structural issue, but the damage should be repaired to prevent further damage or water from entering. Contact a concrete repair company for further evaluation and repair.

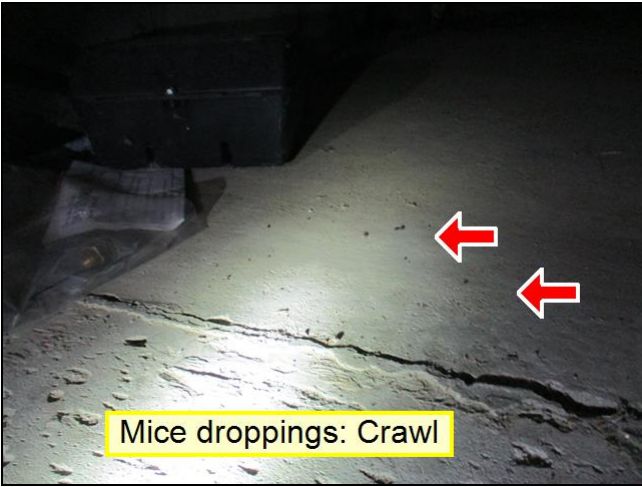
5.0 Item 13(Picture)

🏠 (5) There are signs of rodents entering the home. To properly correct this issue, any penetrations to the exterior should be sealed. Contact a pest control company for further evaluation.

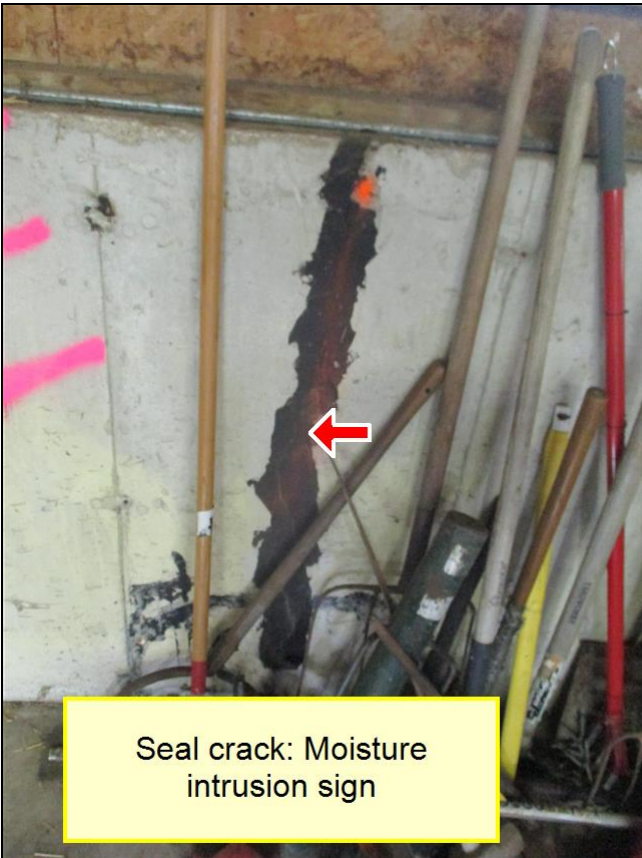
5.0 Item 14(Picture)

📍 (6) There were several cracks in the outbuilding foundation walls. This is not a structural issue, but cracks should be repaired to prevent further damage or water from entering. Contact a waterproofing company to repair all cracks in outbuilding foundation walls.

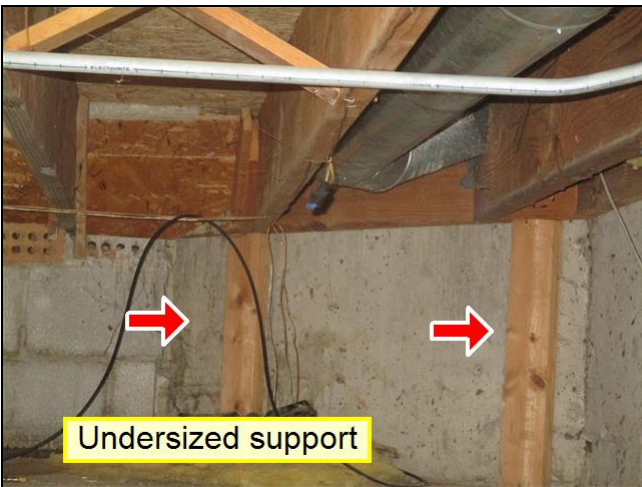
5.4 Item 1(Picture)

5.4 The fireplace room floor structure is supported using only 2X4 lumber (Undersized support) . I recommend contacting a framing contractor for further evaluation.

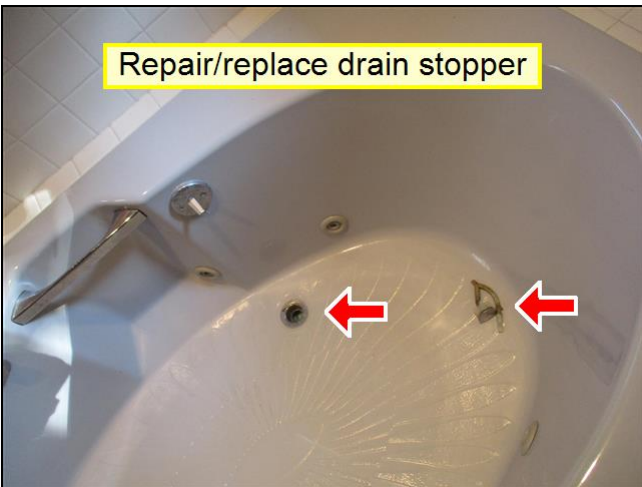
6.1 Item 1(Picture)

The drain stoppers did not function at the master sink/jetted tub. Contact a qualified plumber to repair or replace the drain stoppers.

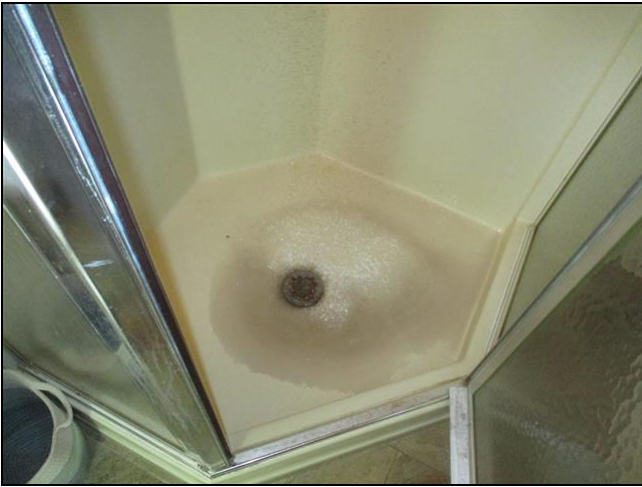
6.2 Item 2(Picture)

(2) The hot water was dirty when operated from fixtures. This is an indication that sediment is building up inside the tank. I recommend draining some sediment from the bottom of the tank. There is a water spigot present for this purpose. I also recommend installing an in-line filter.

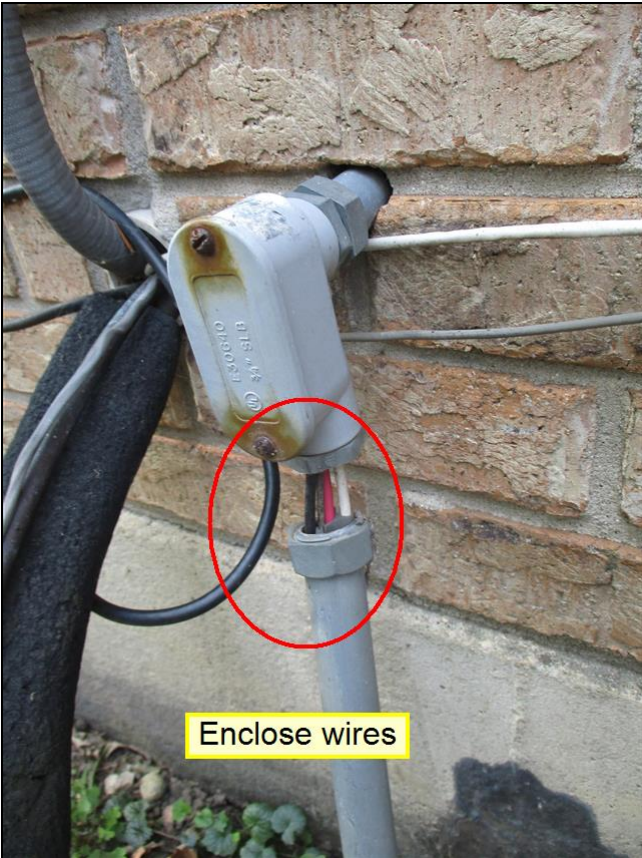
7.2 Item 1(Picture)

**7.2 (1)** Exposed electrical wires were observed on the exterior by the AC unit. If not enclosed, injury to occupants may occur or water may cause damage. Contact a qualified electrician for correction.

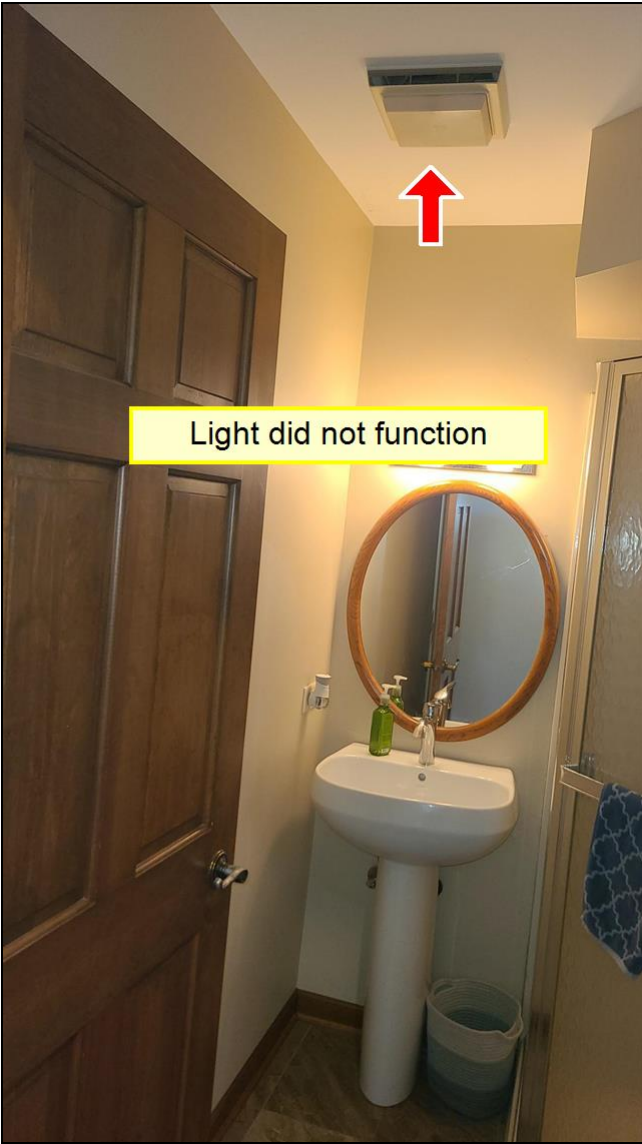
7.2 Item 4(Picture)

🏠 (3) There were several lights that did not function. It may be burnt out light bulbs, or defective light fixtures. I recommend having the home owner replace all burnt out light bulbs so that you can check them when you do your final walk-through.

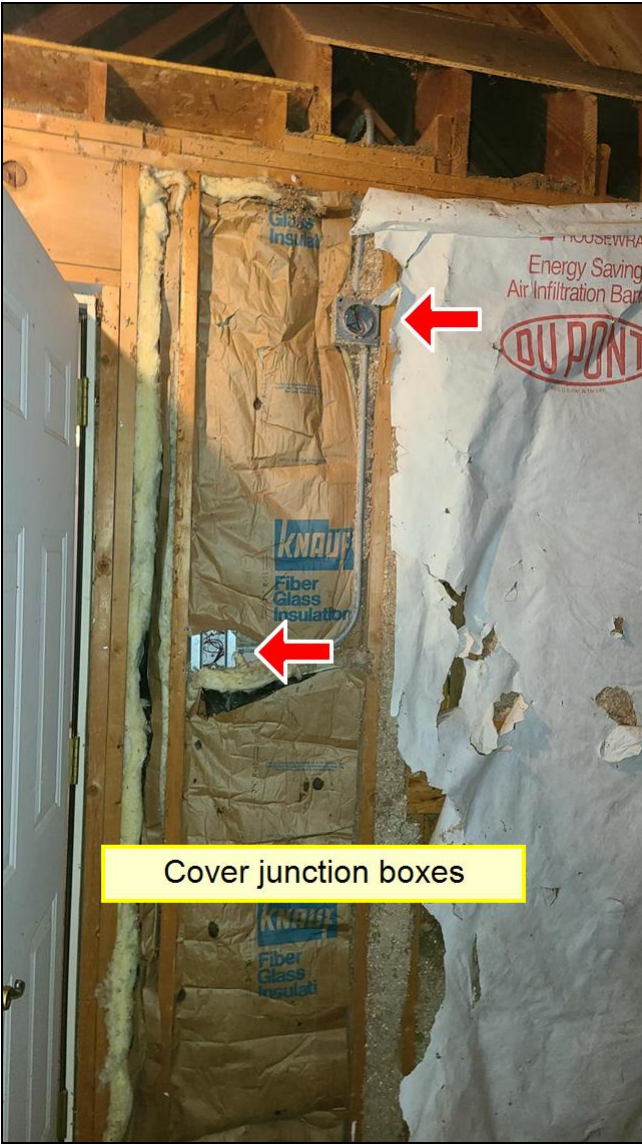
7.2 Item 8(Picture)

📌 (5) There were two open junction boxes in the attic of the home. Open junction boxes are a safety hazard because the wires are exposed to the occupants. Contact a qualified person to install a cover on the open junction box.

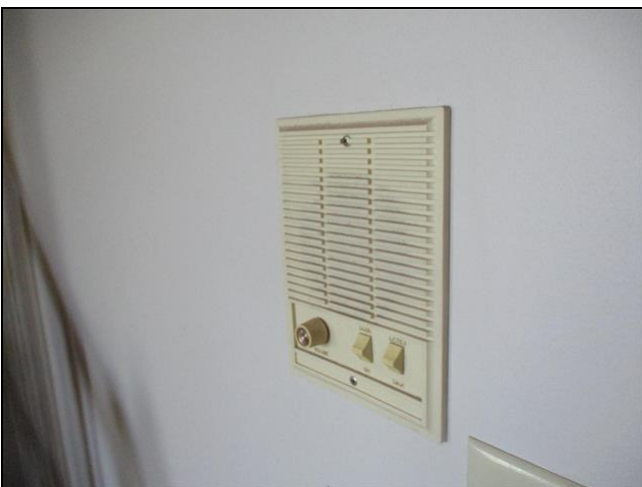
7.2 Item 9(Picture)

(6) The intercom system did not function. Contact a qualified data contractor to further evaluate and repair as needed.

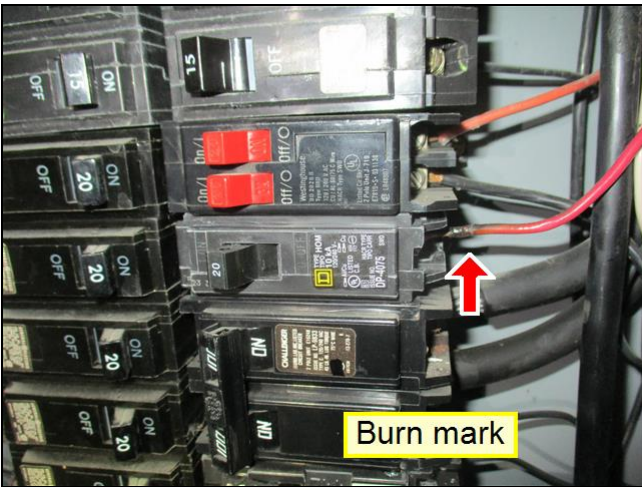
7.6 Item 4(Picture)

🏠 (2) Heat damage was observed on one of the branch electrical wires in the main electrical panel .If not corrected, further damage may occur. Contact a qualified electrician for further evaluation and correction.

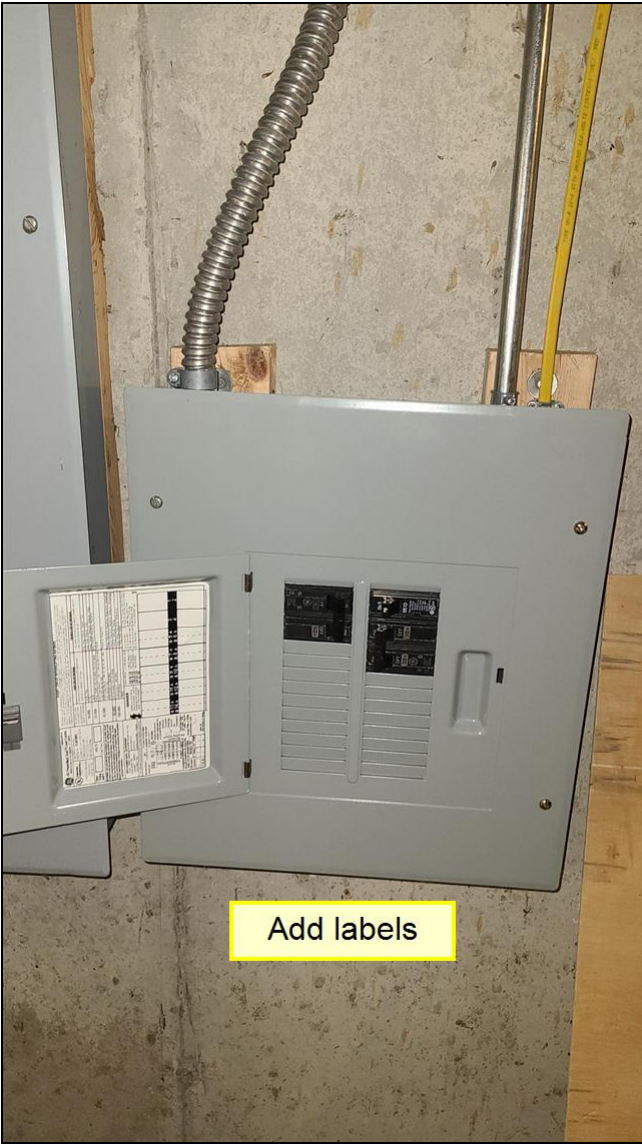
7.6 Item 5(Picture)

(3) There were no labels on the sub electrical panel. I recommend correcting for safety reasons.

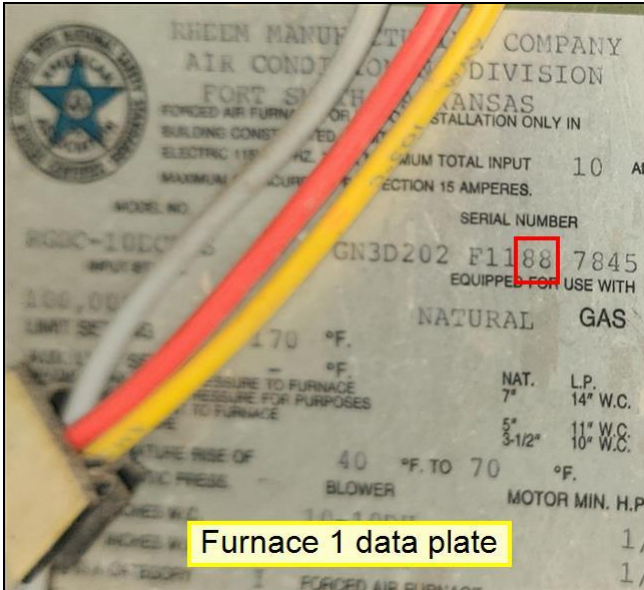
Furnace 1 data plate

When both furnaces were turned on, a strong smoke smell was observed in the home. A cracked heat exchanger might be a possible cause. Contact a qualified HVAC professional for further evaluation of the furnaces

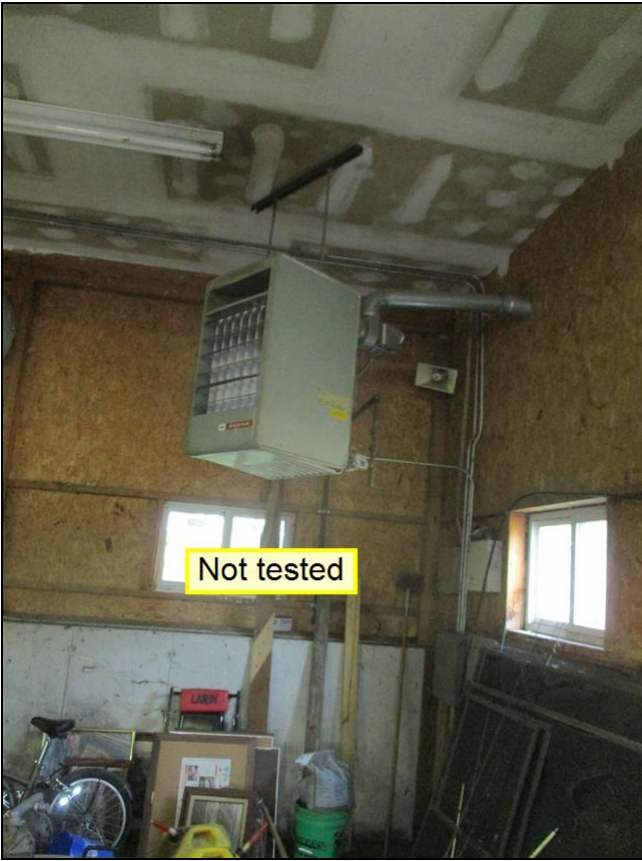
8.4 Item 7(Picture)

(3) I was unable to test the outbuilding heater as i was unable to find the thermostat controlling the heater. I recommend asking the seller for more details.

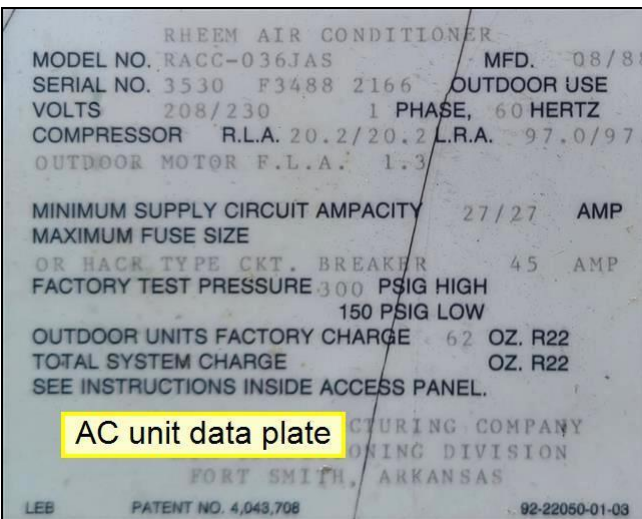
8.8 Item 2(Picture)

8.8 (1) The Rheem air conditioner was manufactured in 1988. The average life expectancy in 15 years. It is difficult to determine how much longer this unit will last, but it is at the end of its' life expectancy. I recommend budgeting for replacement.

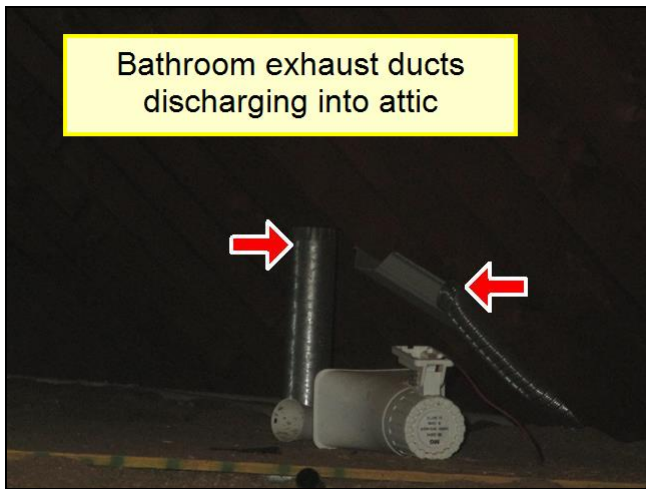
9.3 Item 1(Picture)

9.3 There are two bathroom exhaust fans that are discharging into the attic. If not corrected, moisture related problems may develop. Contact a qualified person to discharge the exhaust fans to the exterior of the home.

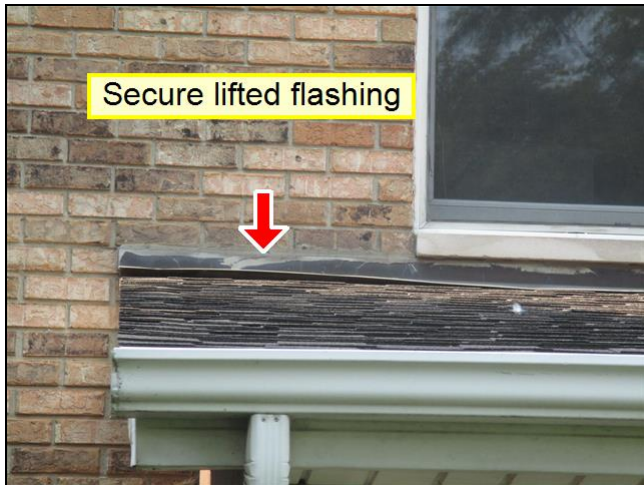
1.0 Item 1(Picture)

Lifted flashing was observed on the front of the home. This occurs when nails push up the flashing, or they are not properly secured. If not secured, moisture may enter and damage home. Contact a qualified roofer for correction.

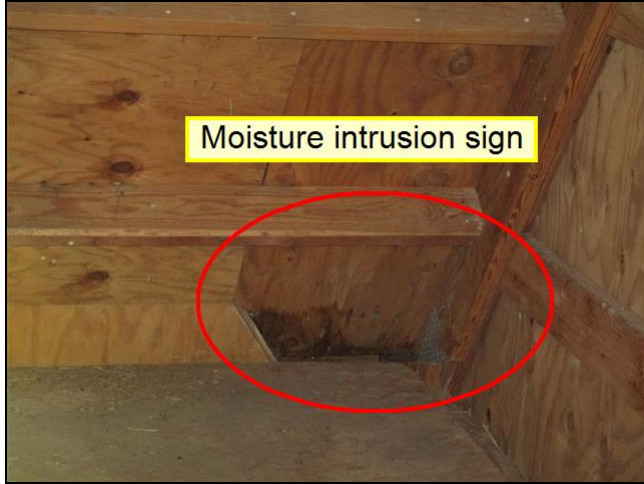
1.1 Item 10(Picture)

(3) A roof leak was observed in the attic of the outbuilding. The area was not wet at time of inspection. If not corrected, moisture related issues will develop and further damage will occur. Contact a qualified roofer for correction and further evaluation of the outbuilding roof.

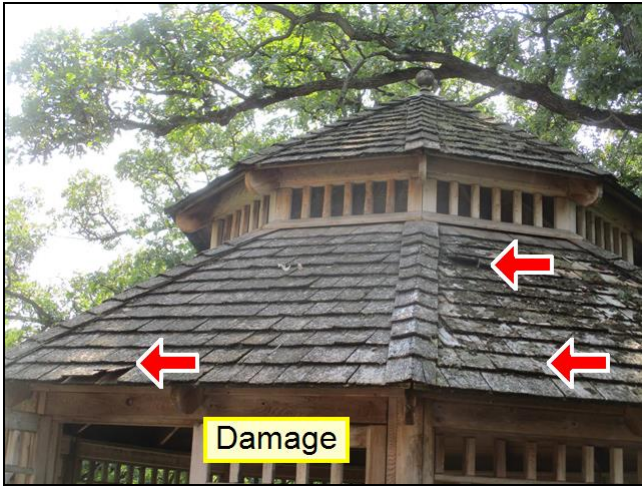
2.4 Item 1(Picture)

(1) The gazebo cedar shakes are showing damage and algae. If not repaired and maintained, leak may occur. Contact a qualified roofer for further evaluation.

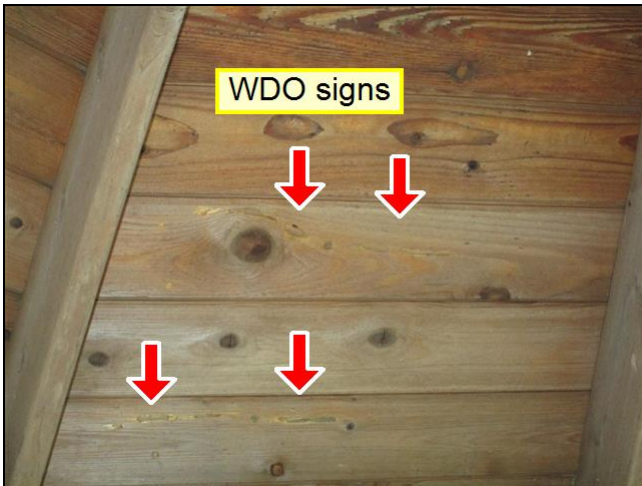
2.4 Item 2(Picture)

(2) Signs of wood destroying organisms (WDOs) were observed in the gazebo ceiling. If not treated, damage to the gazebo and structure may occur. Contact a pest abatement company for further evaluation and treatment options.

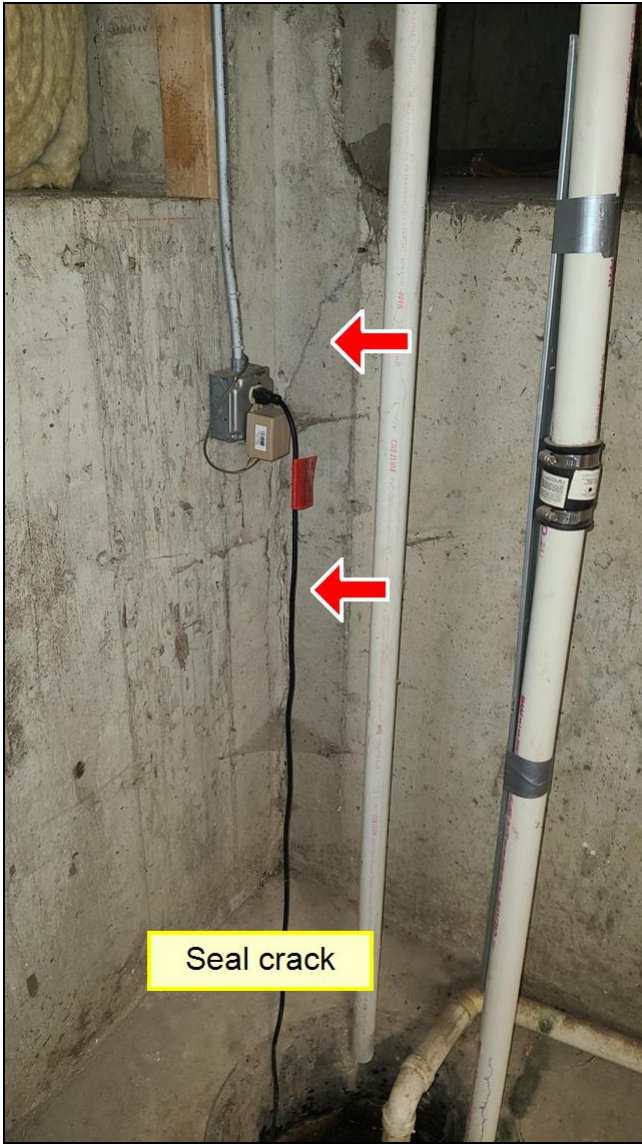
5.0 Item 2(Picture)

NOTE: The cracks that showed sign of seepage is the area that has low grading on the outside.

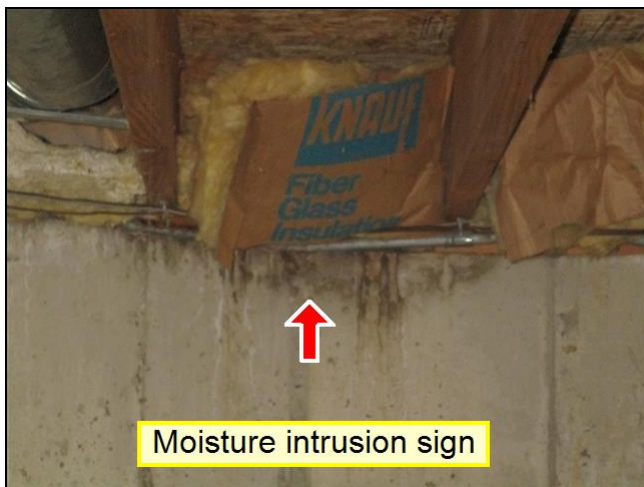
5.0 Item 6(Picture)

(3) Moisture appears to be entering the crawlspace between the foundation wall and the sill plate and through the fireplace cinder blocks at the rear of the home. If not corrected, moisture related issues and further damage may develop. Contact a waterproofing company for correction and further evaluation.

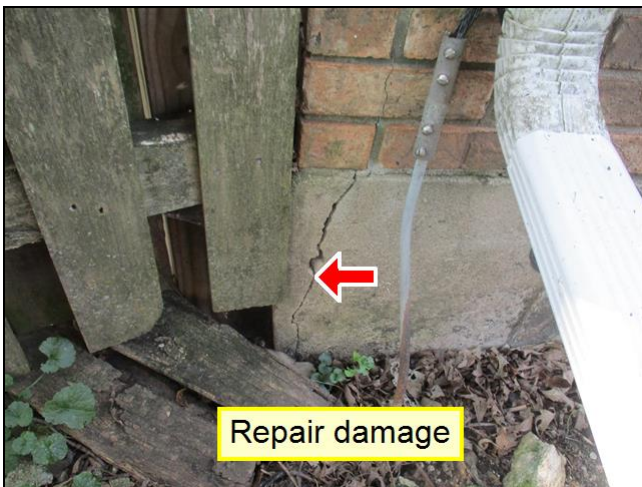
5.0 Item 11(Picture)

(4) Damage was observed on the corner of the foundation slab "Corner pop". This is not a structural issue, but the damage should be repaired to prevent further damage or water from entering. Contact a concrete repair company for further evaluation and repair.

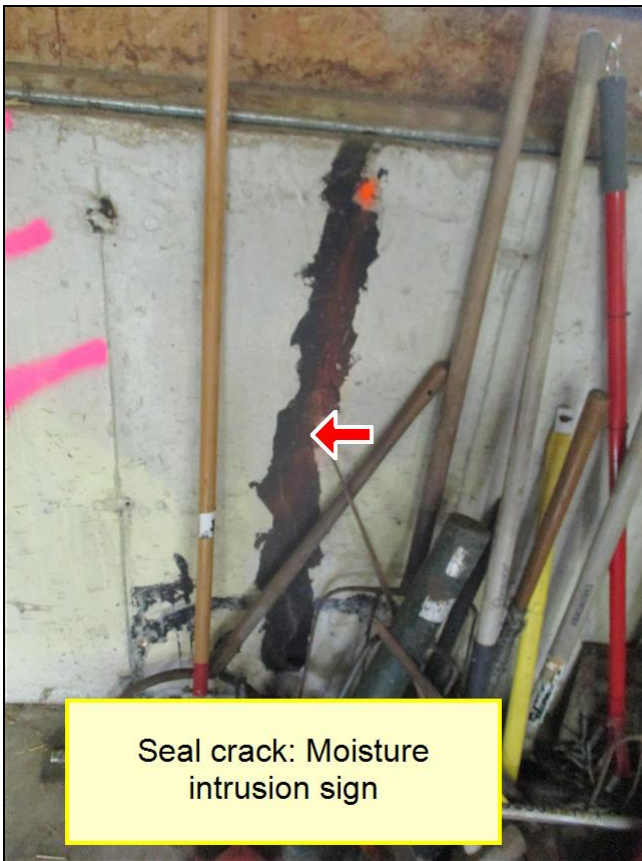
5.0 Item 14(Picture)

(6) There were several cracks in the outbuilding foundation walls. This is not a structural issue, but cracks should be repaired to prevent further damage or water from entering. Contact a waterproofing company to repair all cracks in outbuilding foundation walls.

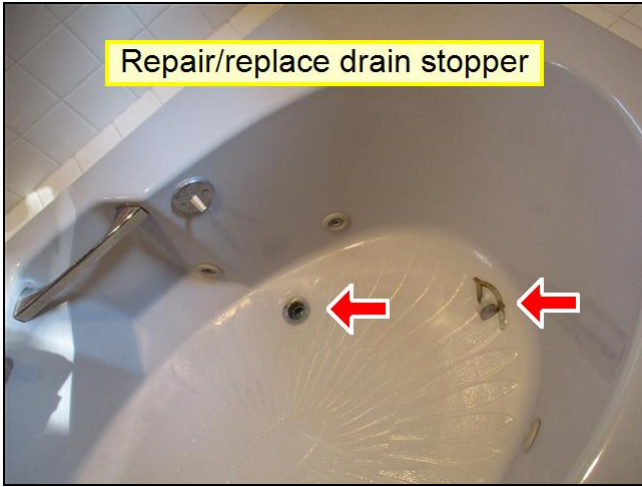
6.1 Item 1(Picture)

(2) The drain stoppers did not function at the master sink/jetted tub. Contact a qualified plumber to repair or replace the drain stoppers.

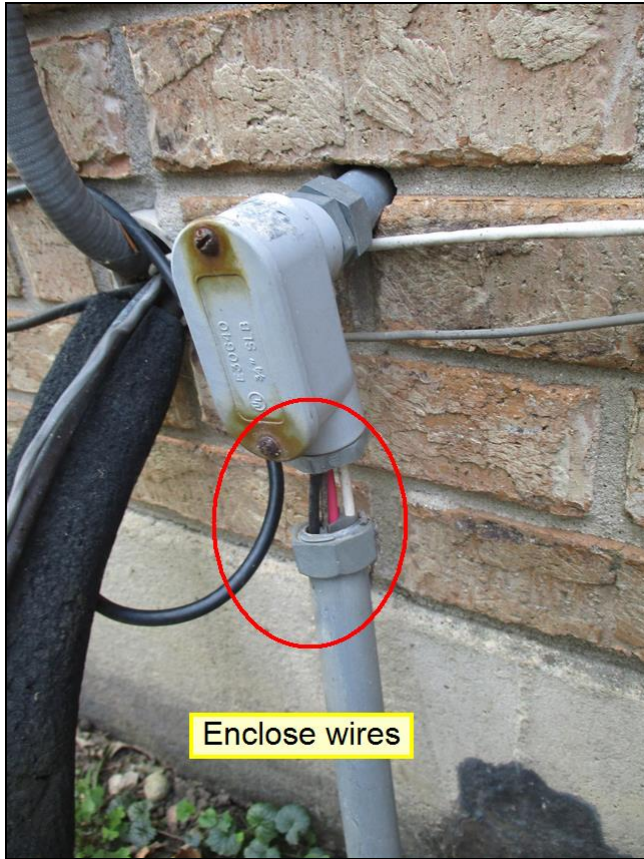
7.2 Item 1(Picture)

(1) Exposed electrical wires were observed on the exterior by the AC unit. If not enclosed, injury to occupants may occur or water may cause damage. Contact a qualified electrician for correction.

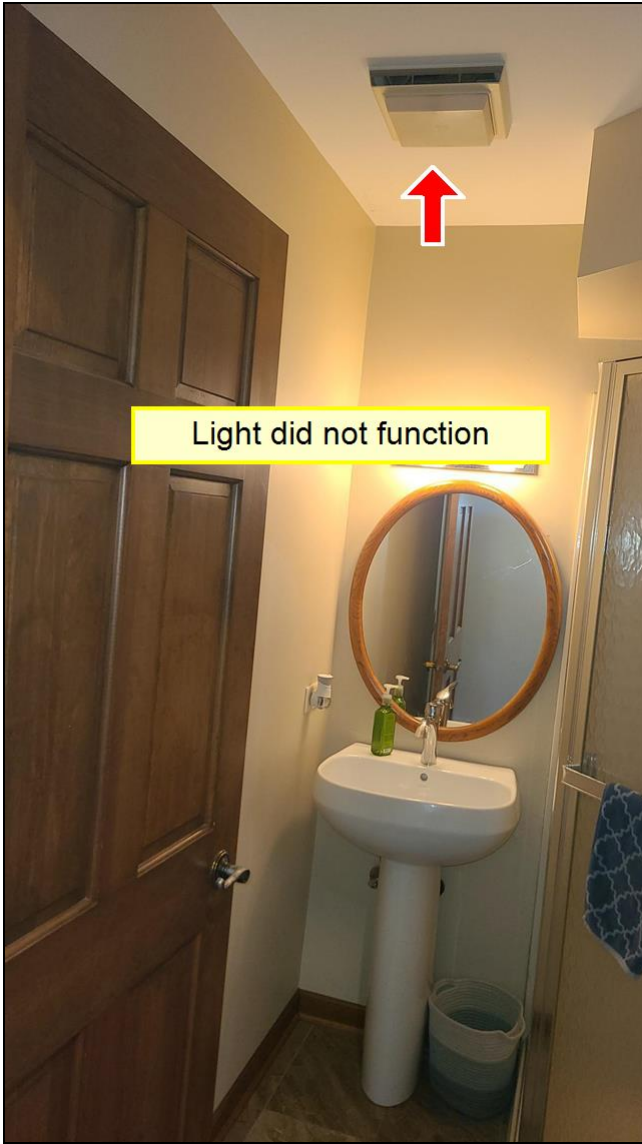
7.2 Item 4(Picture)

(3) There were several lights that did not function. It may be burnt out light bulbs, or defective light fixtures. I recommend having the home owner replace all burnt out light bulbs so that you can check them when you do your final walk-through.

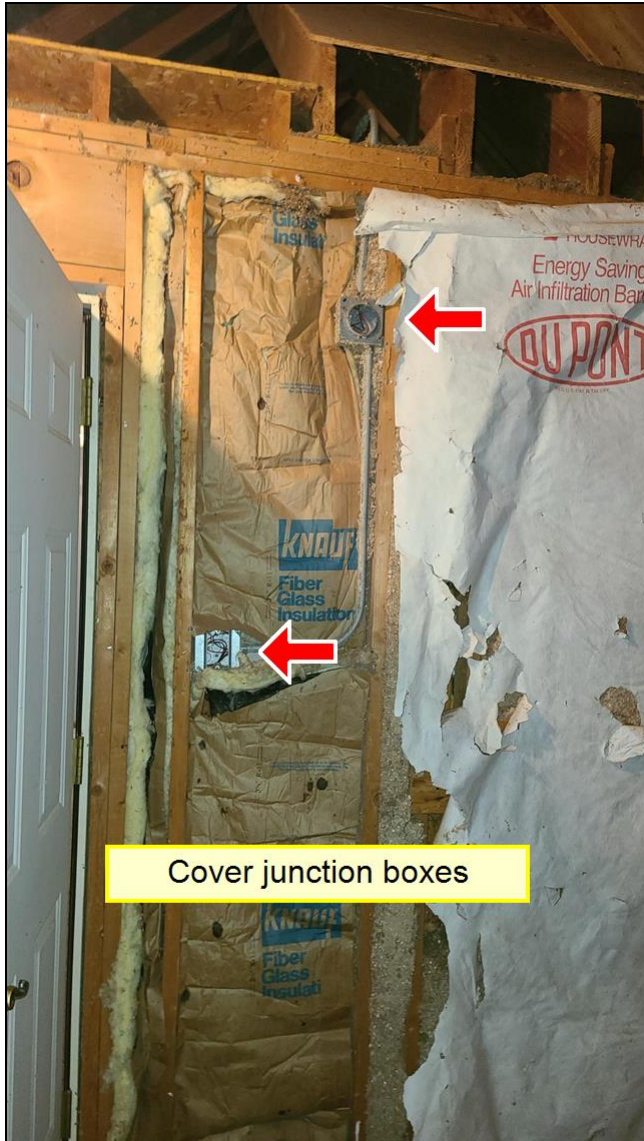
7.2 Item 8(Picture)

(5) There were two open junction boxes in the attic of the home. Open junction boxes are a safety hazard because the wires are exposed to the occupants. Contact a qualified person to install a cover on the open junction box.
