Inspection Report

Property Address:
16233 W Randell St
Manhattan IL 60442

SafeCheck Home Inspection

Date: 9/11/2024	Time: 02:00 PM	Report ID: 20240911-16015-W-Baker-Rd
Property: 16233 W Randell St Manhattan IL 60442	Customer: Joe Smith	Real Estate Professional:

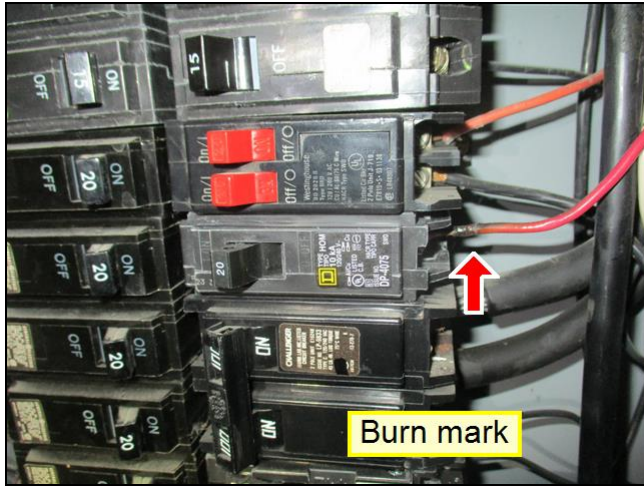
7.6 Item 4(Picture)

(2) Heat damage was observed on one of the branch electrical wires in the main electrical panel .If not corrected, further damage may occur. Contact a qualified electrician for further evaluation and correction.

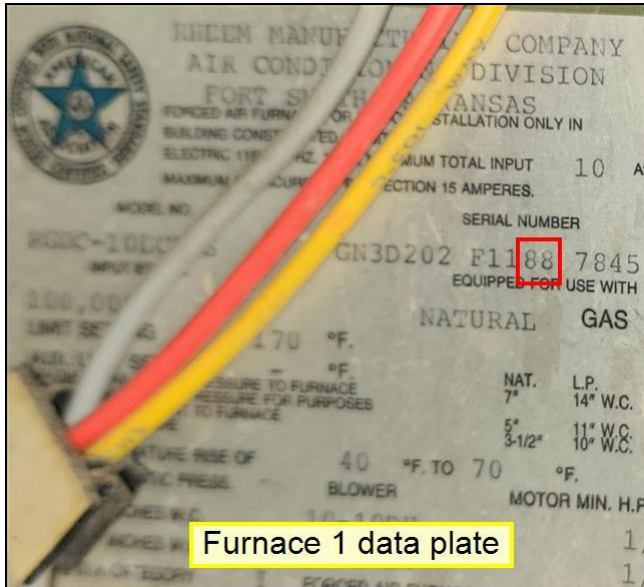
Furnace 1 data plate

When both furnaces were turned on, a strong smoke smell was observed in the home. A cracked heat exchanger might be a possible cause. Contact a qualified HVAC professional for further evaluation of the furnaces

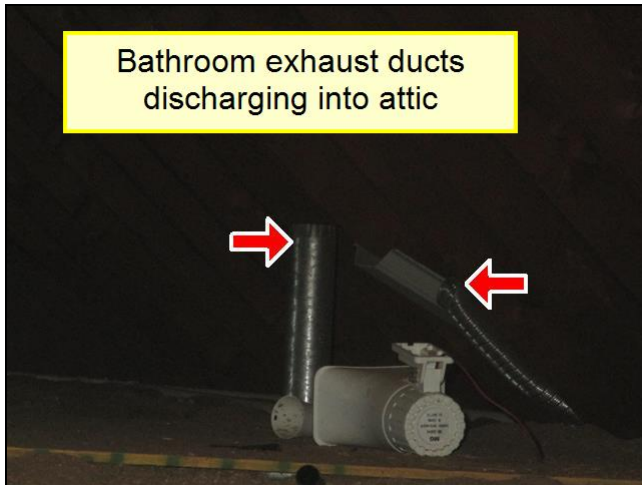
9.3 Item 1(Picture)

There are two bathroom exhaust fans that are discharging into the attic. If not corrected, moisture related problems may develop. Contact a qualified person to discharge the exhaust fans to the exterior of the home.

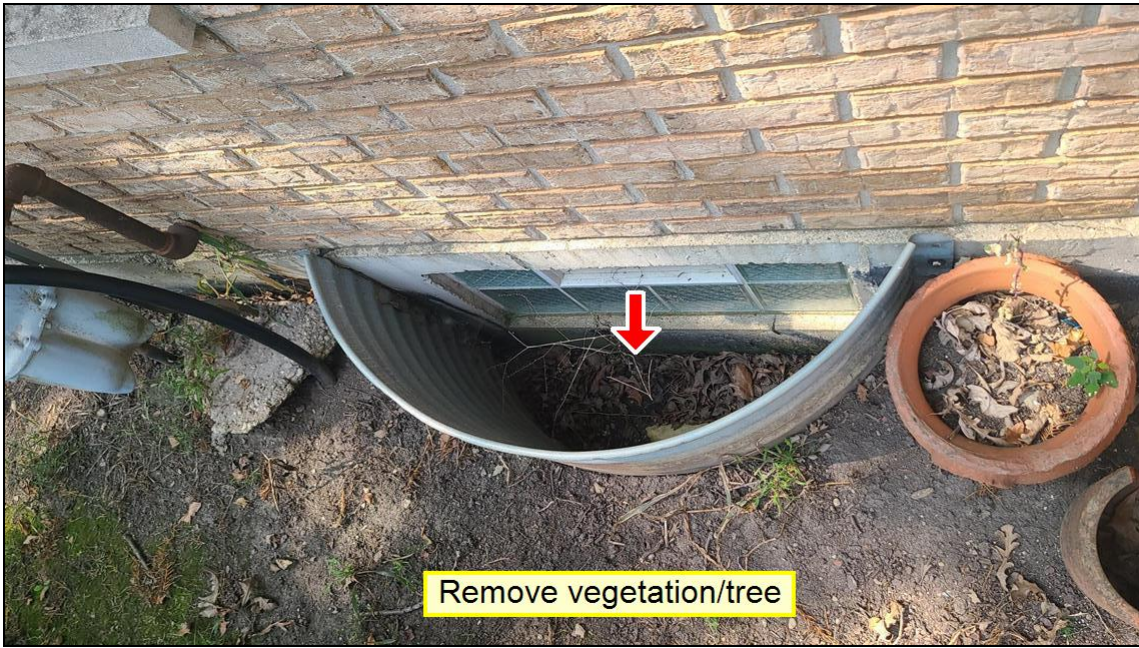
2.5 Item 2(Picture)

(2) Vegetation was observed in the rear window well. Vegetation can attract pests or clog the window well drain. Contact a qualified person to remove the vegetation from the window well.

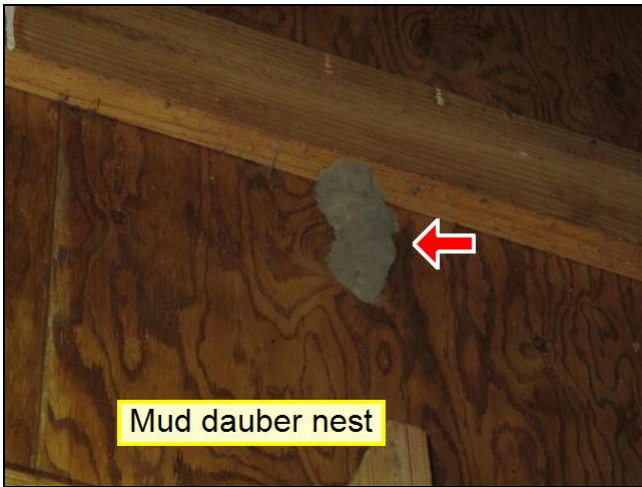
2.5 Item 3(Picture)

(3) There are wasp nests in the attic of the outbuilding. Wasps can cause injury to occupants. I recommend contacting an exterminating company to remove all wasp nests.

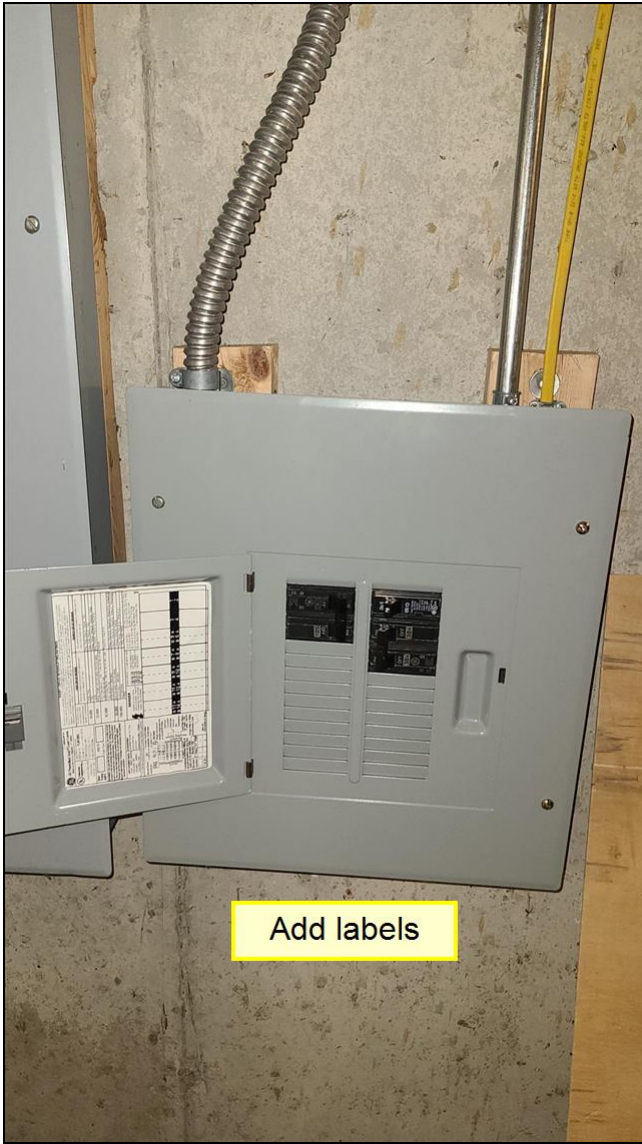
7.6 Item 5(Picture)

(3) There were no labels on the sub electrical panel. I recommend correcting for safety reasons.
