Inspection Report

Property Address:
16233 W Randell St
Manhattan IL 60442

SafeCheck Home Inspection

Date: 9/11/2024	Time: 02:00 PM	Report ID: 20240911-16015-W-Baker-Rd
Property: 16233 W Randell St Manhattan IL 60442	Customer: Joe Smith	Real Estate Professional:

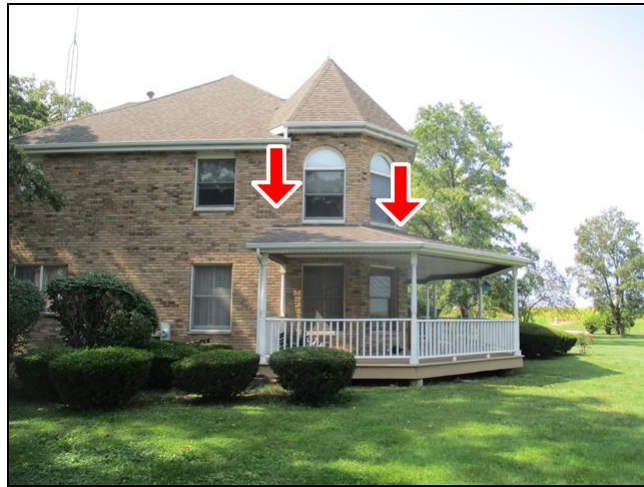
1.0 Item 2(Picture)

1.0 Lifted flashing was observed on the front of the home. This occurs when nails push up the flashing, or they are not properly secured. If not secured, moisture may enter and damage home. Contact a qualified roofer for correction.

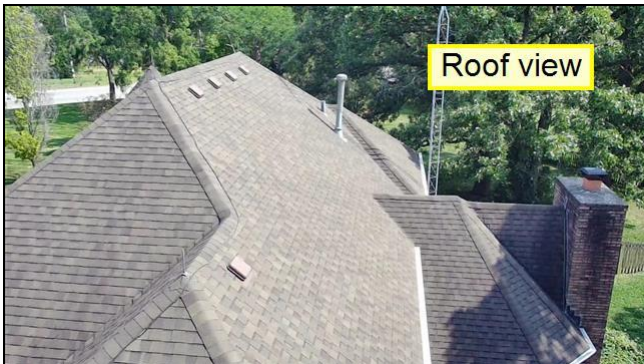
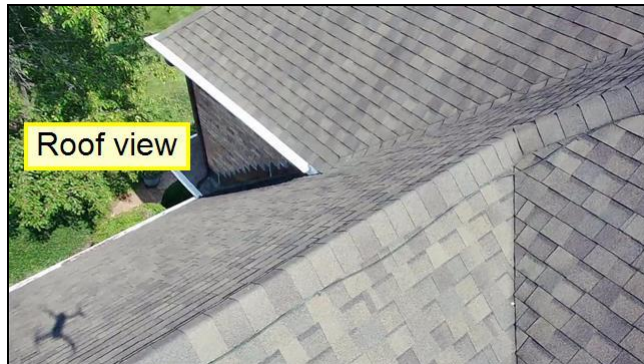
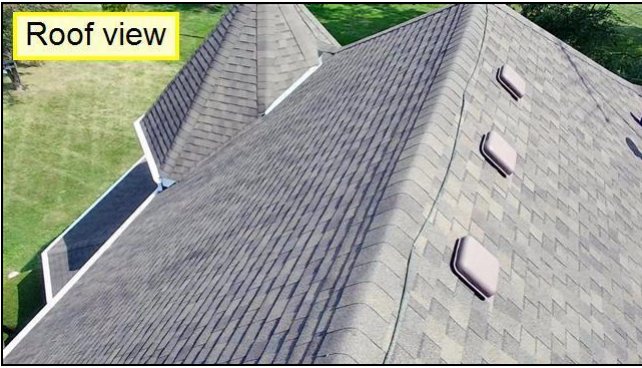
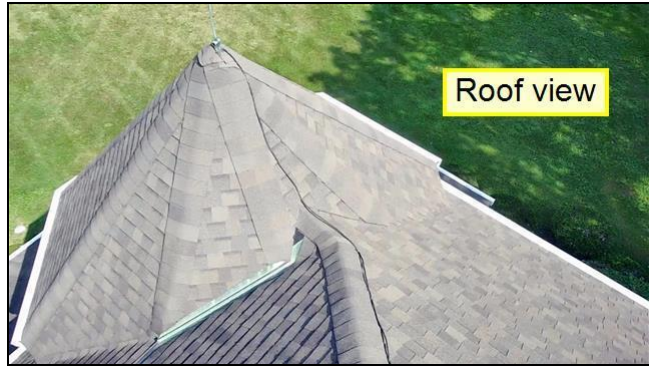
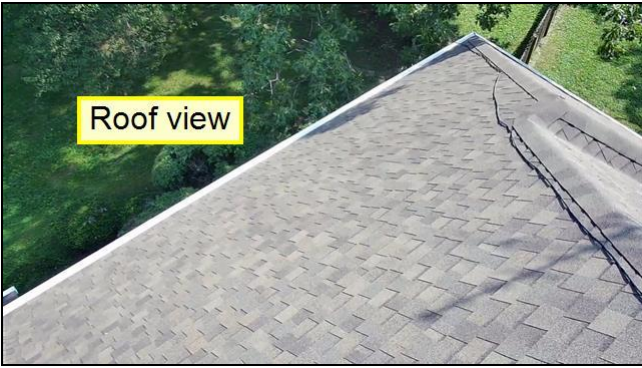
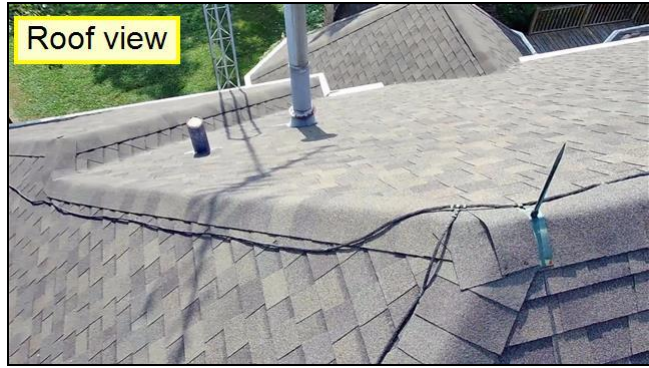
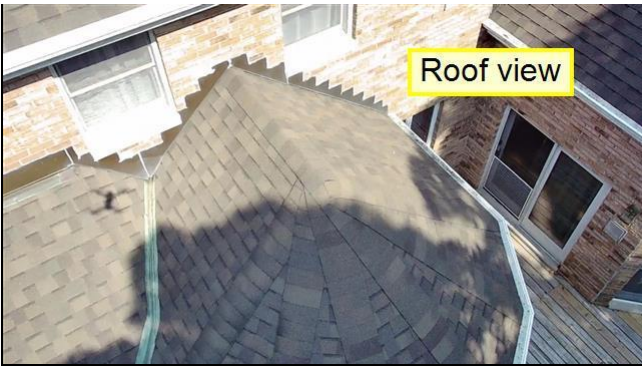
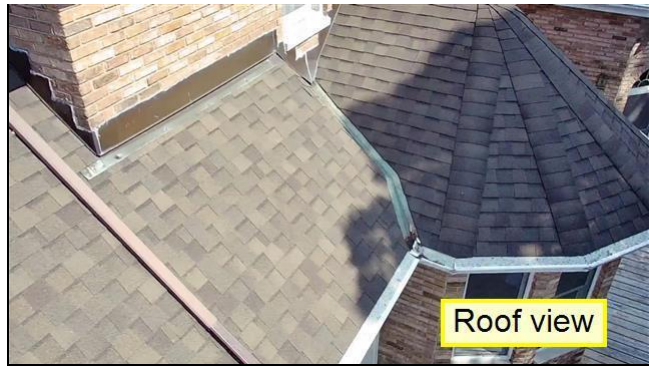
1.1 (1) The shingles were in the third quarter of their life expectancy.

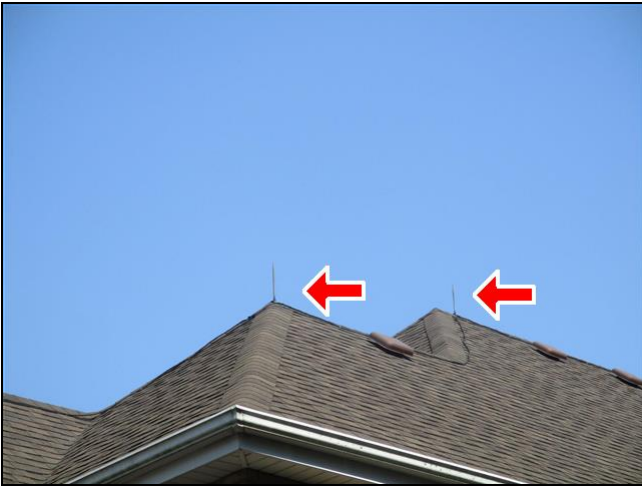
1.1 Item 9(Picture)

(2) Your roof is supplied with lighting rods. These rods protect the roof from damage in case of the lighting strike. This is for your information.

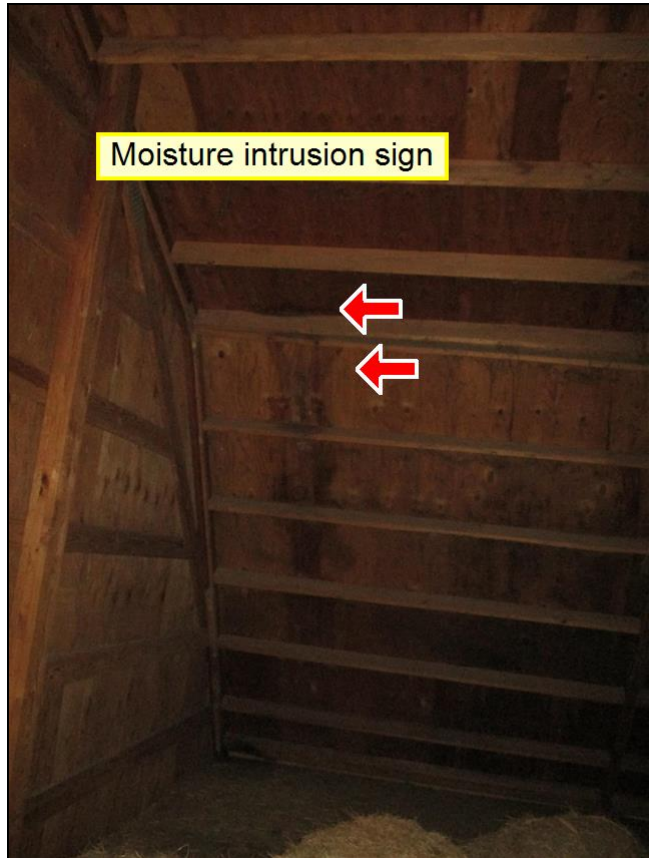
1.1 Item 11(Picture)

🏠 (3) A roof leak was observed in the attic of the outbuilding. The area was not wet at time of inspection. If not corrected, moisture related issues will develop and further damage will occur. Contact a qualified roofer for correction and further evaluation of the outbuilding roof.

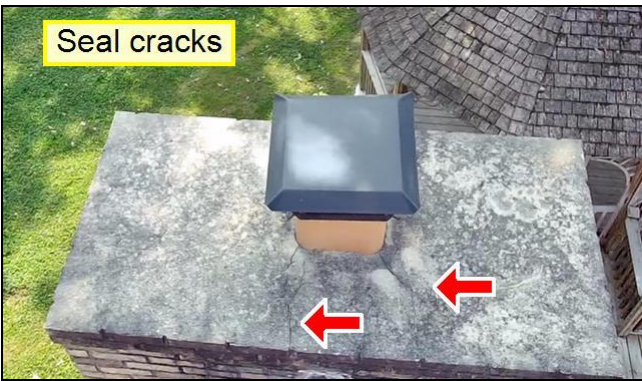
1.2 Item 1(Picture)

1.2 The chimney crown is cracking, and deteriorating. If not repaired, further damage will occur. Contact a qualified contractor to repair the chimney crown.

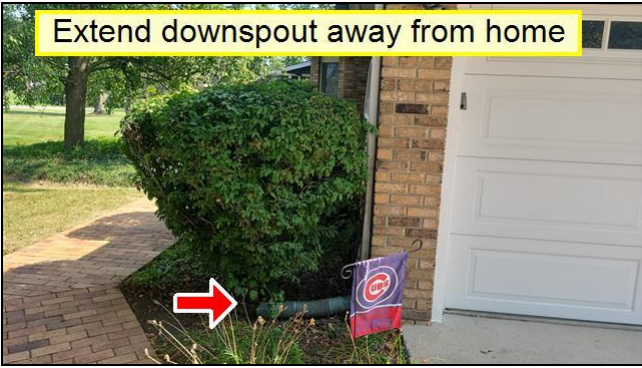
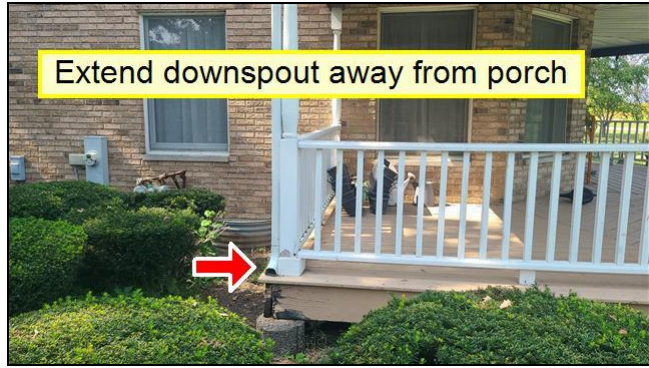
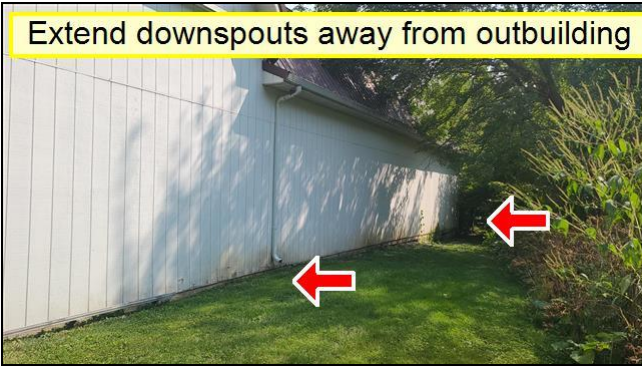
1.3 (1) The downspouts should be extended 6'-8' away from the home/outbuilding. This will prevent damage to the foundation, and water from entering the lower levels of the home. Contact a landscaping contractor to extend all downspouts away from home/outbuilding.

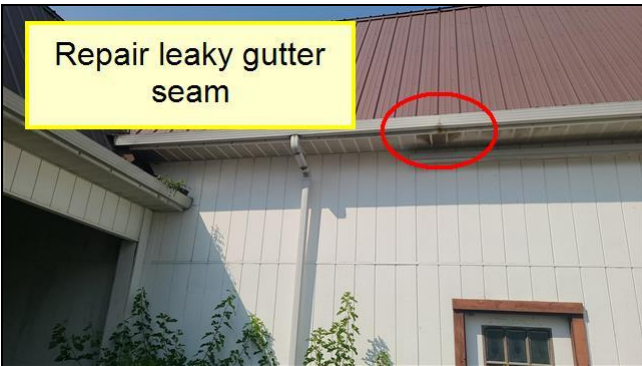
1.3 Item 4(Picture)

📍 (2) There are signs that the gutters are leaking at the seams in the outbuilding. There are water stains and rusting present. Contact a qualified contractor to repair leaking seams.

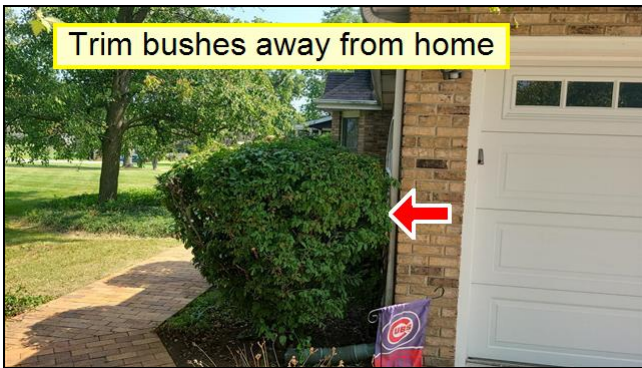
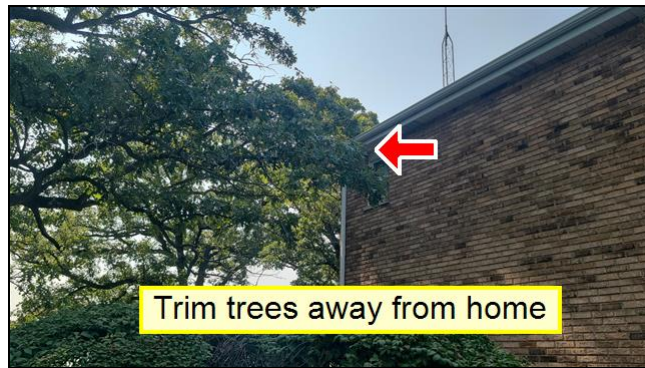
2.0 (1) There are trees and bushes in contact with the home. They should be trimmed or removed to prevent damage to the home. Contact a landscaping company to trim or remove all bushes and trees that are located too close to the home.

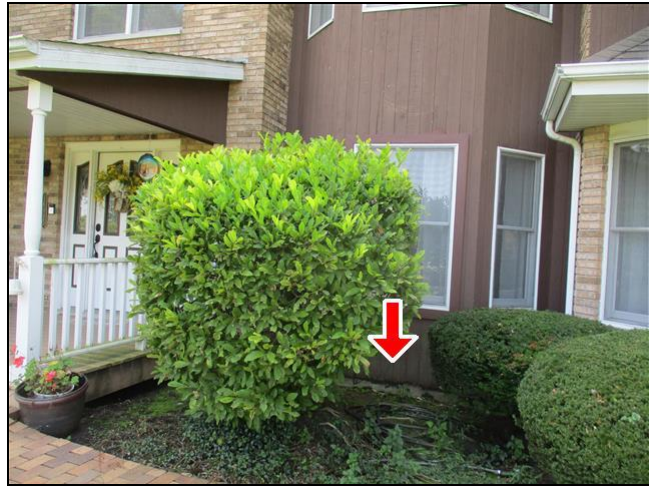
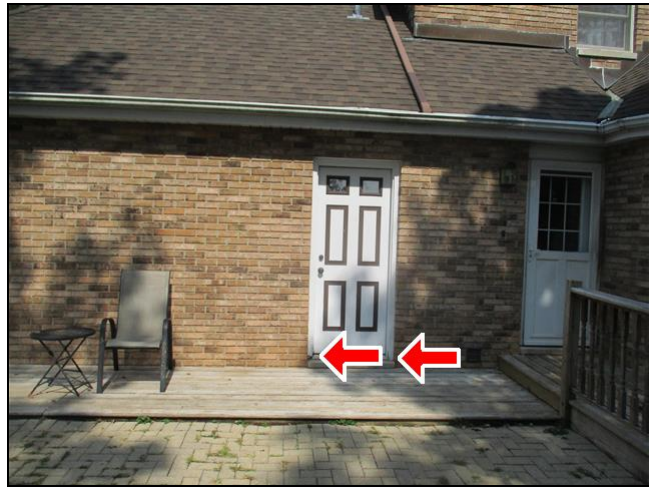
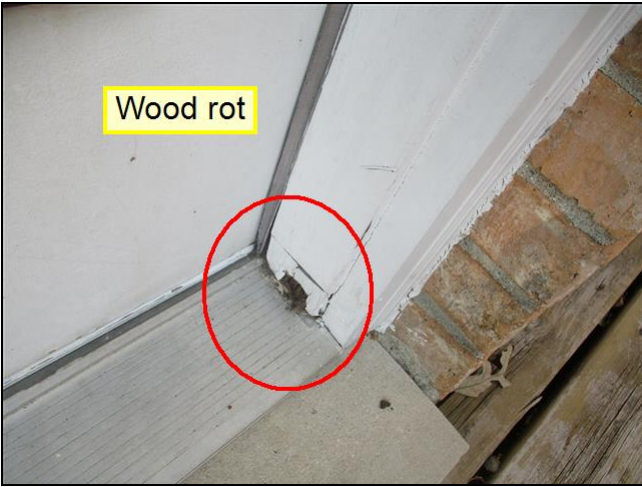
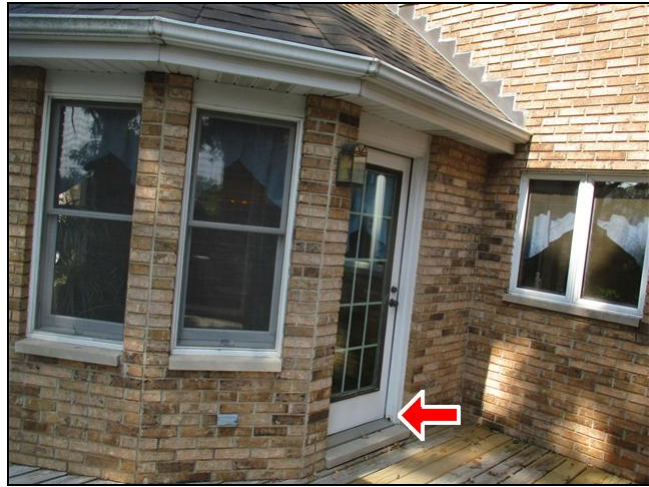
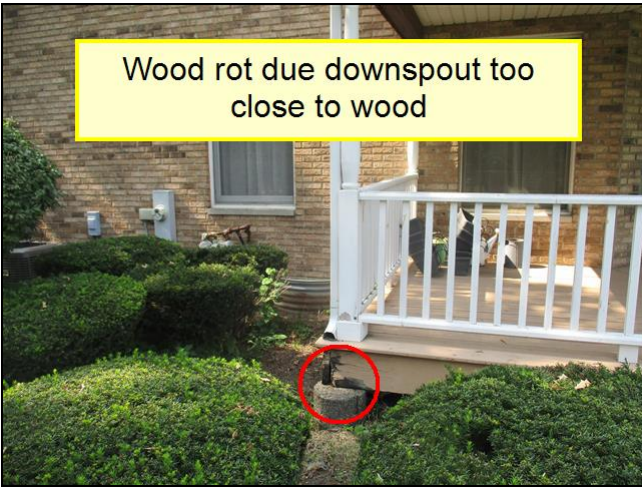
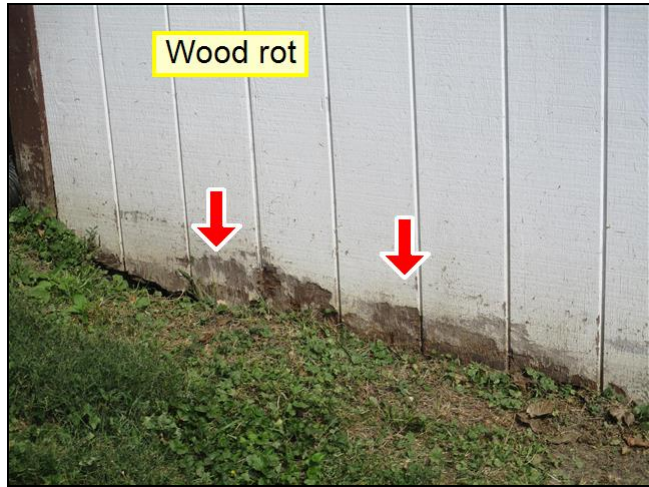
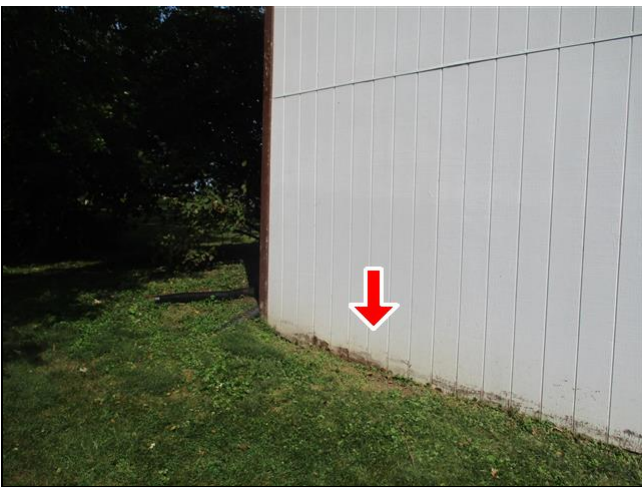
2.0 (2) Wood rot was observed on areas of the exterior of the home and outbuilding. If not corrected, further damage may occur. Contact a qualified contractor for further evaluation and repair. See pictures for details and locations.

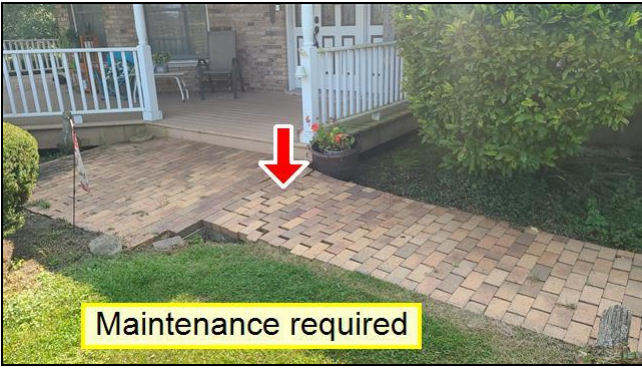
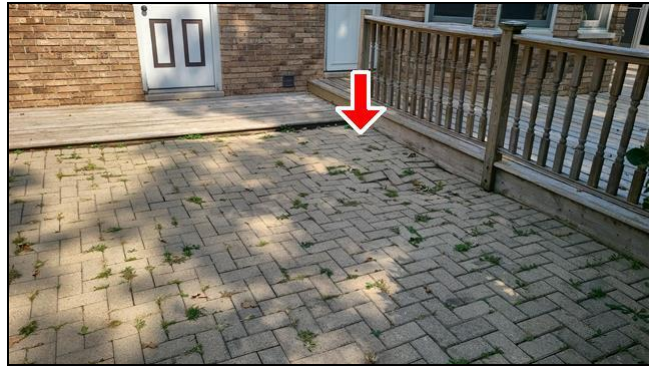
2.1 (1) The brick paver patio needs repair. Brick paver patios need periodic repair and maintenance to prevent damage. The algae must be removed from the joints, the brick power washed, new sand applied, and a new protective coating applied. Contact a landscaping company to perform this repair.

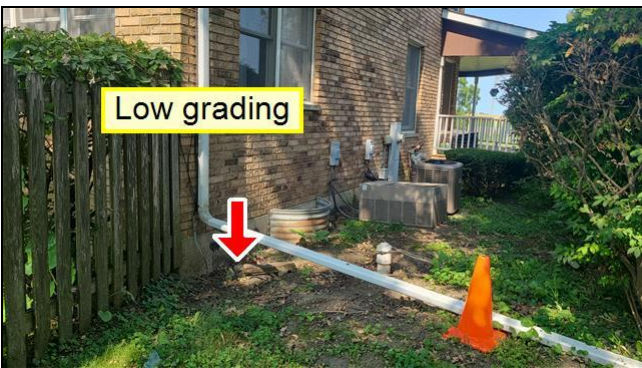
2.1 Item 3(Picture)

🏠 (2) The grading is low on the side of the home. Low grading causes water to flow toward the home. The water can cause damage to the foundation or enter the basement. To correct the low grading, a landscaping company should be contacted to build up all low areas around the home.

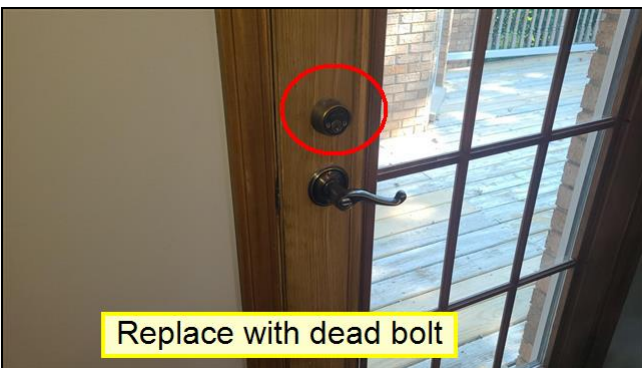
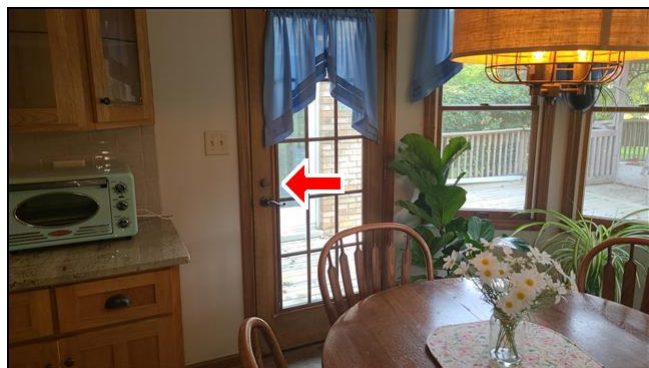
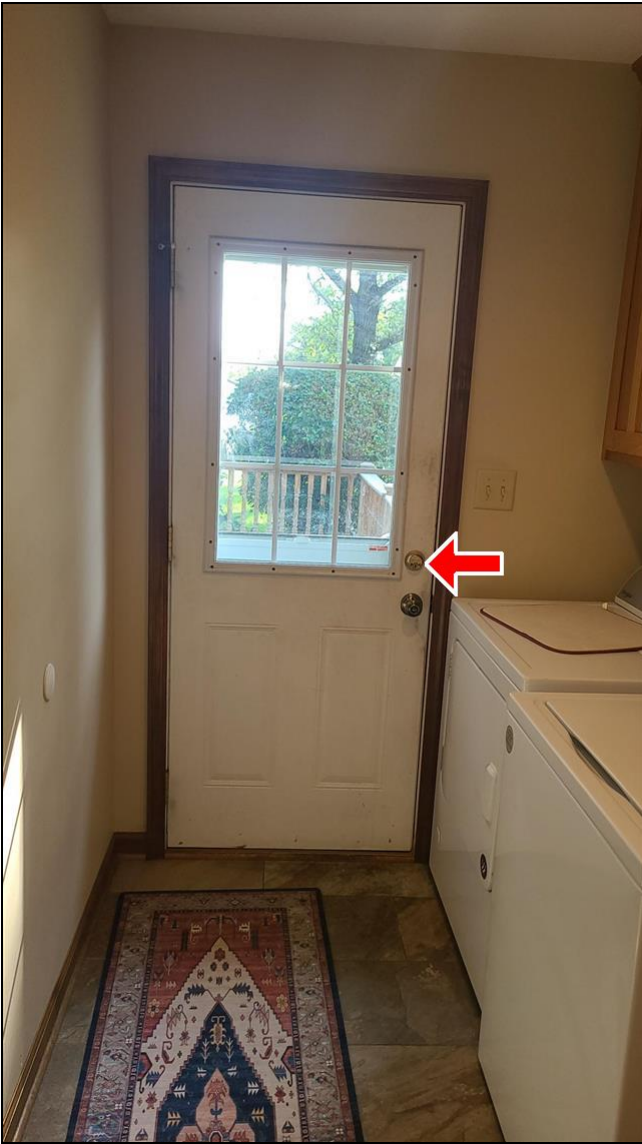
🏠 2.2 The entrance doors are double keyed. This means that a key is required to open the door from the outside and inside of the home. Modern fire safety standards do not allow double keyed locks on doors. In the event of an emergency exit from the home, a key is required to unlock the door. This is a safety issue that must be corrected. Replace double keyed locks on entrance doors.

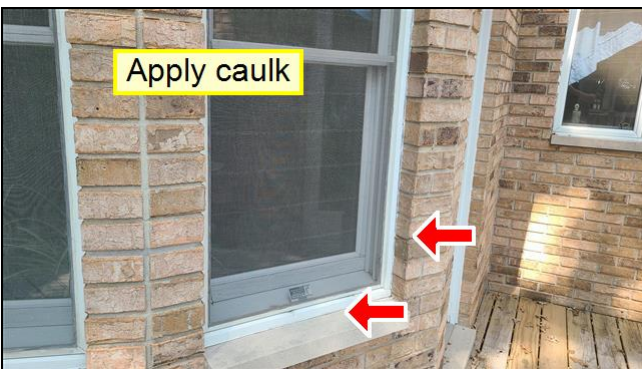
2.3 Item 1(Picture)

2.3 The caulk is failing on several of the exterior windows. If not replaced, water may penetrate into the home. Contact a qualified contractor to remove all old caulk and apply new.

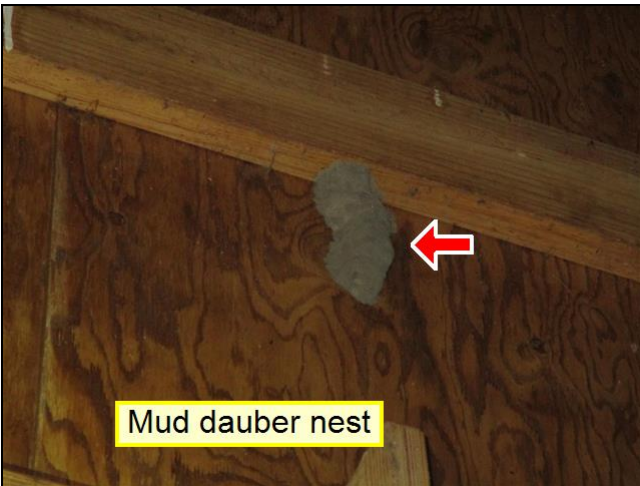
2.5 Item 3(Picture)

(3) There are wasp nests in the attic of the outbuilding. Wasps can cause injury to occupants. I recommend contacting an exterminating company to remove all wasp nests.

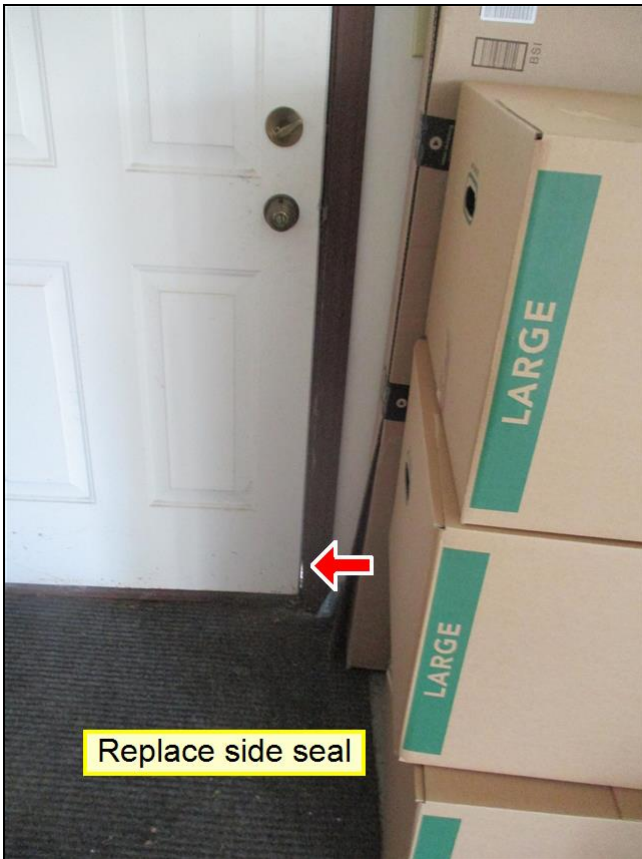
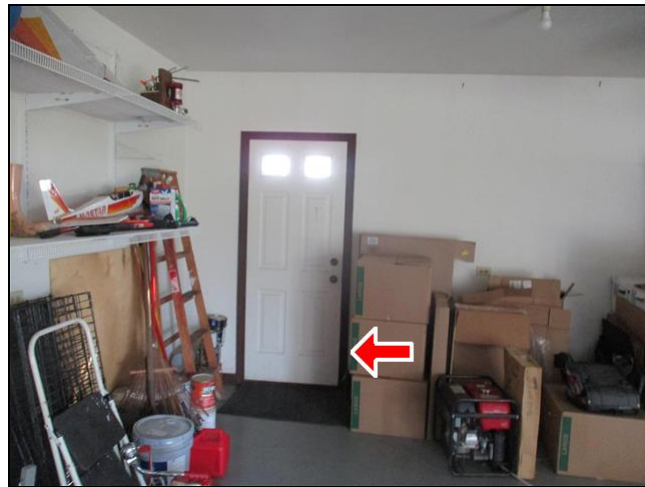
3.2 There is a gap on the side of the garage man door. If not sealed, insects, water, etc., may enter garage. Contact a qualified contractor for correction.

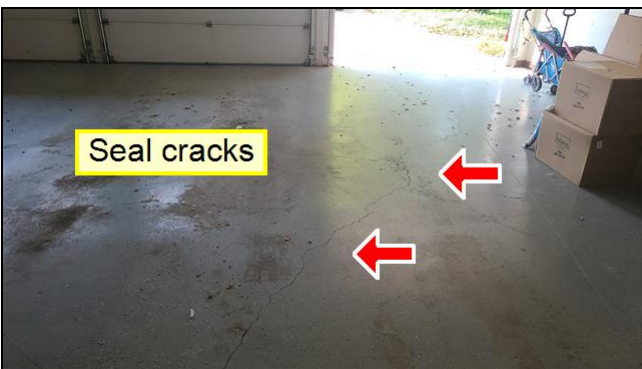
3.4 Item 1(Picture)

3.4 There were some cracks in the garage floor. These cracks are normal, but I recommend repair to prevent further damage. The cracks can be repaired with caulk or any other patching type material.

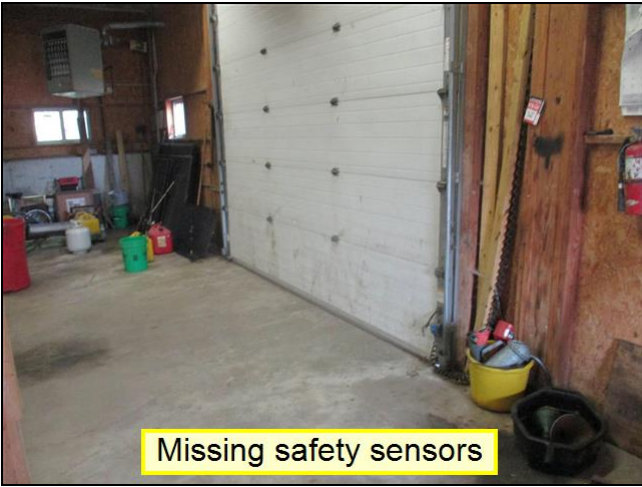
3.5 Item 1(Picture)

3.5 The outbuilding garage door opener is not equipped with safety sensors that prevent injury to occupants or animals. The sensors should be located on the lower portion of the garage door or should have a safety push button or a pressure sensor, and are designed to reverse the direction of the door if someone is beneath. This is a safety code enforced by municipalities. Contact a garage door company for further evaluation.

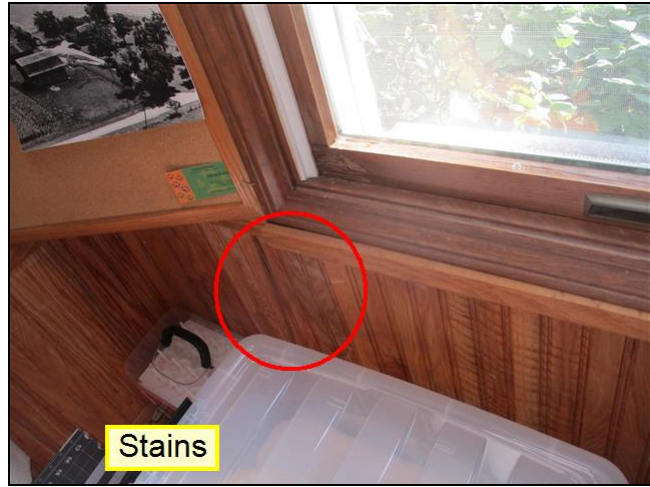
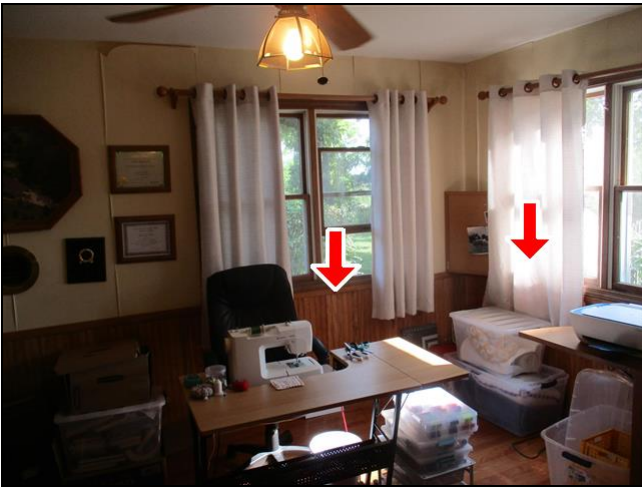
👉 (3) Water damage and stains were observed in paneling under the windows in the office room. Contact a qualified contractor for further evaluation and repair.

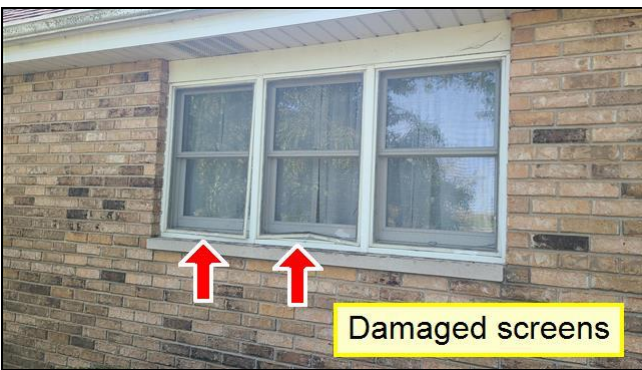
4.4 Item 1(Picture)

🏠 4.4 (1) There were several screens that were damaged. Municipalities and other agencies, require functioning screens on all windows. Contact a qualified contractor to repair all damaged screens.

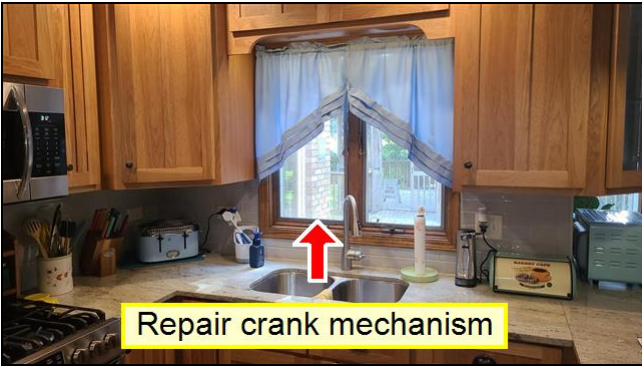
4.4 Item 2(Picture)

🏠 (2) There was one window with a defective window hand crank. The window will not open in its current condition. Contact a window repair company to repair the window hand crank.

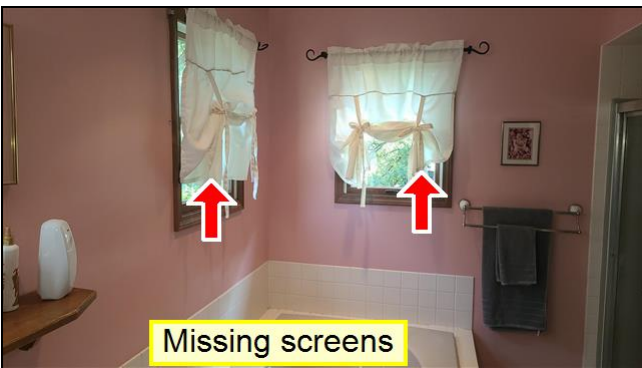
4.4 Item 3(Picture)

🏠 (3) There were several windows with missing screens. Screens are required by local municipalities and other agencies. It is possible that the home owner has the screens stored. I recommend asking home owner to have all screens installed by the final walk through. Check that all windows have screens when you do your final walk through.

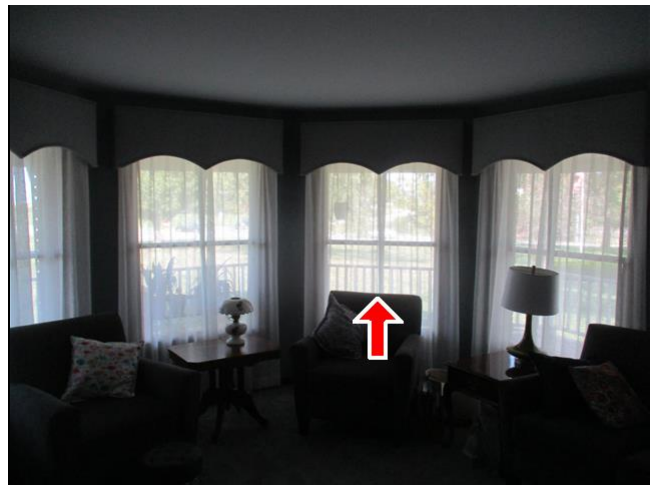
4.4 Item 5(Picture)

🏠 (4) Several of the main level windows would not stay in the open position when opened. The windows slams shut, which could cause injury to occupants. Contact a window repair company to repair the windows.

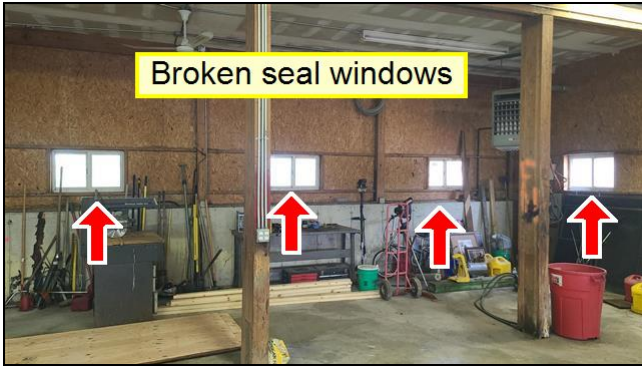
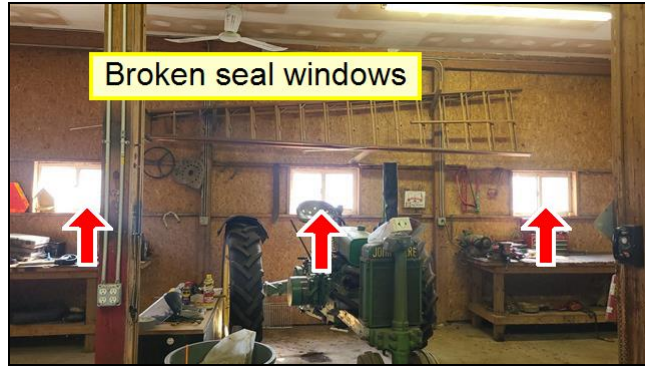
🏠 (5) There were several windows with broken seals in the outbuilding. A window with a broken seal still operates as intended, but it loses insulation value. Contact a window replacement company to replace all glass with broken seals.

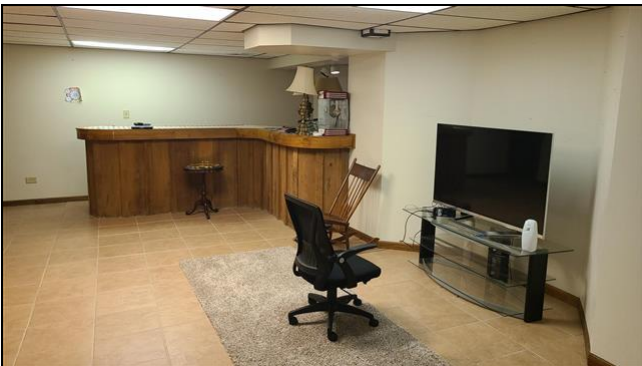
5.0 Item 1(Picture)

5.0 (1) Most of the basement was covered in finish material. Most of the foundation and structure were not visible for inspection. No obvious issues were observed. This is an inspection restriction and for your information.

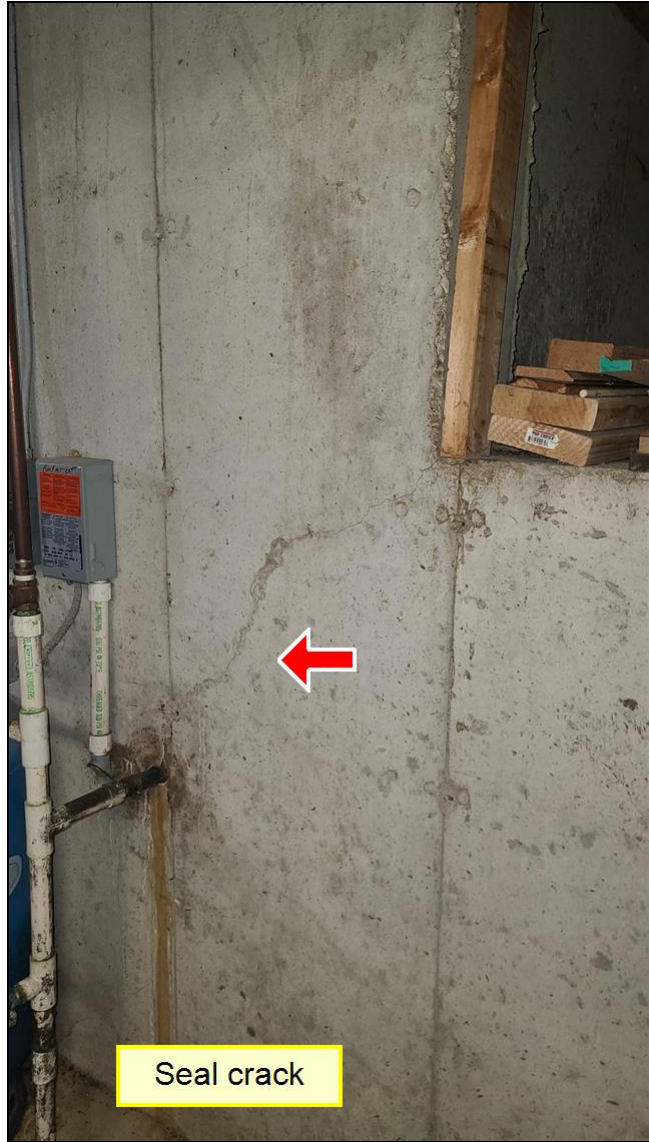
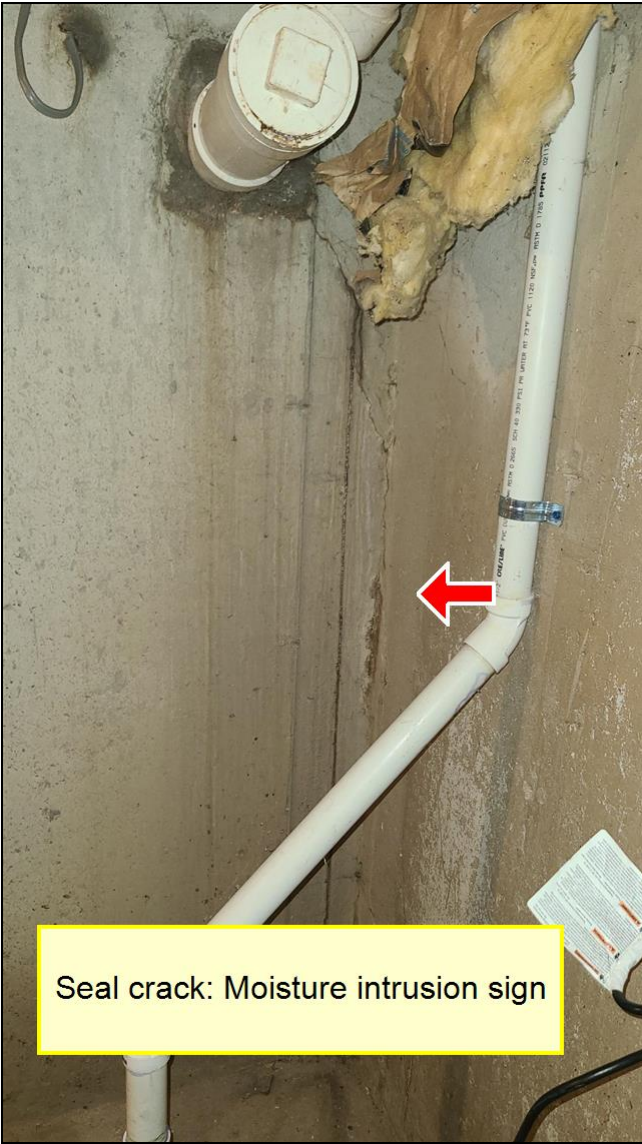
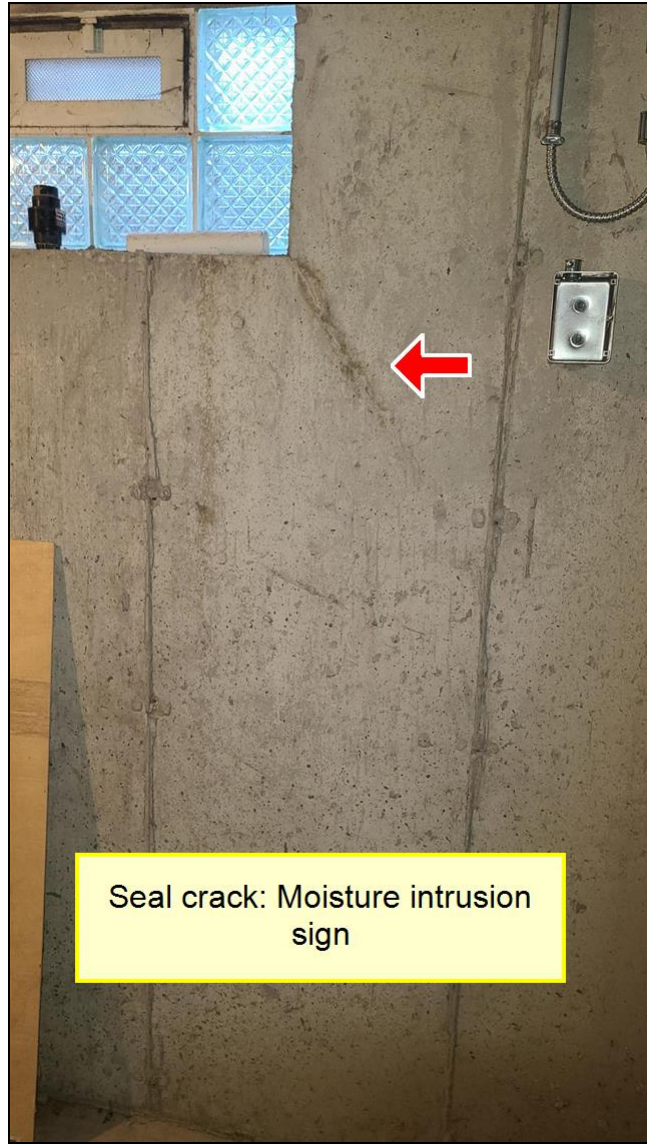
5.0 (2) There were several cracks in the basement foundation walls. This is not a structural issue, but cracks should be repaired to prevent further damage or water from entering. Contact a water proofing company to repair all cracks in basement foundation walls.

NOTE: Some of the cracks were not seeping water at the time of the inspection, but there are signs of water seepage. There are water stains and mineral deposits. Cracks may not seep water now, but WILL during heavy rains.

NOTE: The cracks that showed sign of seepage is the area that has low grading on the outside.

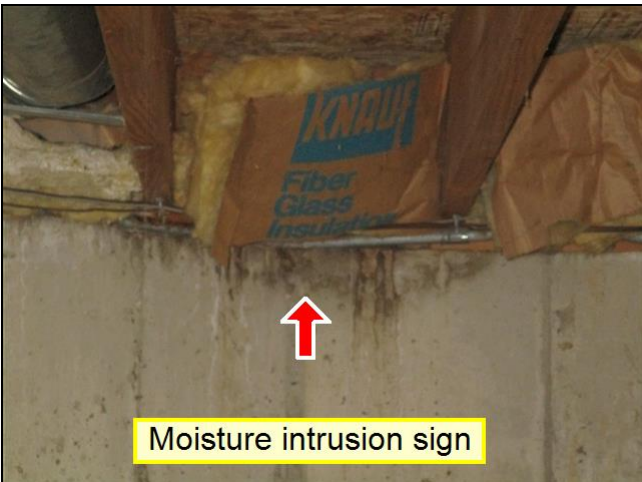
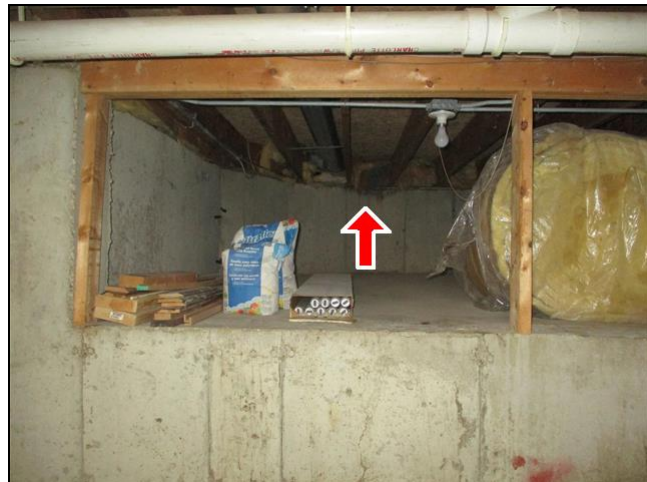
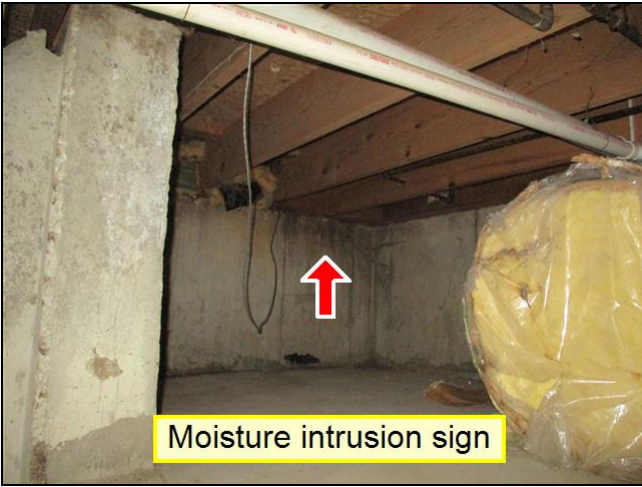
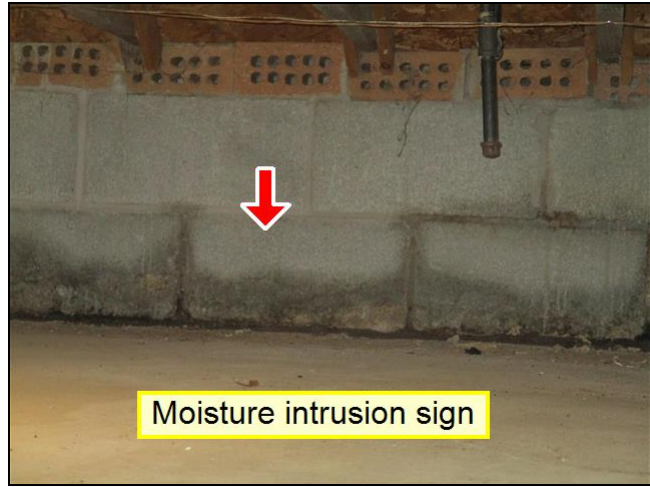
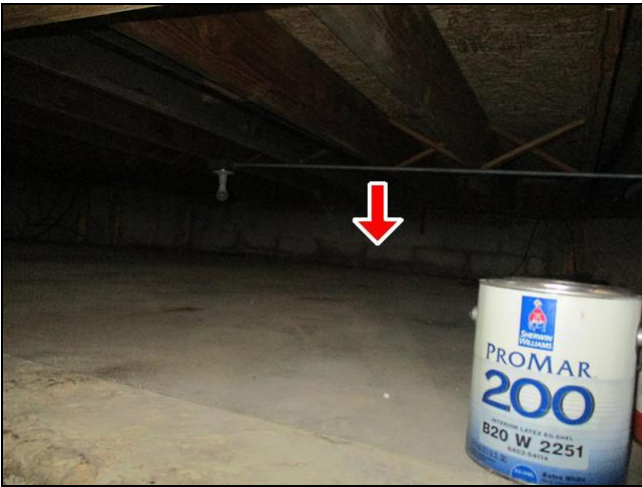
➡ (3) Moisture appears to be entering the crawlspace between the foundation wall and the sill plate and through the fireplace cinder blocks at the rear of the home. If not corrected, moisture related issues and further damage may develop. Contact a waterproofing company for correction and further evaluation.

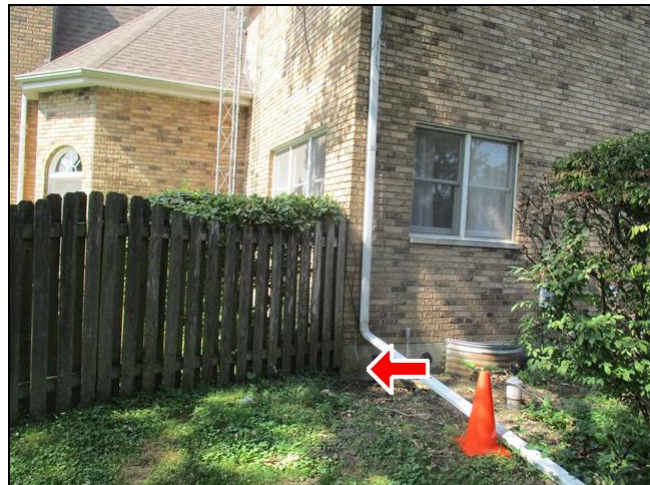
5.0 Item 12(Picture)

🏠 (4) Damage was observed on the corner of the foundation slab "Corner pop". This is not a structural issue, but the damage should be repaired to prevent further damage or water from entering. Contact a concrete repair company for further evaluation and repair.

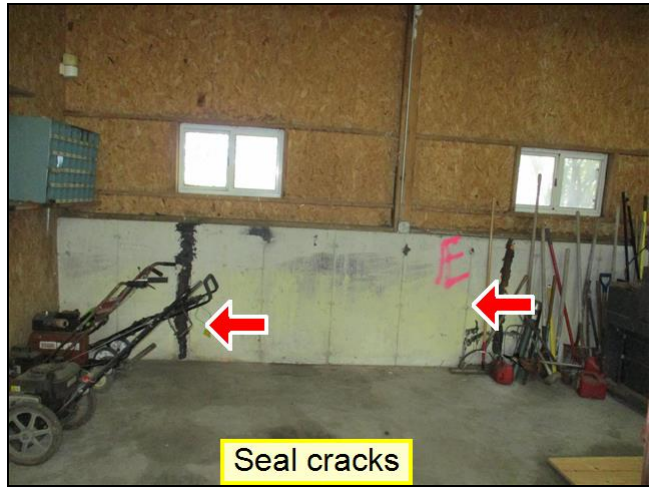
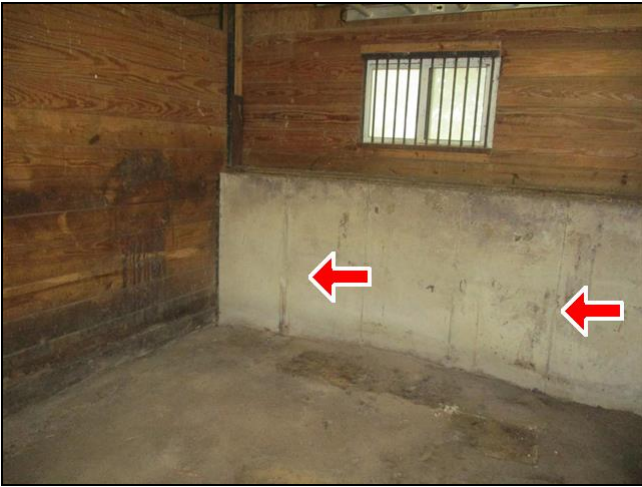
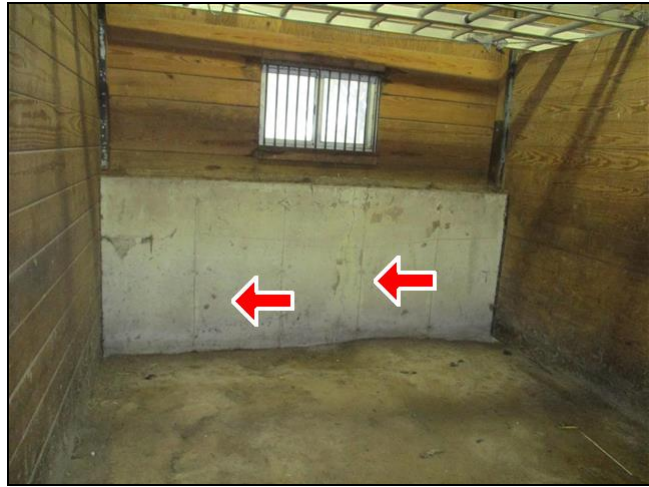
📍 (6) There were several cracks in the outbuilding foundation walls. This is not a structural issue, but cracks should be repaired to prevent further damage or water from entering. Contact a waterproofing company to repair all cracks in outbuilding foundation walls.

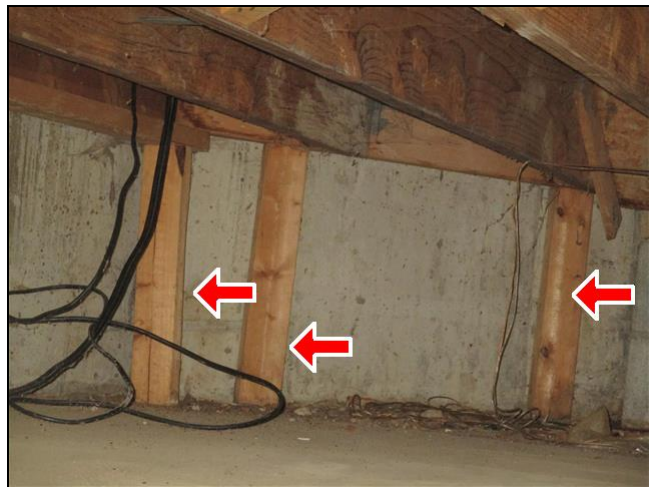
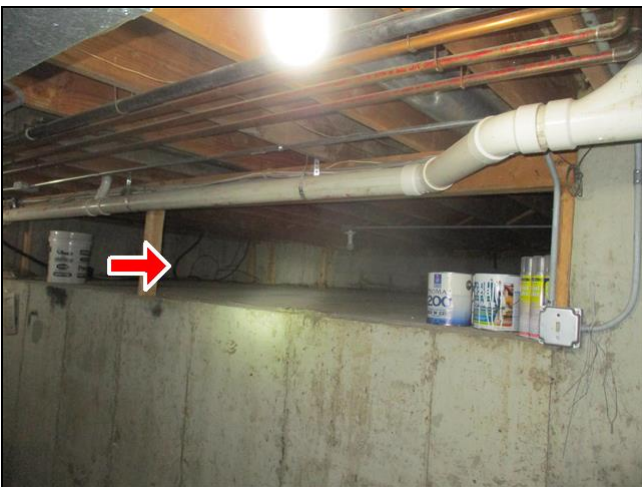
5.4 The fireplace room floor structure is supported using only 2X4 lumber (Undersized support) . I recommend contacting a framing contractor for further evaluation.

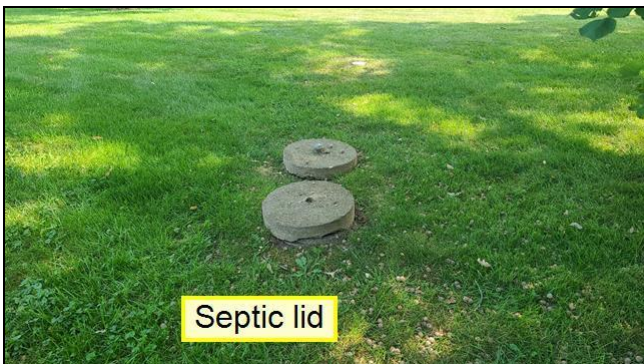
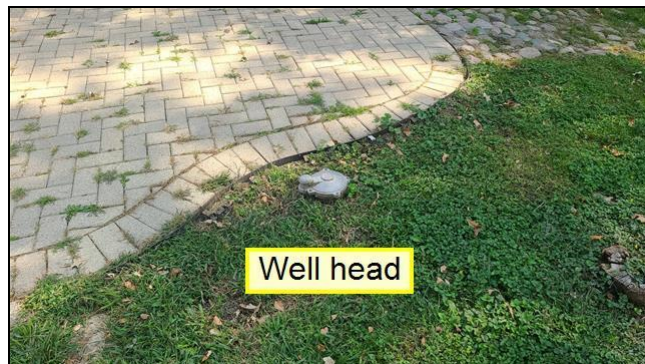
6.0 (1) The home is equipped with a private well and waste disposal system. It is necessary to have the well and waste system inspected for proper operation. Normally this cost is incurred by the seller. If seller is not paying for the inspection, I highly recommend having the systems inspected. Contact a well and septic inspection company to properly check condition of well and waste disposal system.

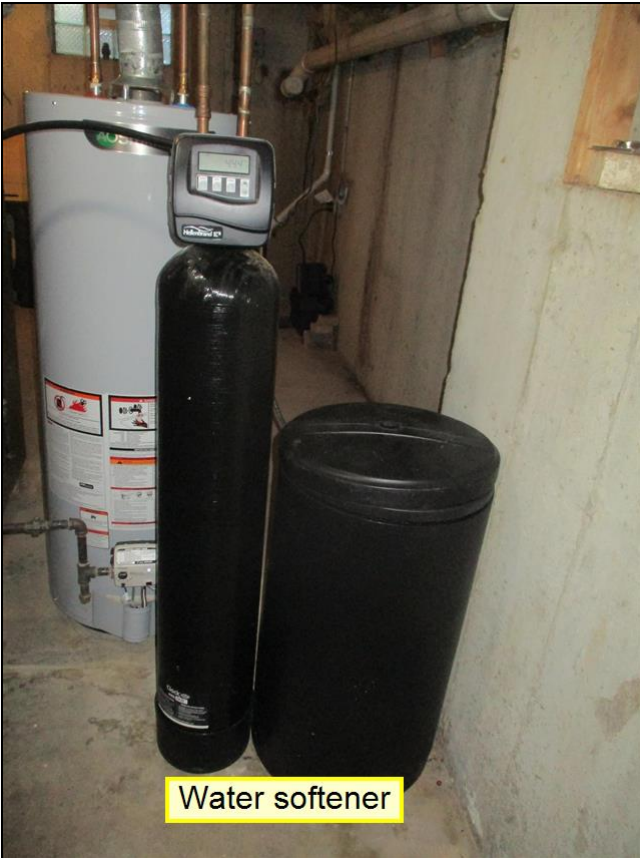
6.0 Item 3(Picture)

(2) The home is equipped with a water softener. The softener will need maintenance and salt added regularly. I recommend asking the current home owner to show you how to operate and maintain this equipment.

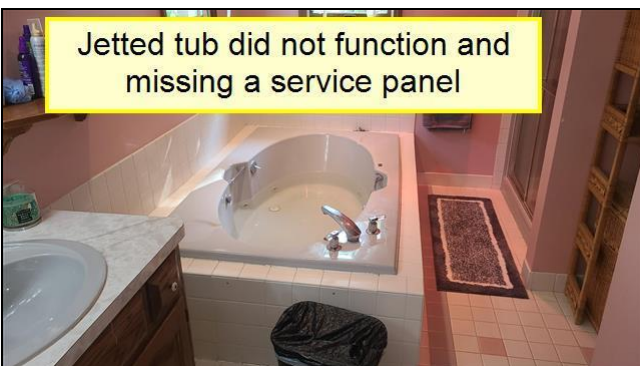
6.0 Item 4(Picture)

📍 (3) There is no access panel for the whirlpool tub water pump. If the pump fails, the tile will need to be removed to access the pump. This comment was intended to inform you that there is no access panel.

The jetted tub did not function at time of inspection. Contact a qualified plumber for further evaluation.

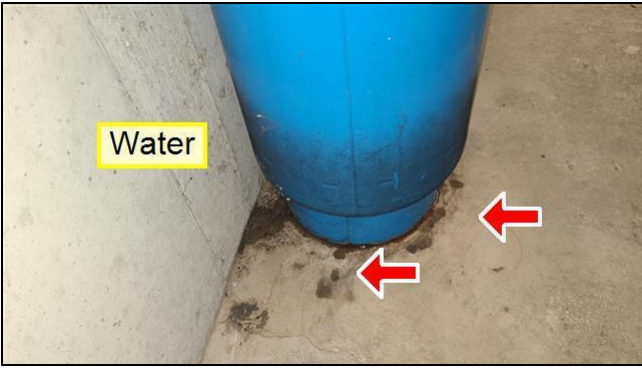
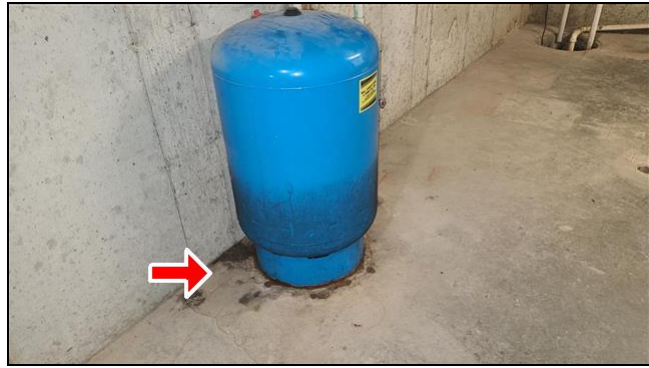
📍 (4) The well pressure tank is leaking into the basement floor. If not corrected, moisture related issues will develop. Contact a qualified plumber for further evaluation.

NOTE: The water might be from condensation.
