Inspection Report

Property Address:
16233 W Randell St
Manhattan IL 60442

SafeCheck Home Inspection

Date: 9/11/2024	Time: 02:00 PM	Report ID: 20240911-16015-W-Baker-Rd
Property: 16233 W Randell St Manhattan IL 60442	Customer: Joe Smith	Real Estate Professional:

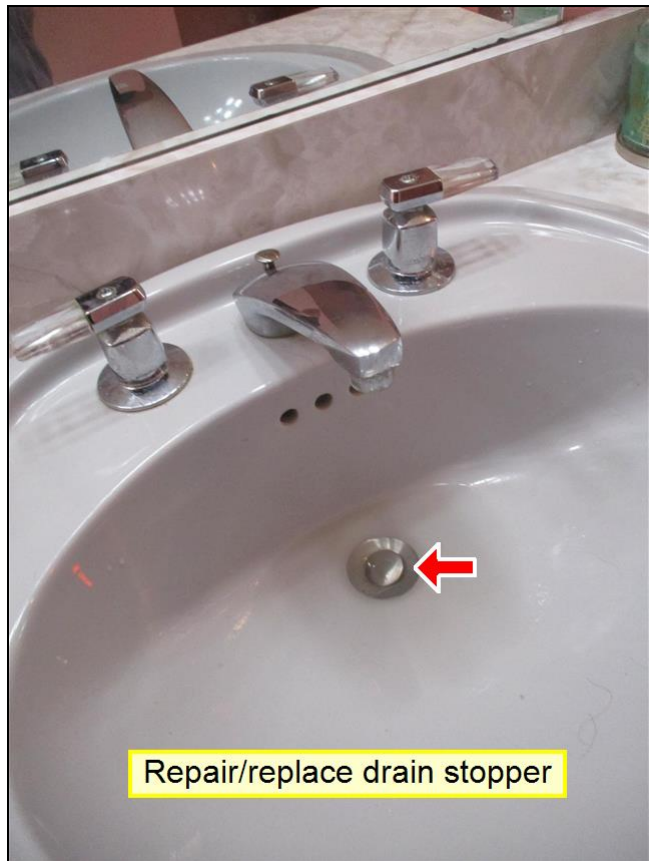
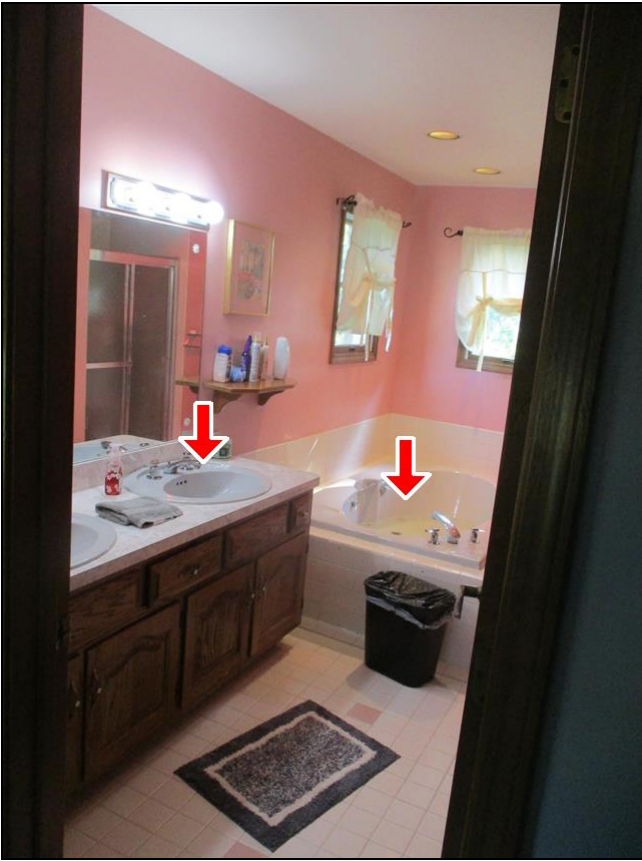
6.1 (1) I inspected all the drain piping in the home, but there is no way to inspect the sewer piping from the home to the city sewer system. The piping is underground and not visible. I recommend contacting a plumbing contractor to televise the sewer pipe. Televising the sewer pipe will reveal if tree roots or damaged pipes are present. Damaged piping can even be present in new construction.

The drain stoppers did not function at the master sink/jetted tub. Contact a qualified plumber to repair or replace the drain stoppers.

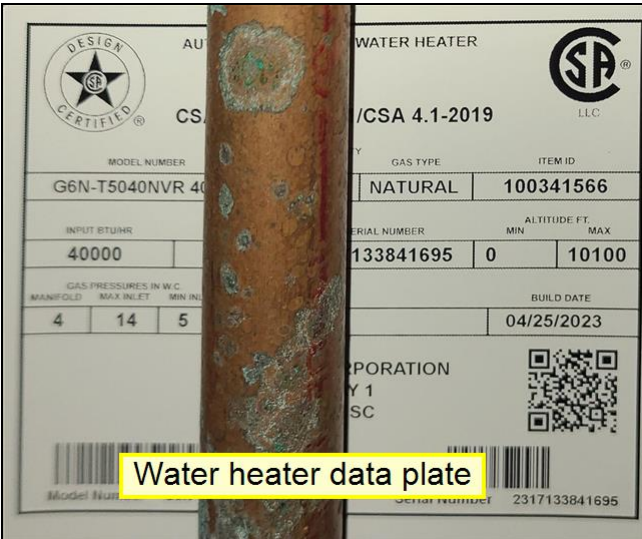
6.2 Item 1(Picture)

6.2 (1) The water heater is a 2023; This is for your information.

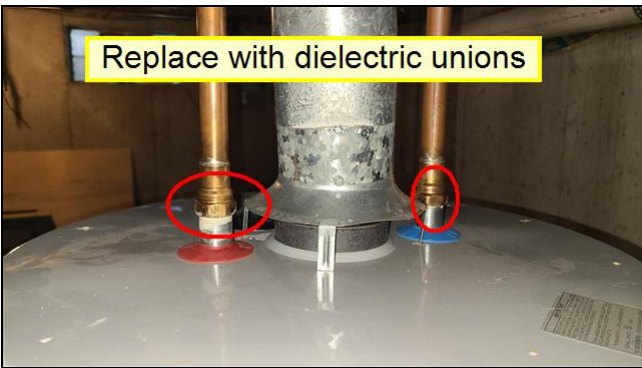
6.2 Item 3(Picture)

👉 (3) The water piping to the water heater is connected without the use of dielectric connectors. Dielectric connectors are required whenever two dissimilar metals are connected together. Dielectric connectors prevent rusting caused by galvanic action. Contact a qualified person to install the dielectric connectors.

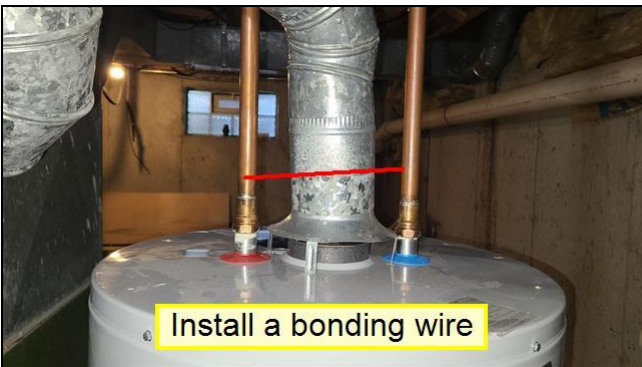
6.2 Item 4(Picture)

👉 (4) There is no bonding wire present on the water heater. A bonding wire is required to prevent the electrolysis that can occur when dissimilar metals are joined together. The bonding wire is intended to allow that faint current between the water pipes to bypass the copper-to-steel fittings and thereby prevent corrosion caused by electrolysis. Contact a qualified person to install a bonding wire.

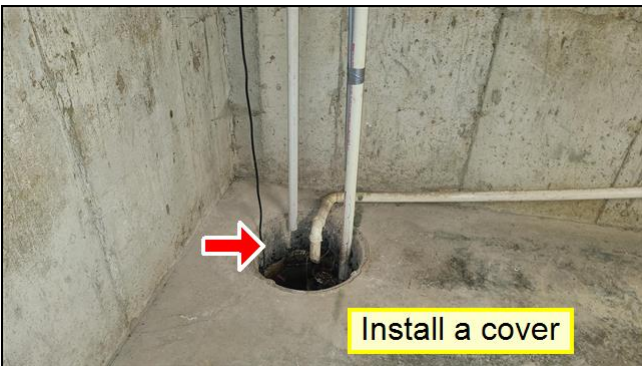
6.6 Item 1(Picture)

6.6 Modern building standards require ejector pits to have a sealed cover. Contact a qualified person to install a sealed cover on the ejector pit.

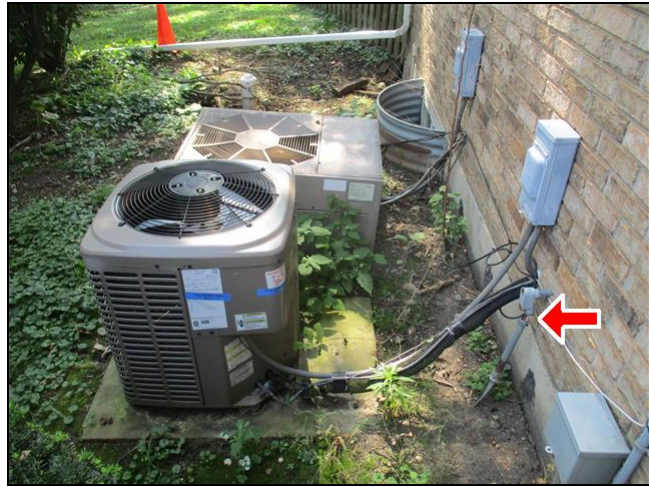
7.2 Item 2(Picture)

**7.2 (1)** Exposed electrical wires were observed on the exterior by the AC unit. If not enclosed, injury to occupants may occur or water may cause damage. Contact a qualified electrician for correction.

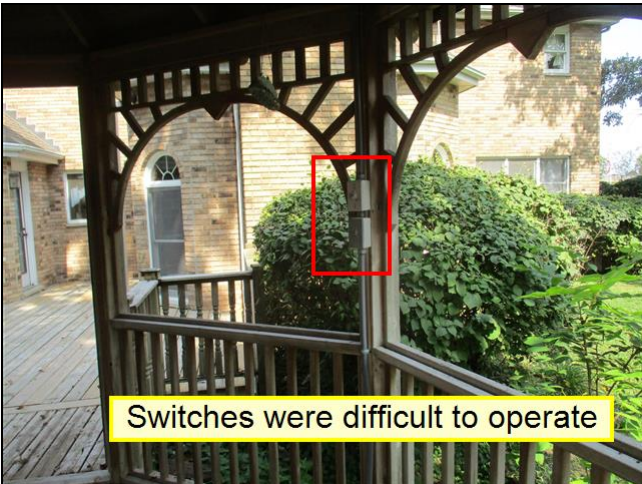
7.2 Item 3(Picture)

🏠 (2) The gazebo ceiling fan electrical switches were difficult to operate. Contact a qualified electrician for further evaluation.

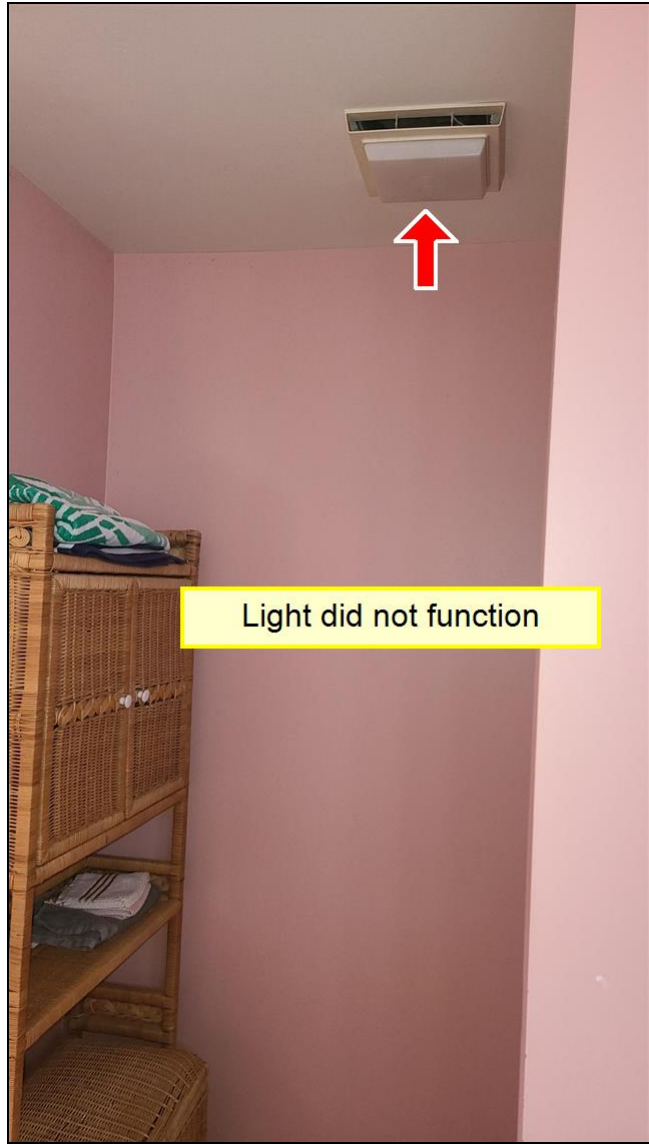
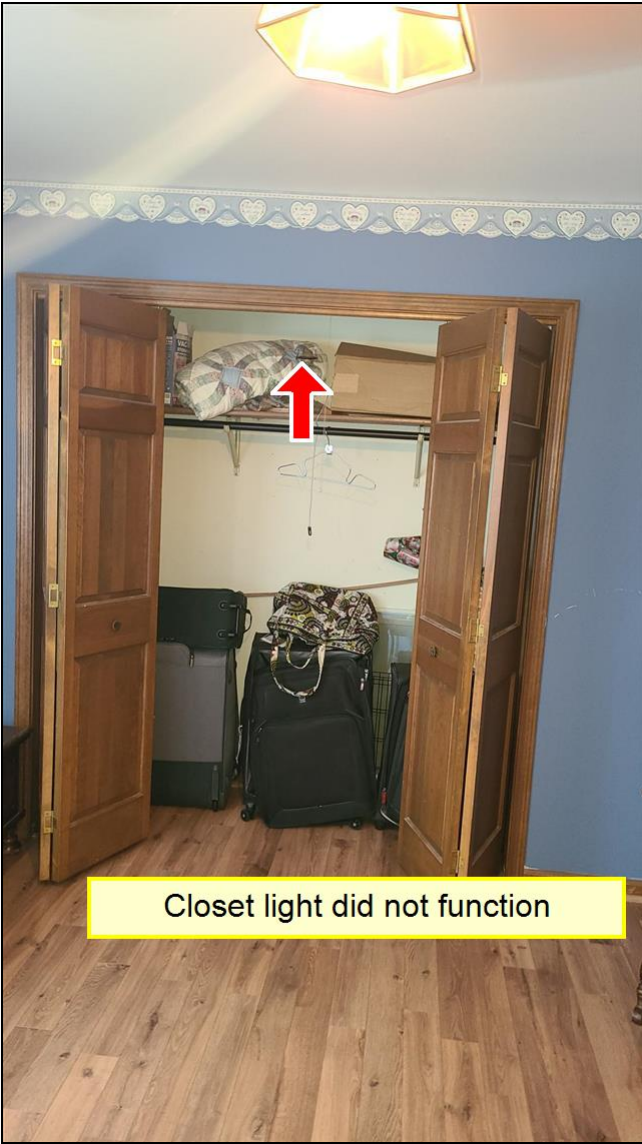
🏠 (3) There were several lights that did not function. It may be burnt out light bulbs, or defective light fixtures. I recommend having the home owner replace all burnt out light bulbs so that you can check them when you do your final walk-through.

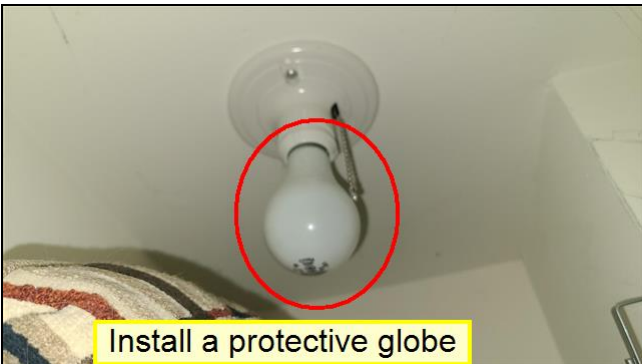
7.2 Item 7(Picture)

📌 (4) Modern fire safety standards require closet light bulbs to be covered by a protective globe or other type of cover. This is to prevent the hot light bulb from contacting clothing and starting a fire. I recommend installing globe type light fixtures in all closets.

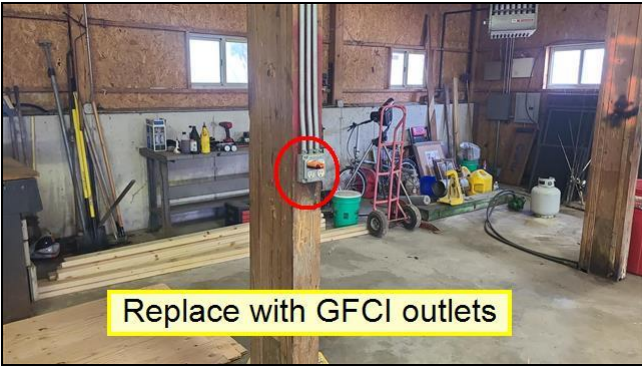
7.3 Item 1(Picture)

7.3 The outbuilding electrical outlets are not GFCI (ground fault circuit interrupted) protected. GFCI type electrical outlets protect the family against electrical hazards. When this home was built, it was not required to have GFCI electrical outlets in

the outbuilding. Modern standards require GFCI outlets in the outbuilding. I recommend updating electrical outlets in outbuilding to GFCI type outlets.

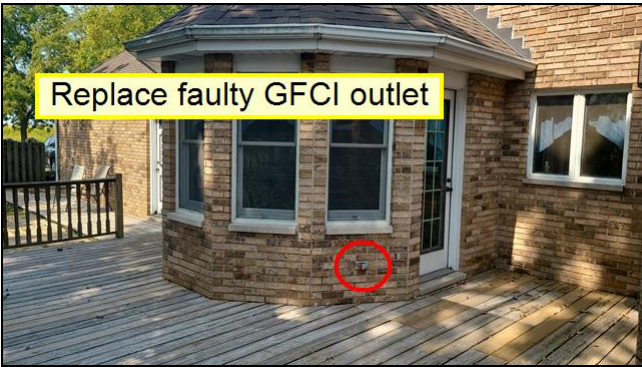
7.4 Item 1(Picture)

**7.4** The exterior rear GFCI (ground fault circuit interrupted) electrical outlet did not trip when tested. This is an important safety device that must be operational. Contact a qualified person to replace the outlet.

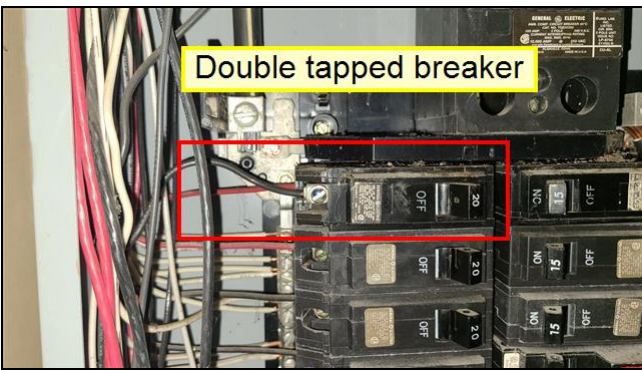
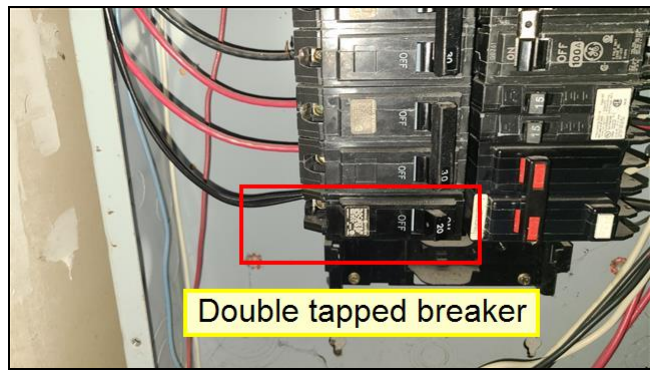
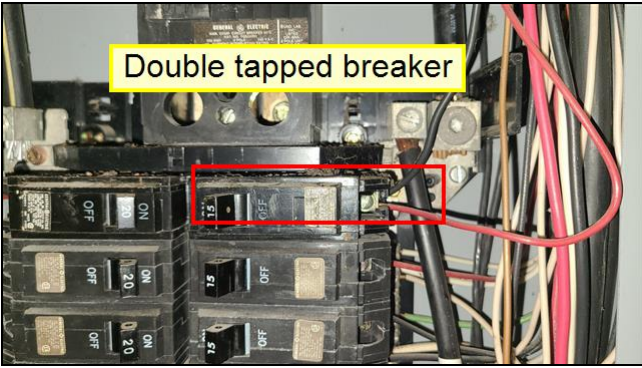
7.6 (1) There are three double tapplings of circuit breakers present in the main electric panel. Double tapping is when two wires are connected to one circuit breaker. Modern standards do not allow for two wires to be connected to one circuit breaker. This is considered a safety hazard that must be corrected. Contact a qualified electrical contractor to correct double tapplings in electrical panel.

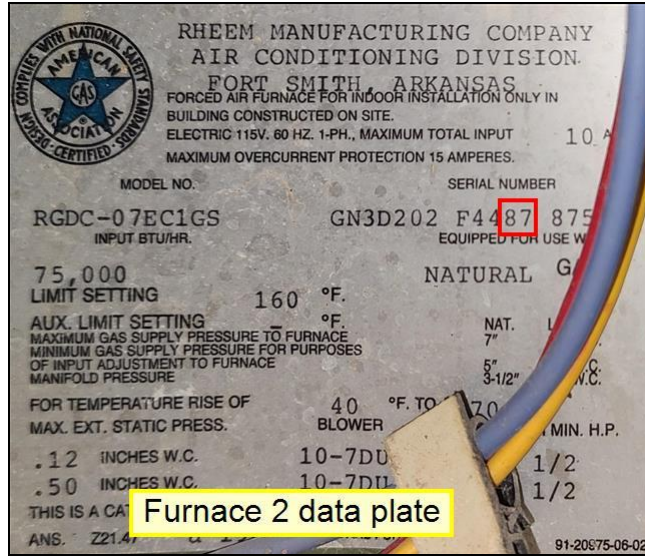
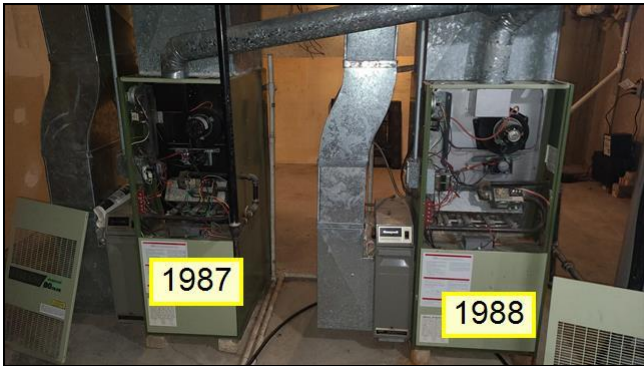
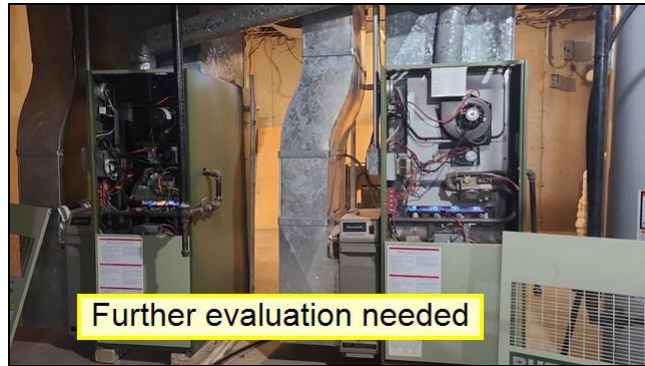
**8.4 (1)** The furnaces were manufactured in 1987,1988. The national average for furnaces is 20 years. It is difficult to determine the remaining life of these units, but they are at the end of their expected life cycle. I recommend budgeting for replacement.

When both furnaces were turned on, a strong smoke smell was observed in the home. A cracked heat exchanger might be a possible cause. Contact a qualified HVAC professional for further evaluation of the furnaces

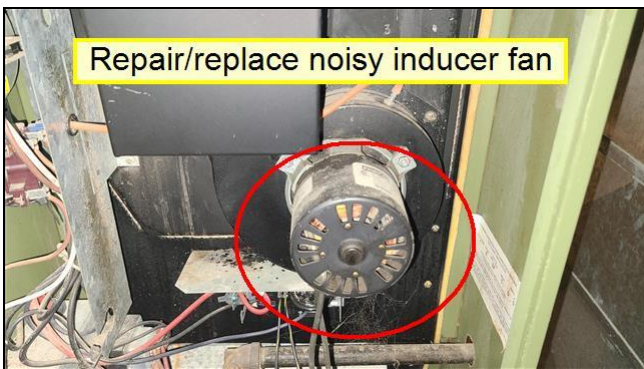
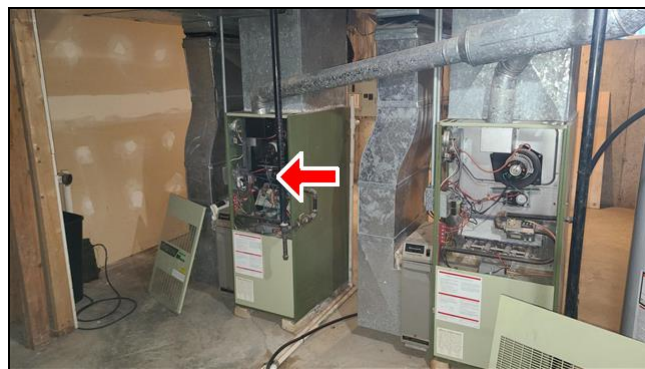
🏠 (2) The draft inducer motor was very noisy when the heat was operated. Service is needed. Contact a HVAC professional for correction and further evaluation of the furnace.

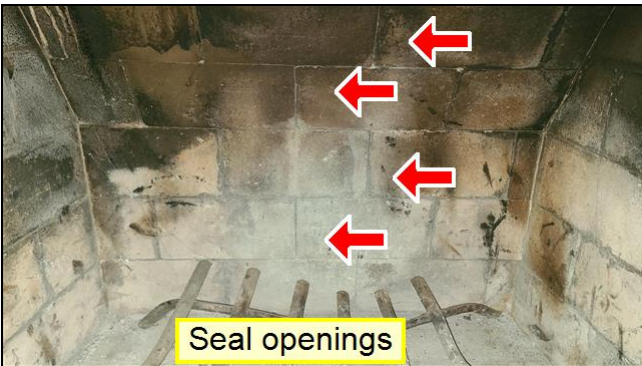
8.6 Item 1(Picture)

📌 (2) There are cracks in the firebox. The bricks and mortar are cracking. This can allow flame, smoke and fumes outside of the controlled burn area. If not corrected, further damage may occur. Contact a fireplace company or chimney sweep for correction and further evaluation.

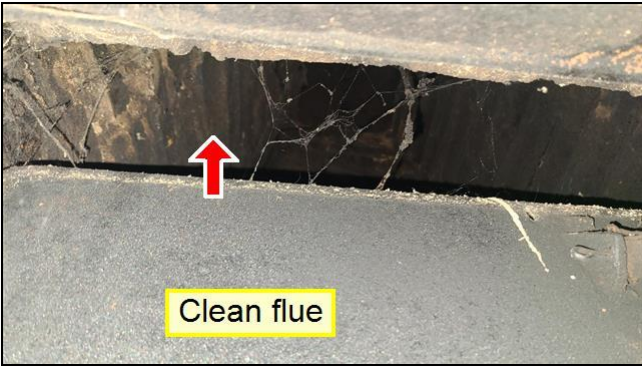
8.6 Item 2(Picture)

(3) There is a creosote buildup on the fireplace flue. This can cause a chimney fire, so it should be removed immediately. Contact a chimney sweep, to clean the chimney.

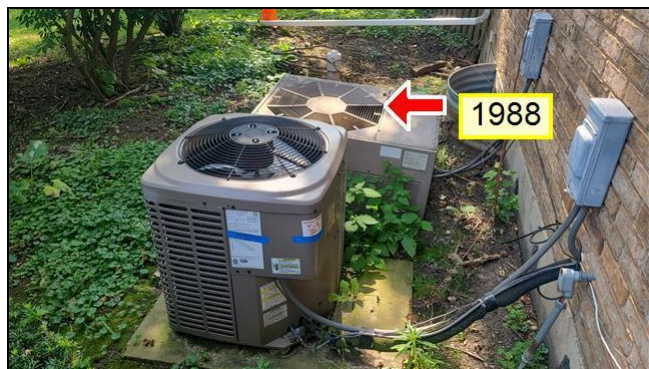
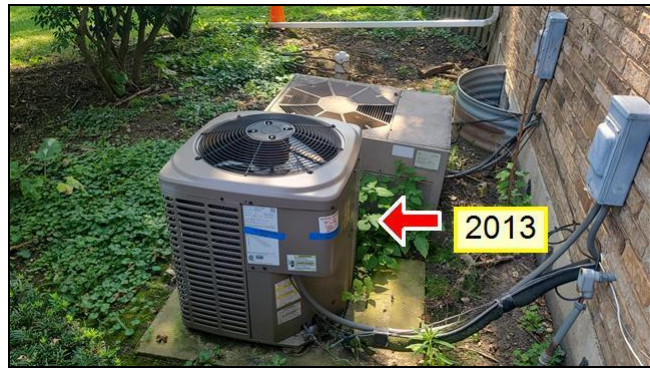
8.8 (1) The Rheem air conditioner was manufactured in 1988. The average life expectancy in 15 years. It is difficult to determine how much longer this unit will last, but it is at the end of its' life expectancy. I recommend budgeting for replacement.

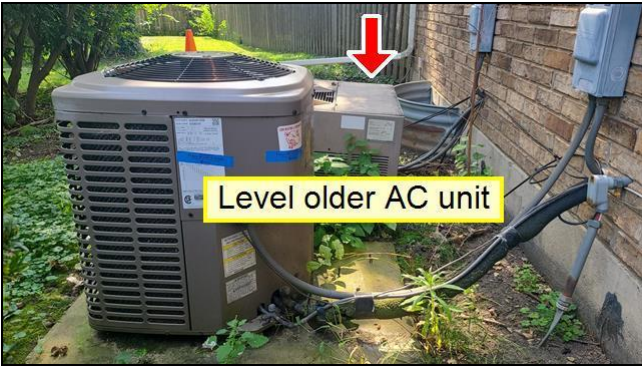
8.8 Item 5(Picture)

🏠 (3) One of the air conditioning units is not properly leveled. It is important that the AC unit is properly leveled to prevent bearings from failing prematurely. Contact a qualified person to properly level the unit.

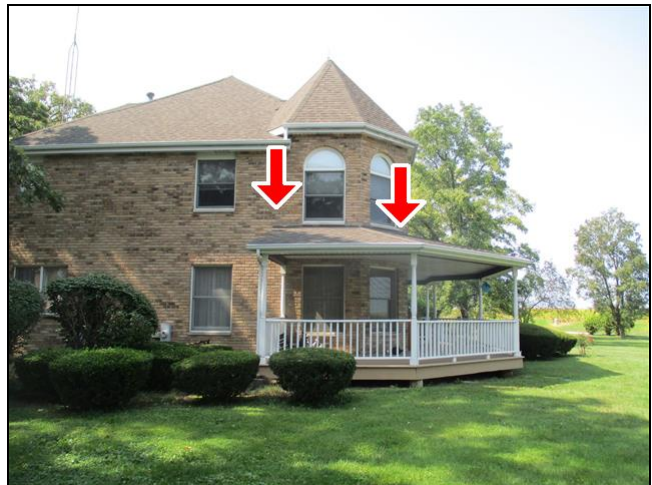
1.0 Item 2(Picture)

Lifted flashing was observed on the front of the home. This occurs when nails push up the flashing, or they are not properly secured. If not secured, moisture may enter and damage home. Contact a qualified roofer for correction.

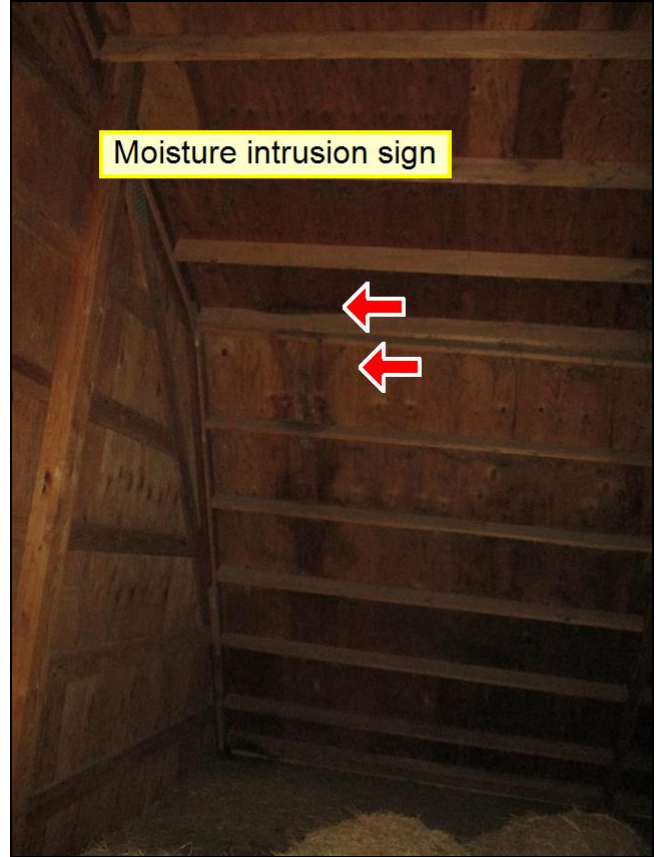
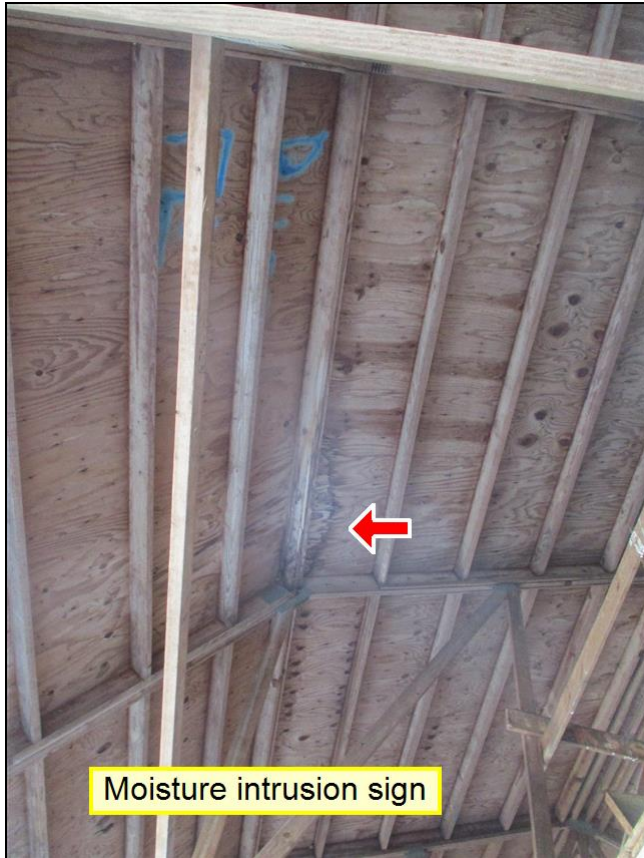
(3) A roof leak was observed in the attic of the outbuilding. The area was not wet at time of inspection. If not corrected, moisture related issues will develop and further damage will occur. Contact a qualified roofer for correction and further evaluation of the outbuilding roof.

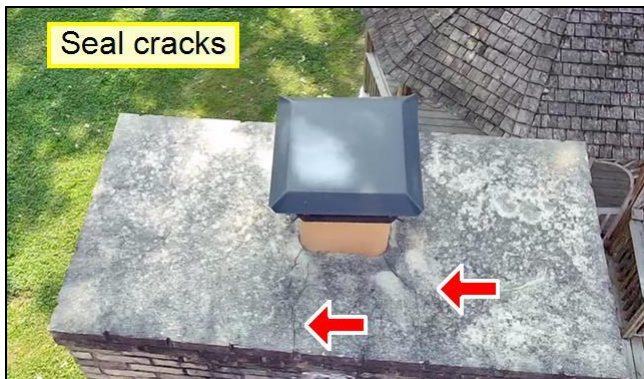
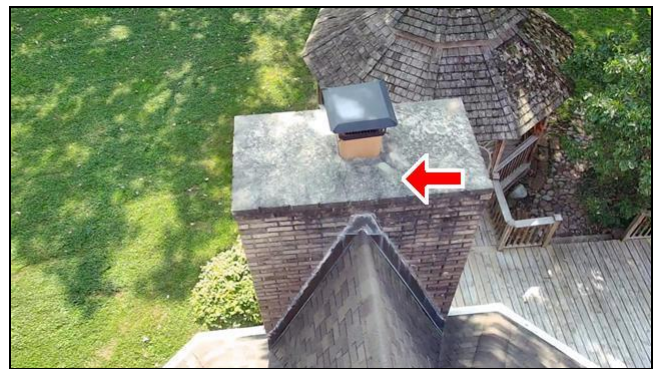
The chimney crown is cracking, and deteriorating. If not repaired, further damage will occur. Contact a qualified contractor to repair the chimney crown.

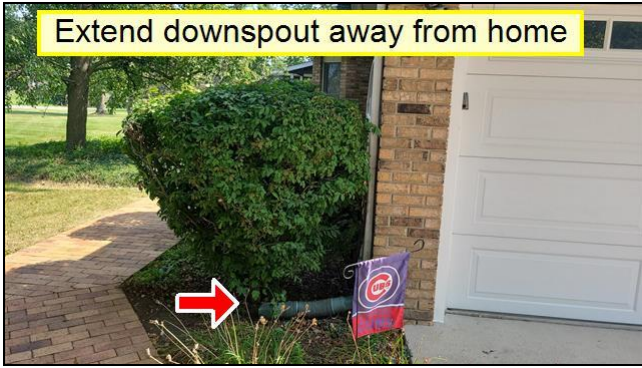
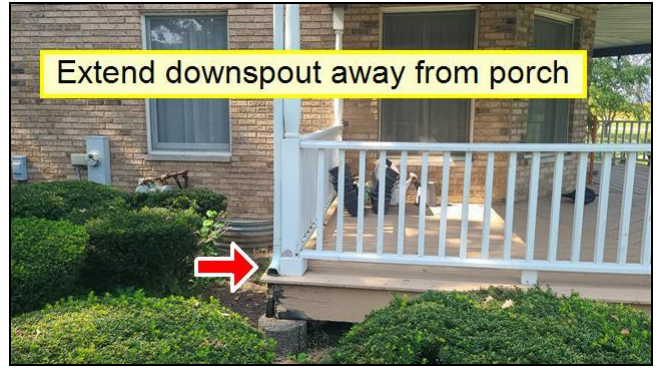
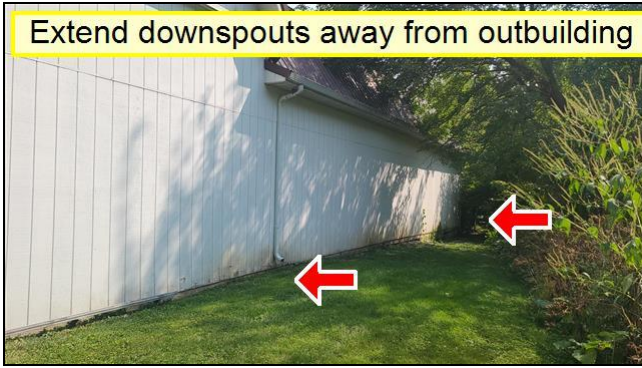
(1) The downspouts should be extended 6'-8' away from the home/outbuilding. This will prevent damage to the foundation, and water from entering the lower levels of the home. Contact a landscaping contractor to extend all downspouts away from home/outbuilding.

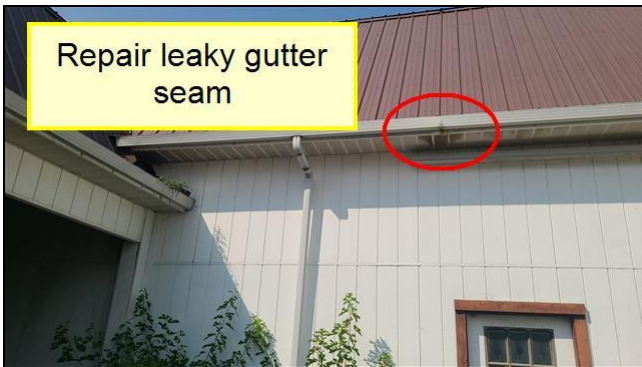
1.3 Item 4(Picture)

(2) There are signs that the gutters are leaking at the seams in the outbuilding. There are water stains and rusting present. Contact a qualified contractor to repair leaking seams.

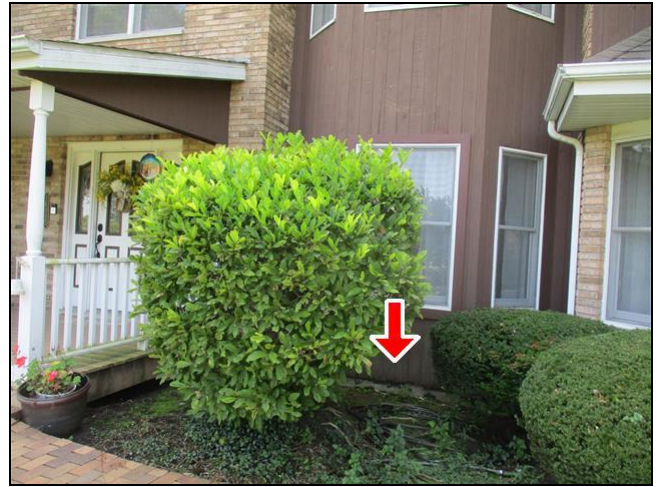
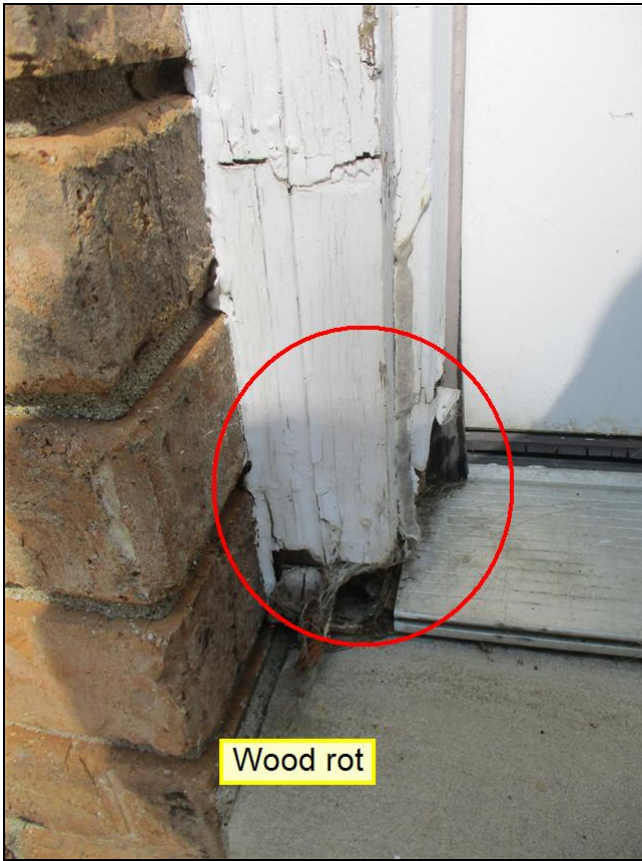
(2) Wood rot was observed on areas of the exterior of the home and outbuilding. If not corrected, further damage may occur. Contact a qualified contractor for further evaluation and repair. See pictures for details and locations.

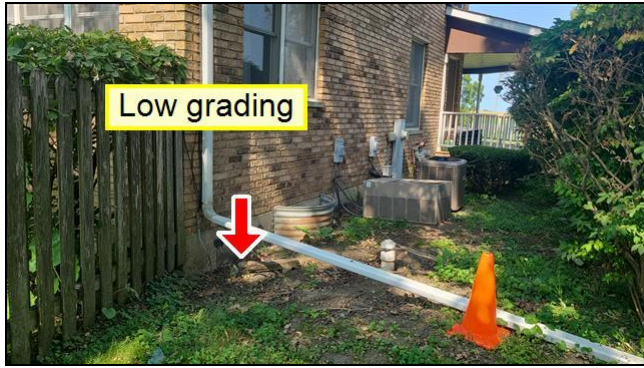
2.1 Item 3(Picture)

(2) The grading is low on the side of the home. Low grading causes water to flow toward the home. The water can cause damage to the foundation or enter the basement. To correct the low grading, a landscaping company should be contacted to build up all low areas around the home.

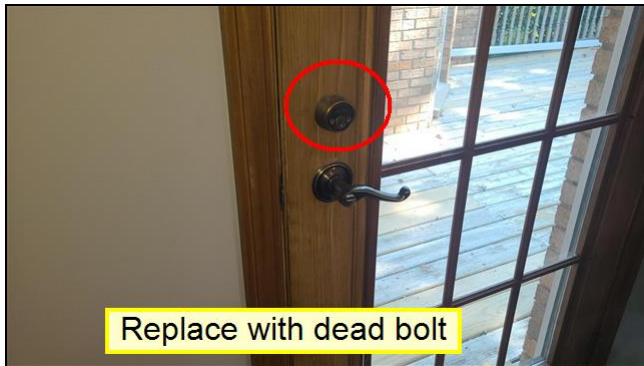
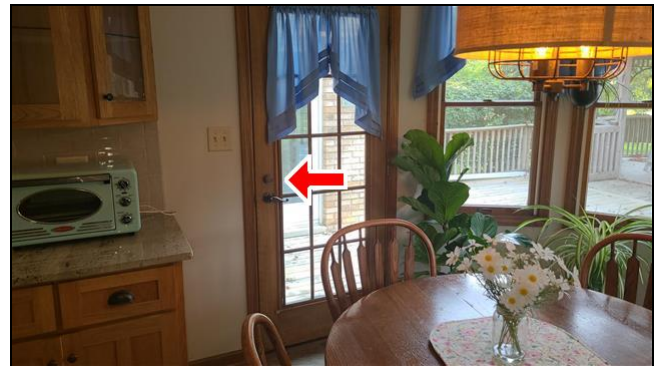
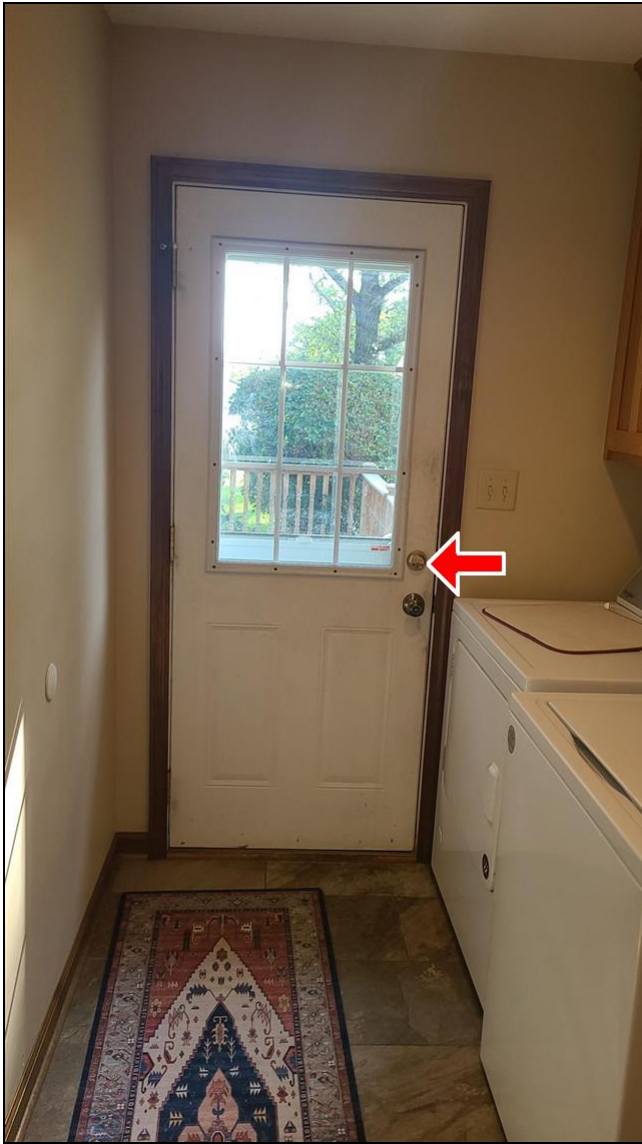
The entrance doors are double keyed. This means that a key is required to open the door from the outside and inside of the home. Modern fire safety standards do not allow double keyed locks on doors. In the event of an emergency exit from the home, a key is required to unlock the door. This is a safety issue that must be corrected. Replace double keyed locks on entrance doors.

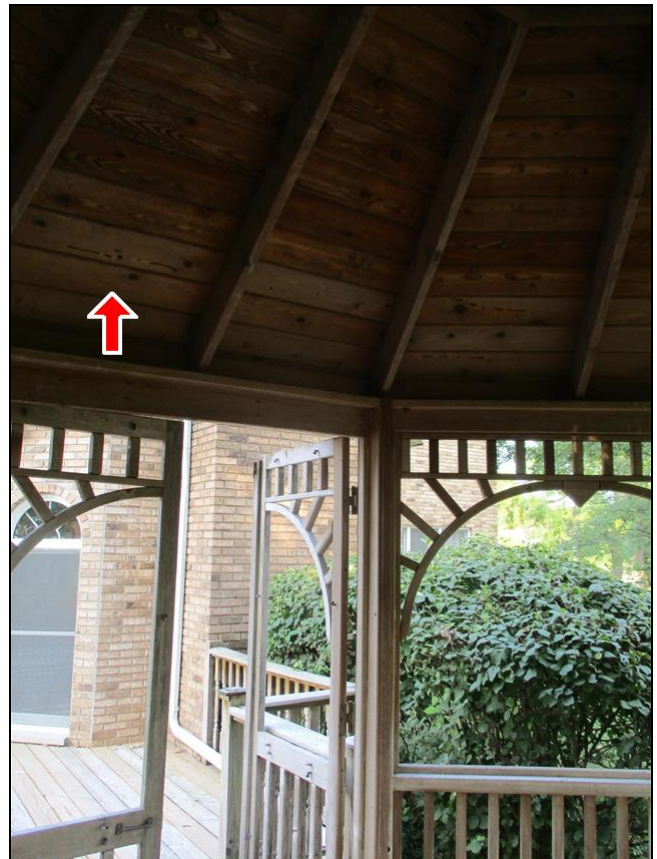
2.4 Item 3(Picture)

(2) Signs of wood destroying organisms (WDOs) were observed in the gazebo ceiling. If not treated, damage to the gazebo and structure may occur. Contact a pest abatement company for further evaluation and treatment options.

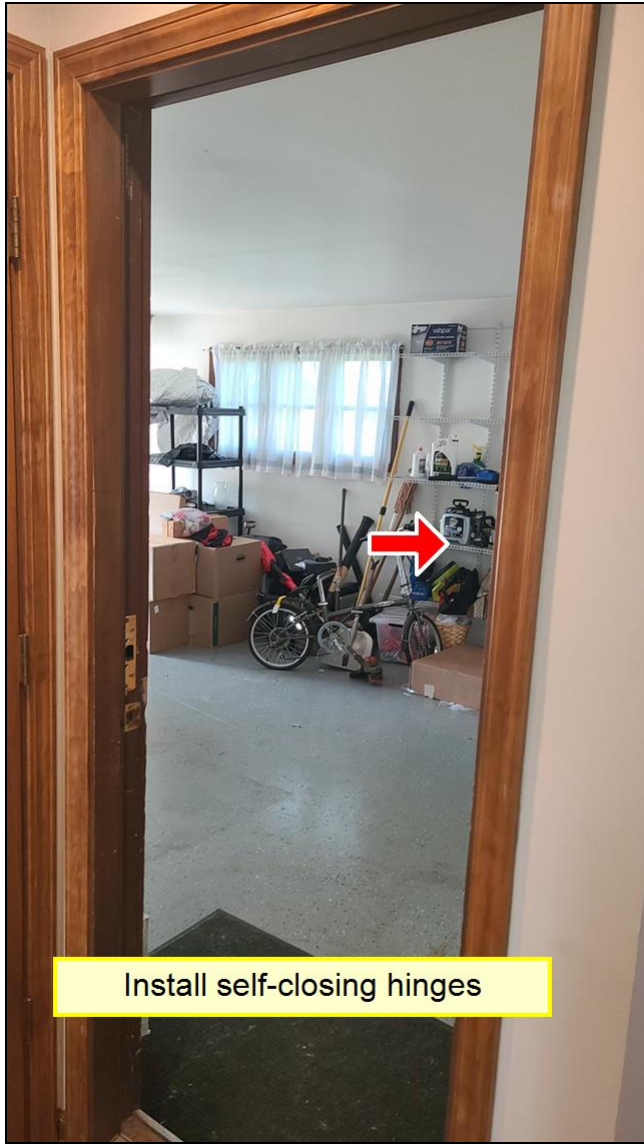
3.3 Item 1(Picture)

The occupant door to the garage, is not equipped with self closing hinges. Modern fire safety standards require the door between the home and garage, to have self closing hinges. Contact a qualified person to install self closing hinges on garage occupant door.

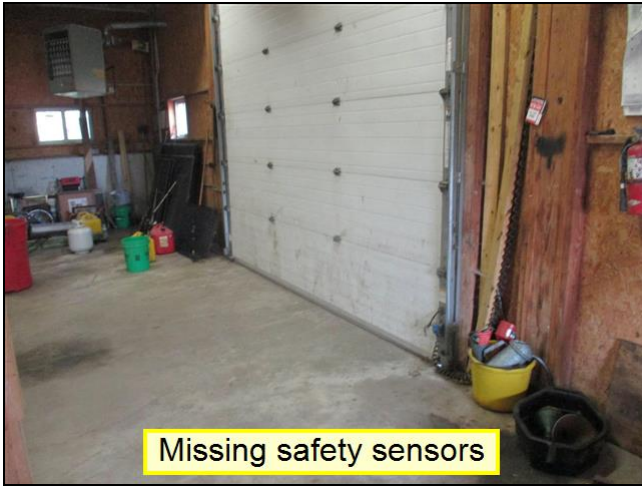
3.5 Item 1(Picture)

The outbuilding garage door opener is not equipped with safety sensors that prevent injury to occupants or animals. The sensors should be located on the lower portion of the garage door or should have a safety push button or a pressure sensor, and are designed to reverse the direction of the door if someone is beneath. This is a safety code enforced by municipalities. Contact a garage door company for further evaluation.

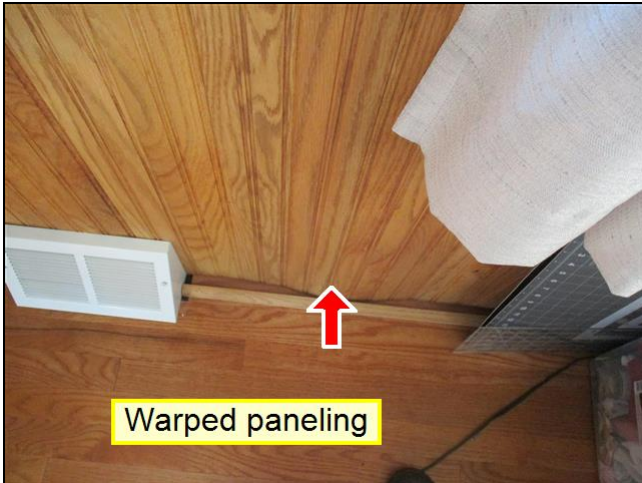
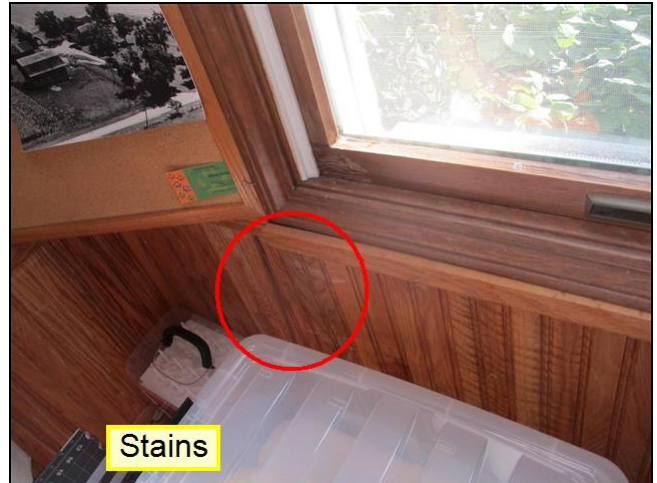
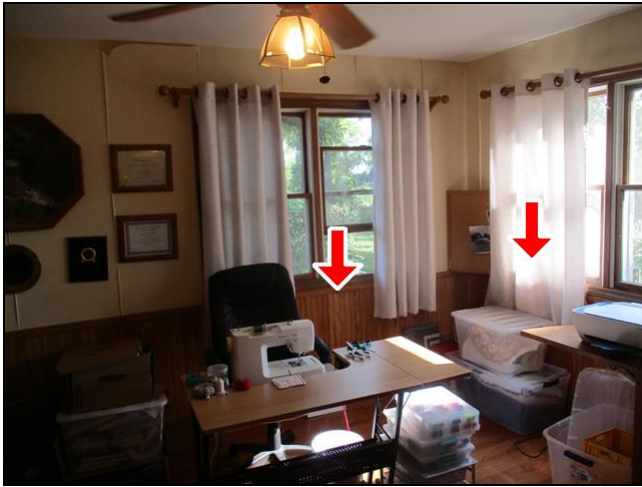
(3) Water damage and stains were observed in paneling under the windows in the office room. Contact a qualified contractor for further evaluation and repair.

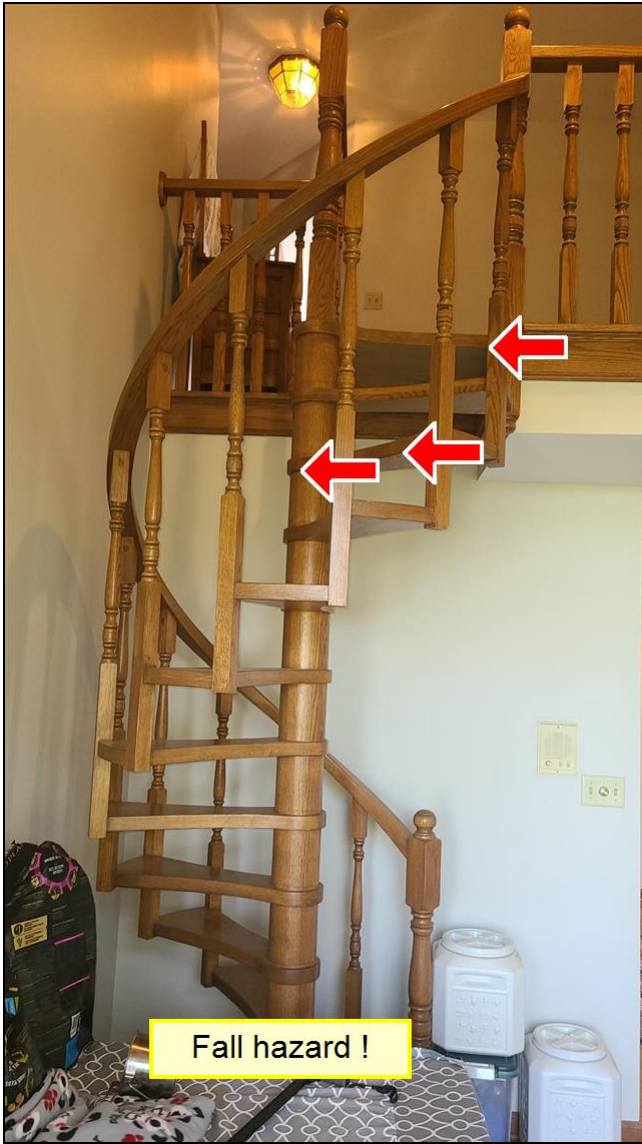
4.3 Item 1(Picture)

The staircase balusters are too far apart. Modern building standards require the opening to be 4" or less. When this home was built, this was not the requirement. This is a safety requirement to prevent children from falling through the openings. Contact a qualified contractor to install balusters that are 4" or less apart.

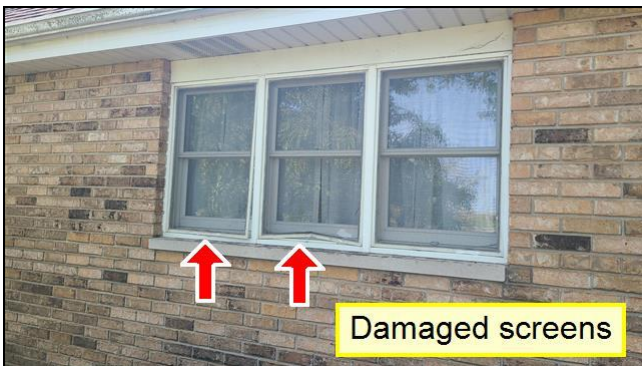
4.4 Item 1(Picture)

(1) There were several screens that were damaged. Municipalities and other agencies, require functioning screens on all windows. Contact a qualified contractor to repair all damaged screens.

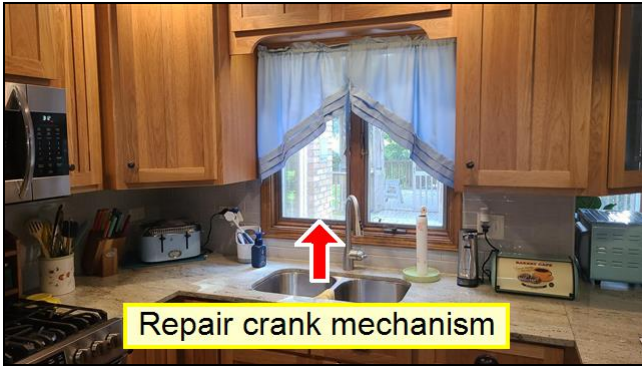
4.4 Item 2(Picture)

(2) There was one window with a defective window hand crank. The window will not open in its current condition. Contact a window repair company to repair the window hand crank.

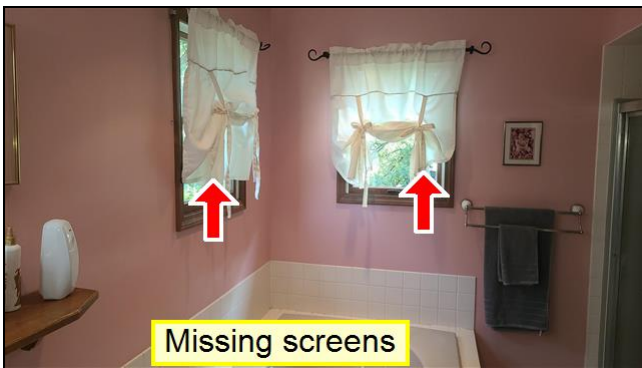
4.4 Item 3(Picture)

(3) There were several windows with missing screens. Screens are required by local municipalities and other agencies. It is possible that the home owner has the screens stored. I recommend asking home owner to have all screens installed by the final walk through. Check that all windows have screens when you do your final walk through.

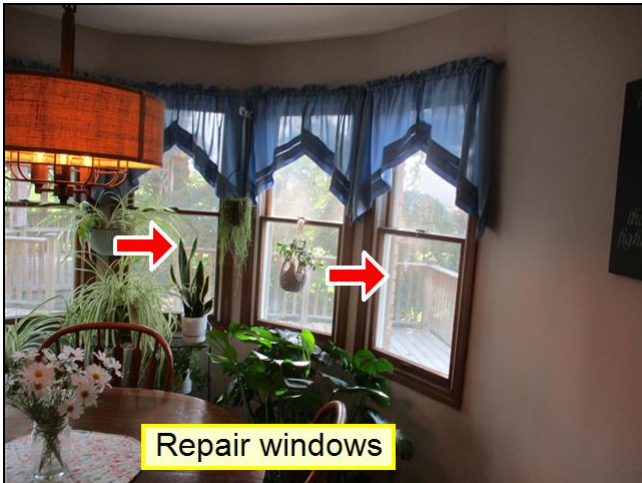
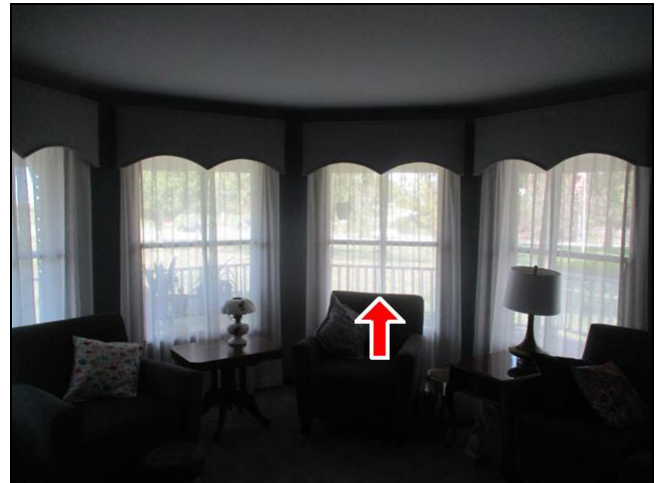
(4) Several of the main level windows would not stay in the open position when opened. The windows slams shut, which could cause injury to occupants. Contact a window repair company to repair the windows.

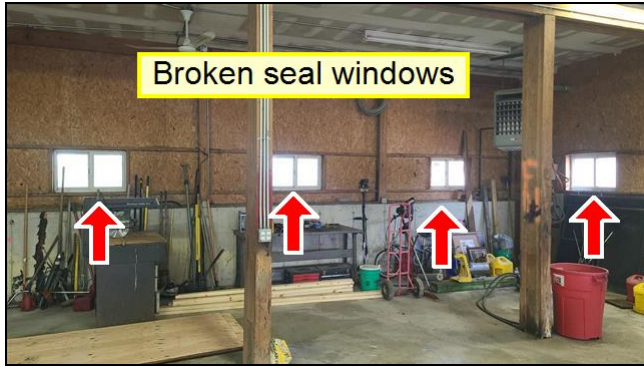
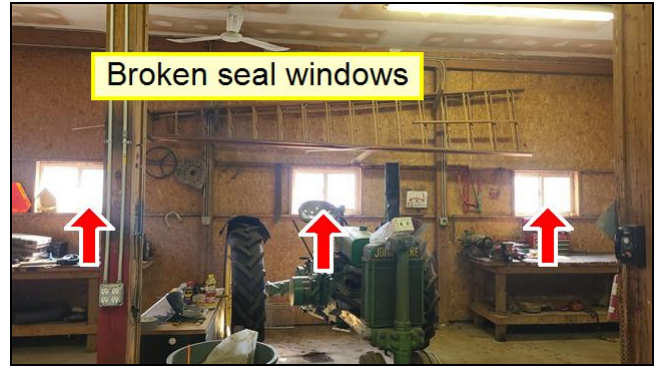
(5) There were several windows with broken seals in the outbuilding. A window with a broken seal still operates as intended, but it loses insulation value. Contact a window replacement company to replace all glass with broken seals.
