Inspection Report

Property Address:
16233 W Randell St
Manhattan IL 60442

SafeCheck Home Inspection

Date: 9/11/2024	Time: 02:00 PM	Report ID: 20240911-16015-W-Baker-Rd
Property: 16233 W Randell St Manhattan IL 60442	Customer: Joe Smith	Real Estate Professional:

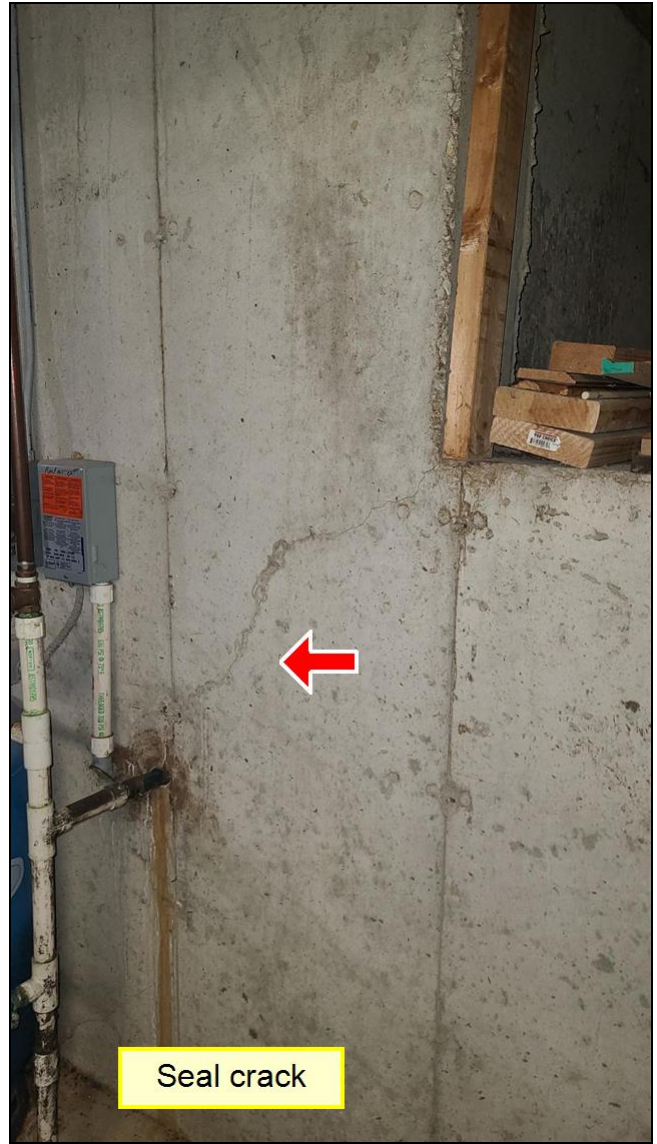
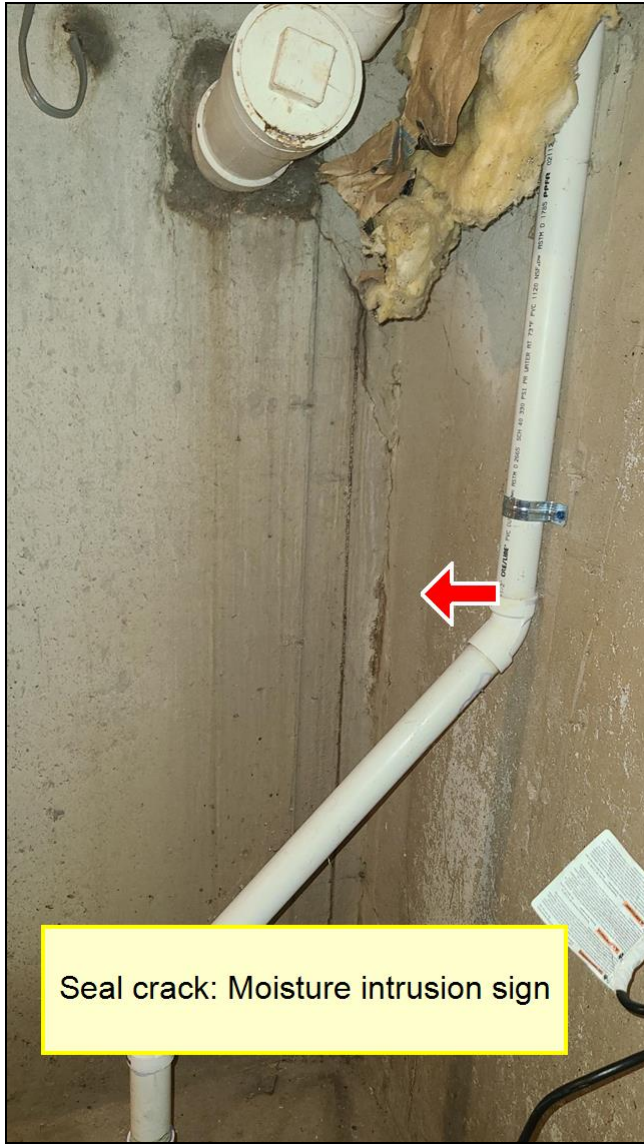
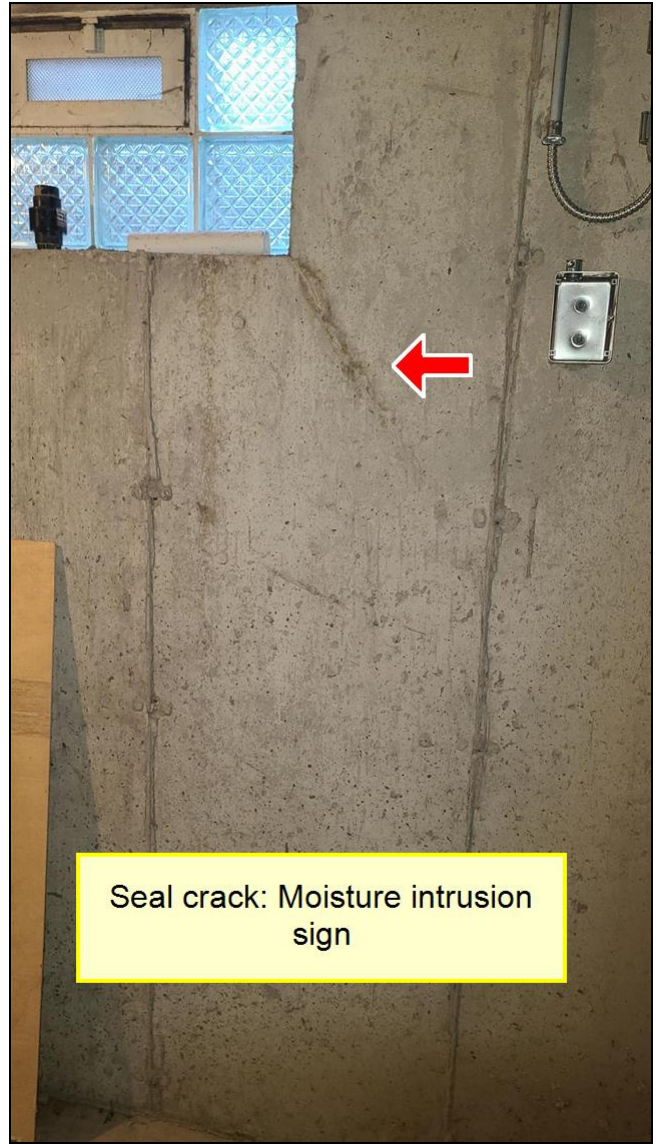
(2) There were several cracks in the basement foundation walls. This is not a structural issue, but cracks should be repaired to prevent further damage or water from entering. Contact a water proofing company to repair all cracks in basement foundation walls.

NOTE: Some of the cracks were not seeping water at the time of the inspection, but there are signs of water seepage. There are water stains and mineral deposits. Cracks may not seep water now, but WILL during heavy rains.

NOTE: The cracks that showed sign of seepage is the area that has low grading on the outside.

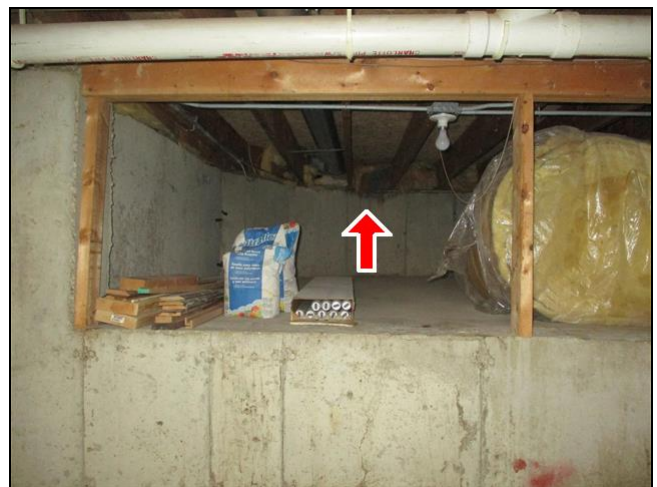
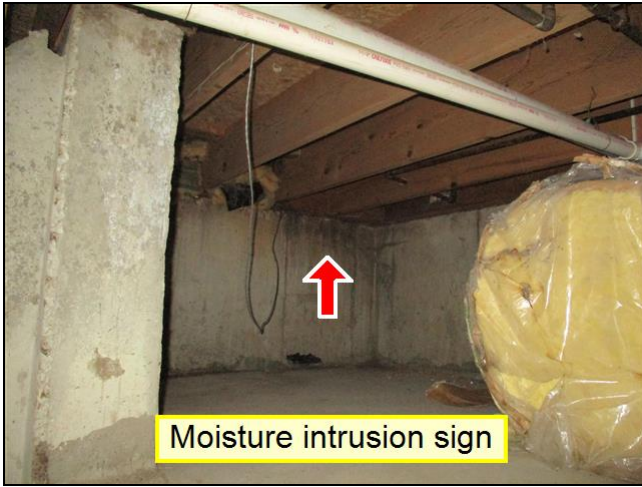
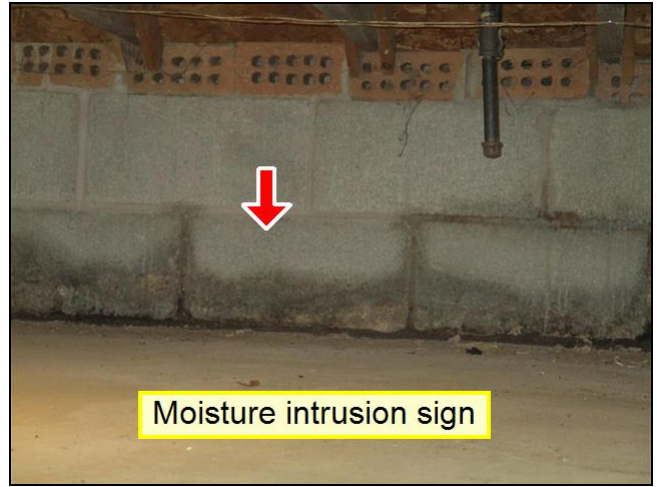
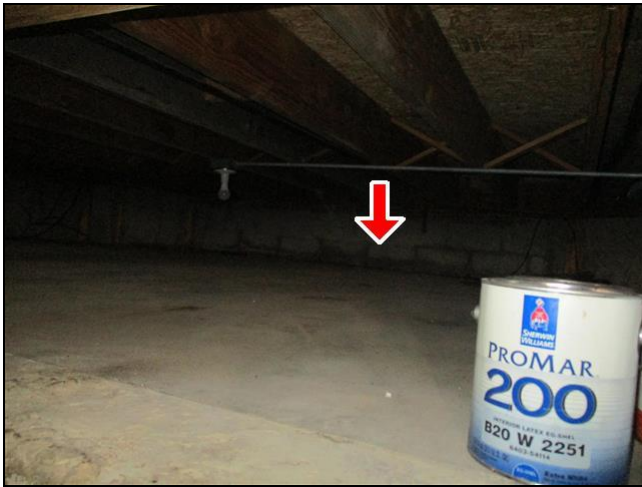
(3) Moisture appears to be entering the crawlspace between the foundation wall and the sill plate and through the fireplace cinder blocks at the rear of the home. If not corrected, moisture related issues and further damage may develop. Contact a waterproofing company for correction and further evaluation.

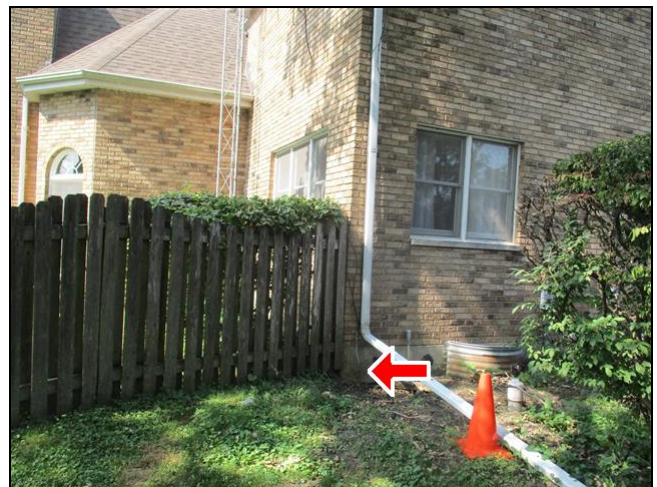
5.0 Item 12(Picture)

(4) Damage was observed on the corner of the foundation slab "Corner pop". This is not a structural issue, but the damage should be repaired to prevent further damage or water from entering. Contact a concrete repair company for further evaluation and repair.

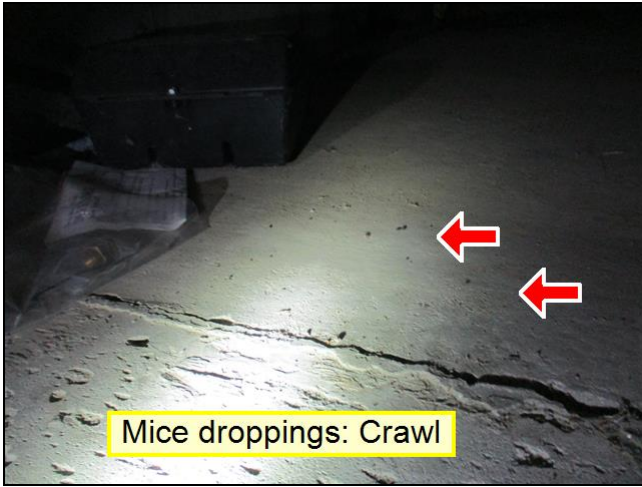
5.0 Item 13(Picture)

(5) There are signs of rodents entering the home. To properly correct this issue, any penetrations to the exterior should be sealed. Contact a pest control company for further evaluation.

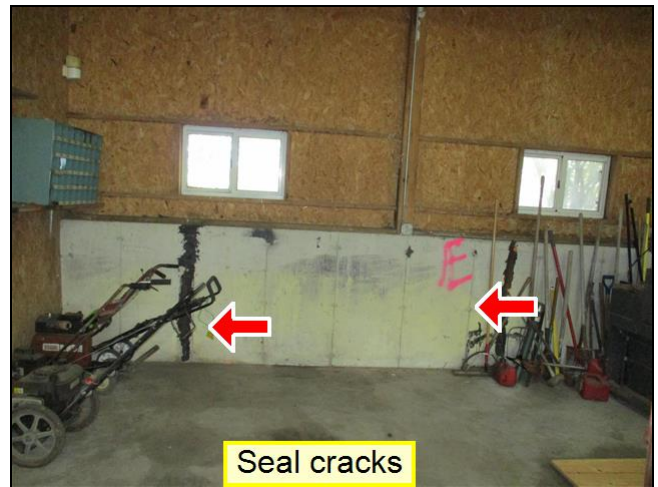
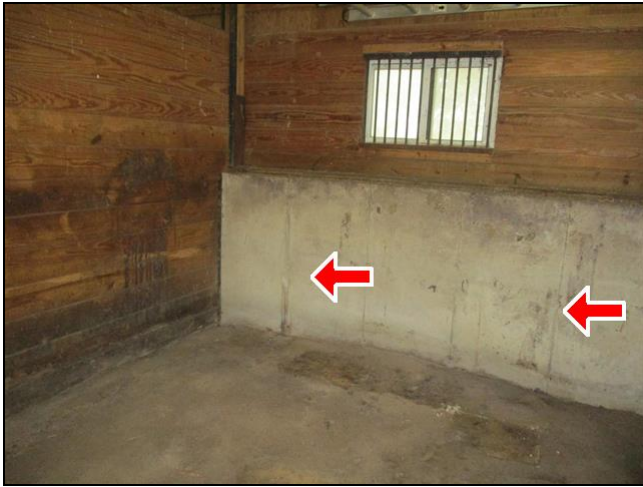
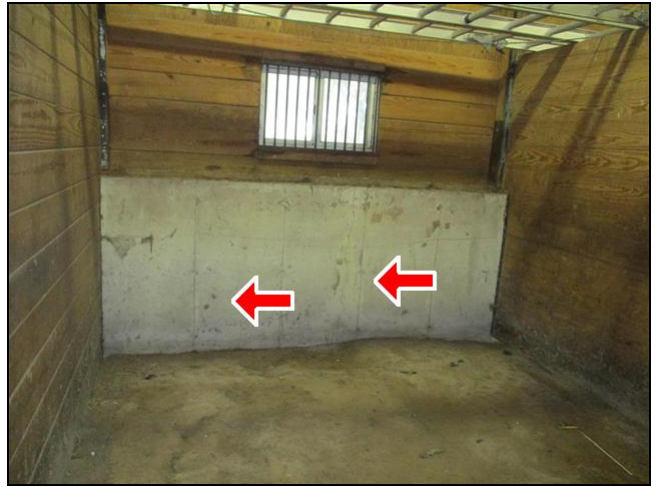
(6) There were several cracks in the outbuilding foundation walls. This is not a structural issue, but cracks should be repaired to prevent further damage or water from entering. Contact a waterproofing company to repair all cracks in outbuilding foundation walls.

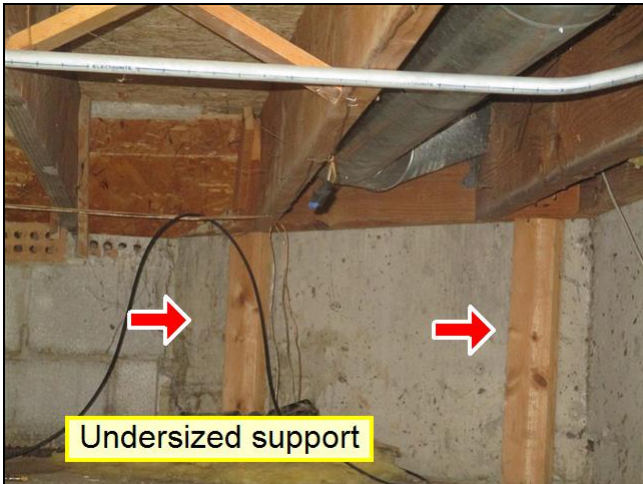
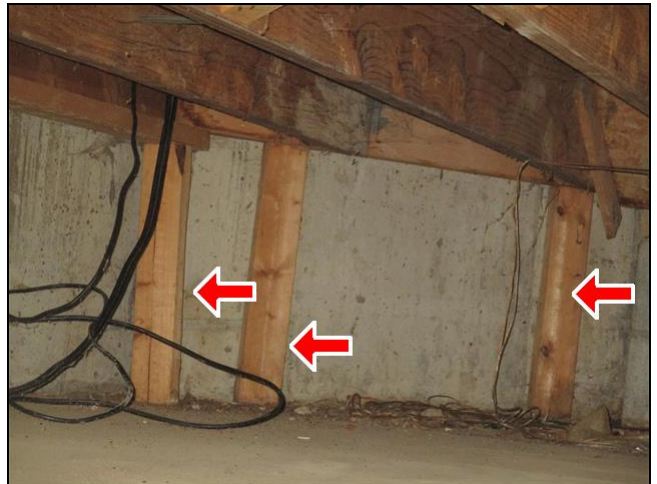
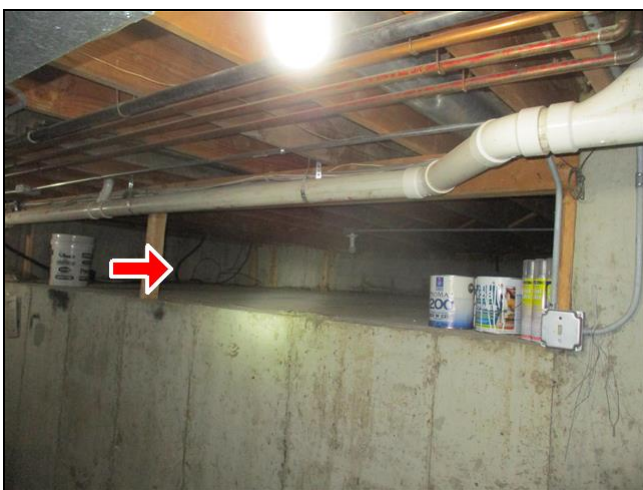
The fireplace room floor structure is supported using only 2X4 lumber (Undersized support) . I recommend contacting a framing contractor for further evaluation.

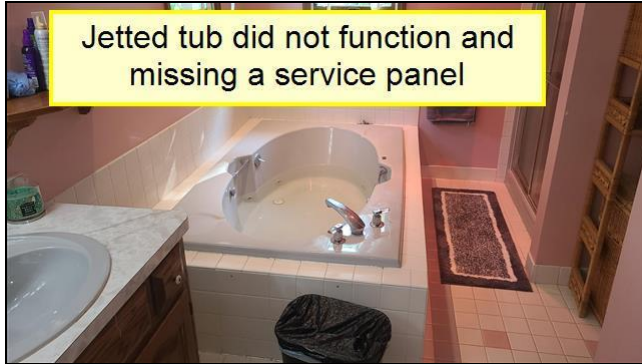
6.0 Item 4(Picture)

(3) There is no access panel for the whirlpool tub water pump. If the pump fails, the tile will need to be removed to access the pump. This comment was intended to inform you that there is no access panel.

The jetted tub did not function at time of inspection. Contact a qualified plumber for further evaluation.

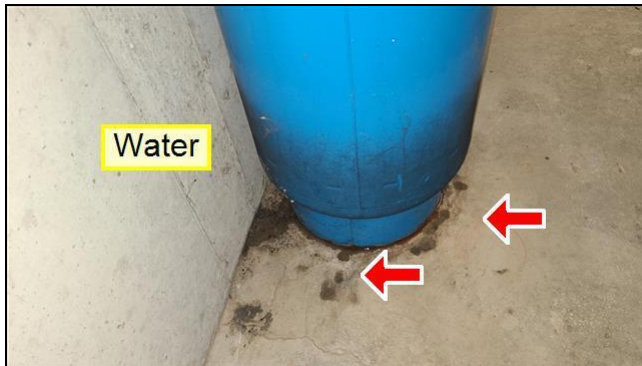
6.0 Item 5(Picture)

(4) The well pressure tank is leaking into the basement floor. If not corrected, moisture related issues will develop. Contact a qualified plumber for further evaluation.

NOTE: The water might be from condensation.

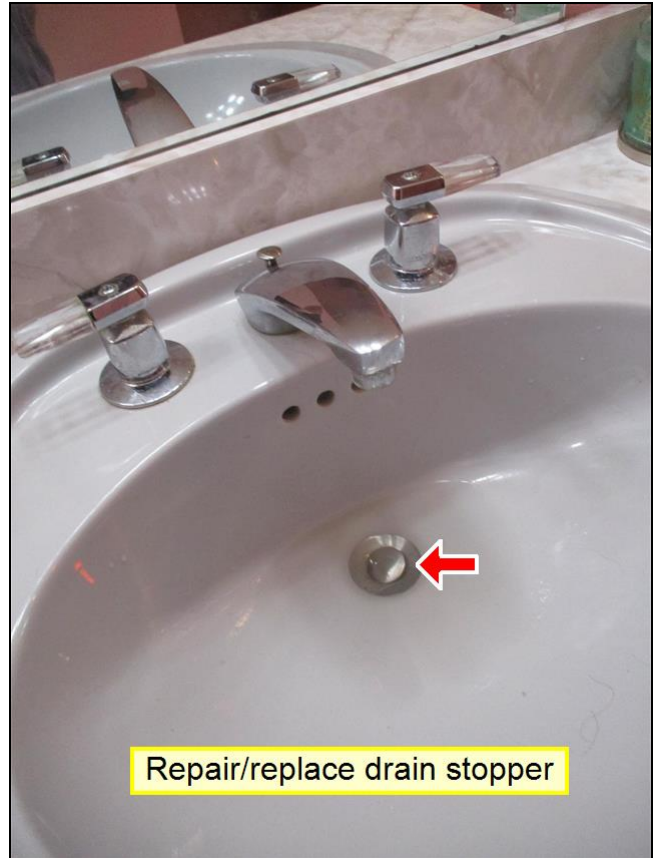
6.1 Item 2(Picture)

(2) The drain stoppers did not function at the master sink/jetted tub. Contact a qualified plumber to repair or replace the drain stoppers.

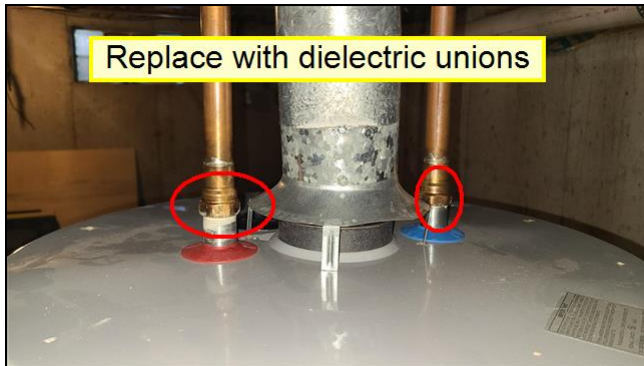
6.2 Item 3(Picture)

(3) The water piping to the water heater is connected without the use of dielectric connectors. Dielectric connectors are required whenever two dissimilar metals are connected together. Dielectric connectors prevent rusting caused by galvanic action. Contact a qualified person to install the dielectric connectors.

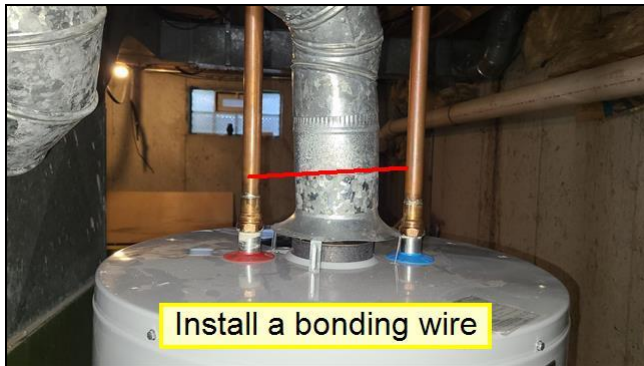
6.2 Item 4(Picture)

(4) There is no bonding wire present on the water heater. A bonding wire is required to prevent the electrolysis that can occur when dissimilar metals are joined together. The bonding wire is intended to allow that faint current between the water pipes to bypass the copper-to-steel fittings and thereby prevent corrosion caused by electrolysis. Contact a qualified person to install a bonding wire.

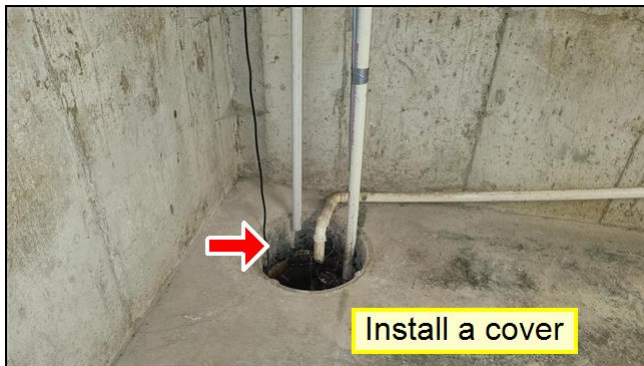
6.6 Item 1(Picture)

Modern building standards require ejector pits to have a sealed cover. Contact a qualified person to install a sealed cover on the ejector pit.

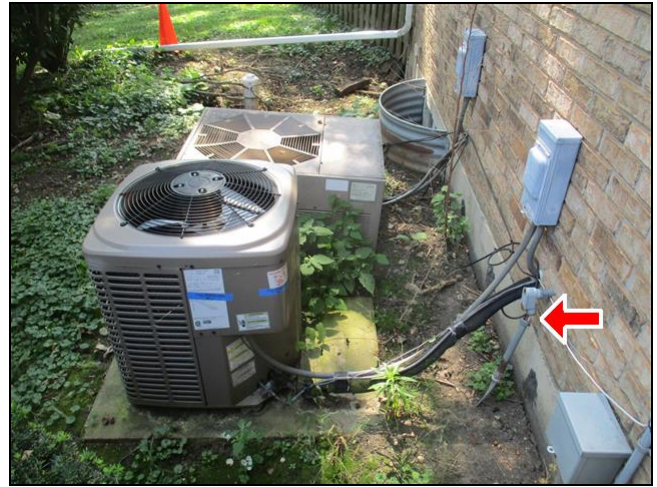
7.2 Item 2(Picture)

(1) Exposed electrical wires were observed on the exterior by the AC unit. If not enclosed, injury to occupants may occur or water may cause damage. Contact a qualified electrician for correction.

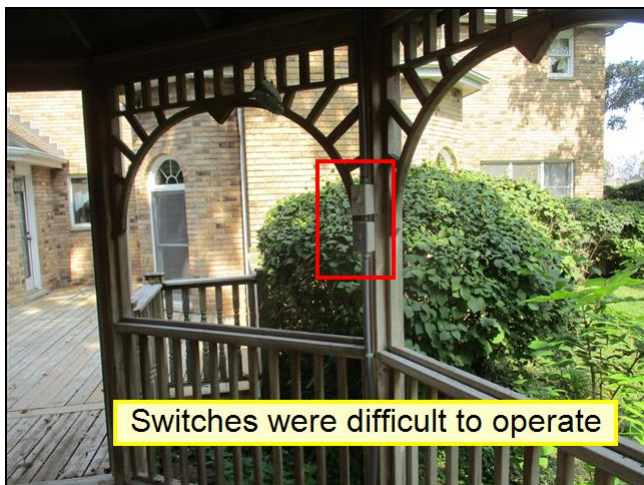
7.2 Item 3(Picture)

(2) The gazebo ceiling fan electrical switches were difficult to operate. Contact a qualified electrician for further evaluation.

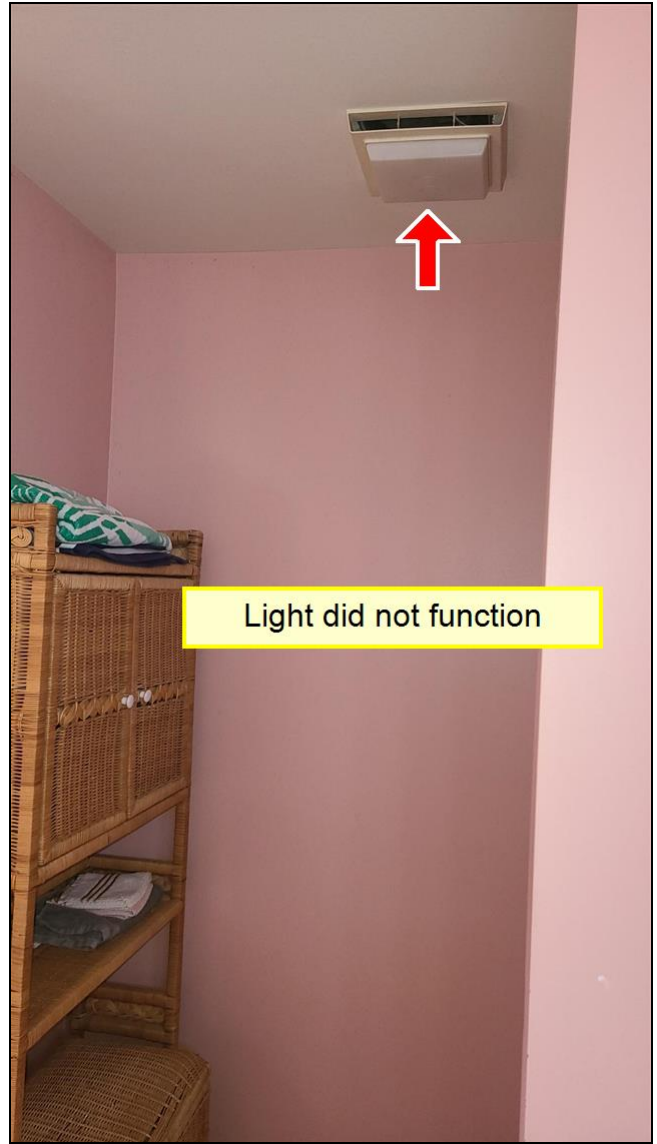
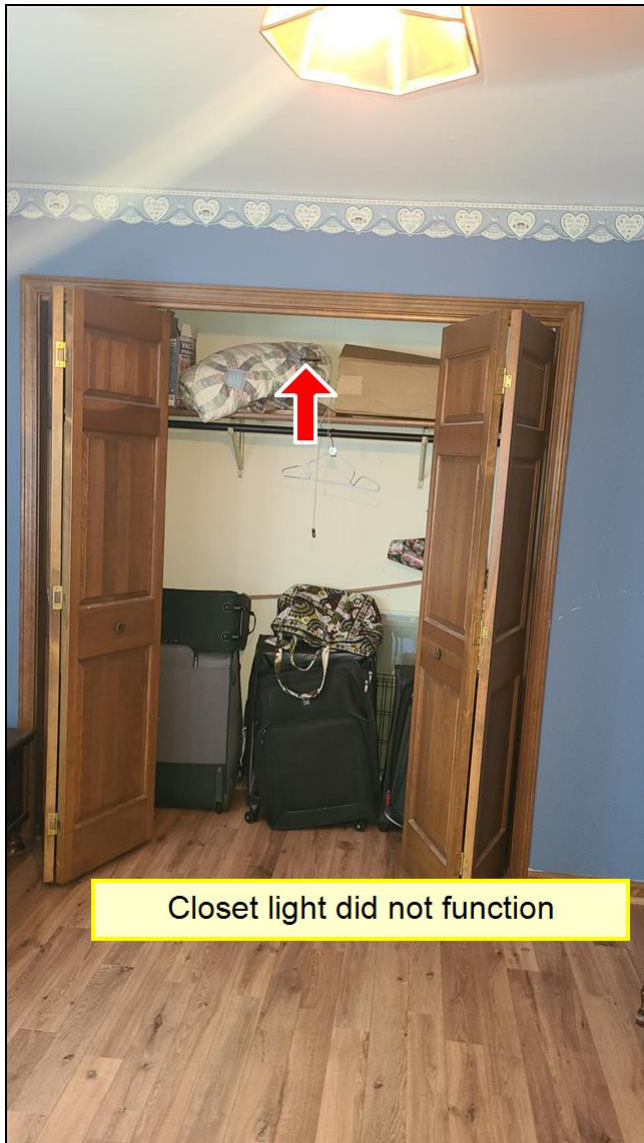
(3) There were several lights that did not function. It may be burnt out light bulbs, or defective light fixtures. I recommend having the home owner replace all burnt out light bulbs so that you can check them when you do your final walk-through.

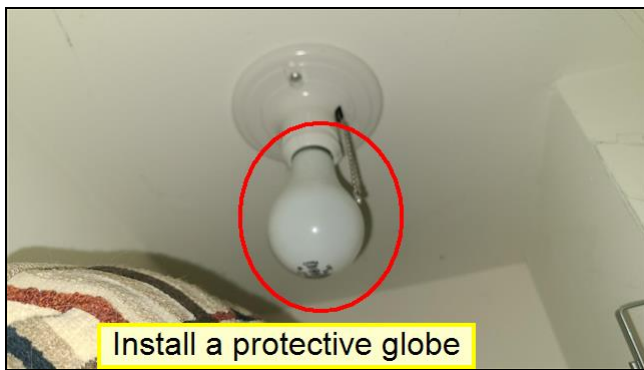
7.2 Item 7(Picture)

(4) Modern fire safety standards require closet light bulbs to be covered by a protective globe or other type of cover. This is to prevent the hot light bulb from contacting clothing and starting a fire. I recommend installing globe type light fixtures in all closets.

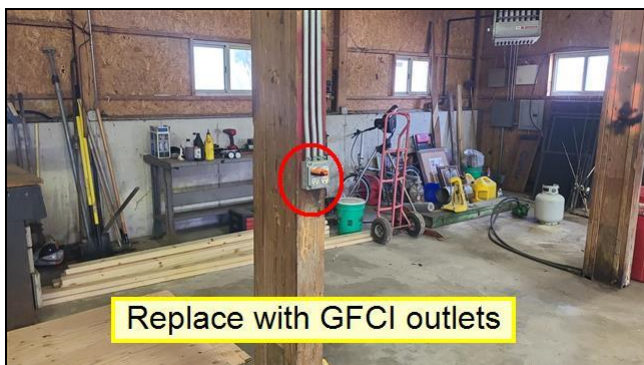
7.3 Item 1(Picture)

The outbuilding electrical outlets are not GFCI (ground fault circuit interrupted) protected. GFCI type electrical outlets protect the family against electrical hazards. When this home was built, it was not required to have GFCI electrical outlets in the outbuilding. Modern standards require GFCI outlets in the outbuilding. I recommend updating electrical outlets in outbuilding to GFCI type outlets.

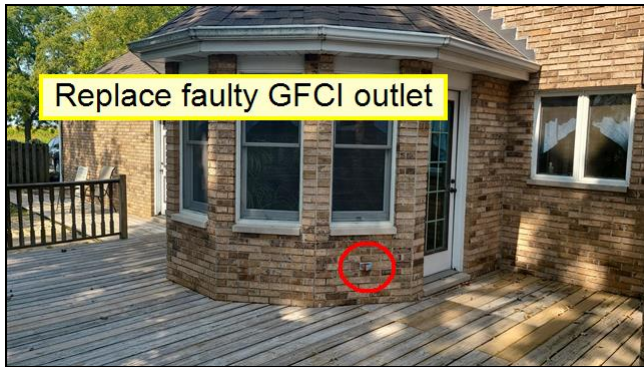
7.4 Item 1(Picture)

The exterior rear GFCI (ground fault circuit interrupted) electrical outlet did not trip when tested. This is an important safety device that must be operational. Contact a qualified person to replace the outlet.

Replace faulty GFCI outlet

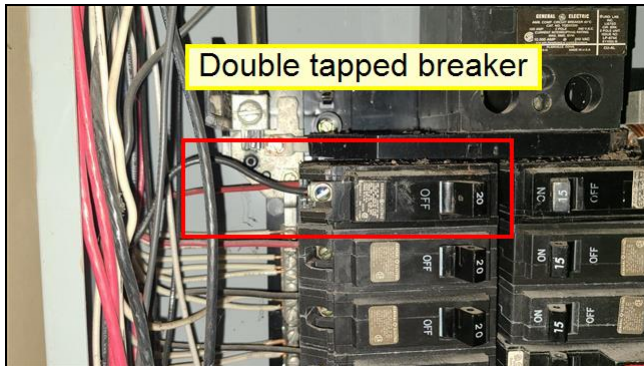
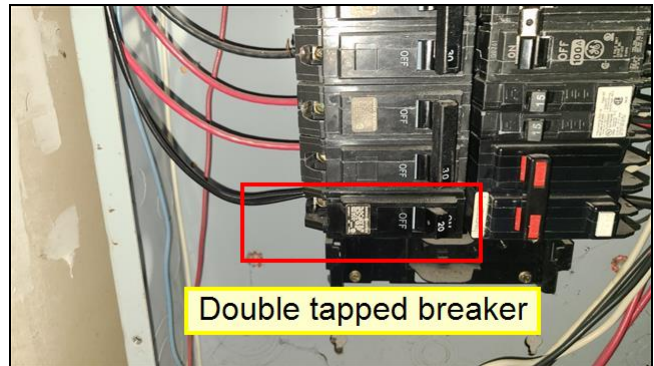
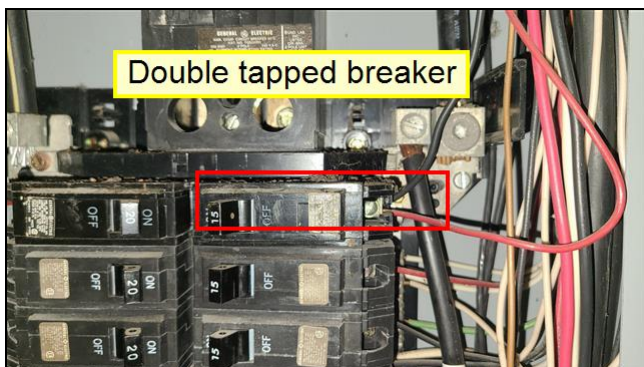
(1) There are three double tapplings of circuit breakers present in the main electric panel. Double tapping is when two wires are connected to one circuit breaker. Modern standards do not allow for two wires to be connected to one circuit breaker. This is considered a safety hazard that must be corrected. Contact a qualified electrical contractor to correct double tapplings in electrical panel.

Double tapped breaker

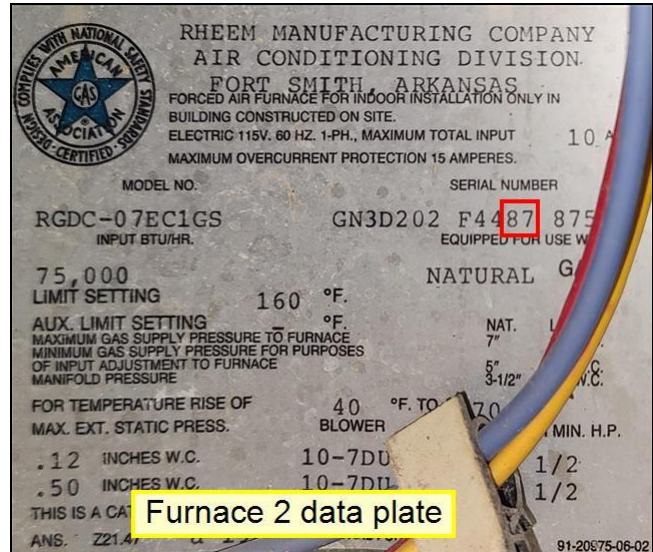
8.4 Item 2(Picture)

(1) The furnaces were manufactured in 1987,1988. The national average for furnaces is 20 years. It is difficult to determine the remaining life of these units, but they are at the end of their expected life cycle. I recommend budgeting for replacement.

When both furnaces were turned on, a strong smoke smell was observed in the home. A cracked heat exchanger might be a possible cause. Contact a qualified HVAC professional for further evaluation of the furnaces

Furnace 2 data plate

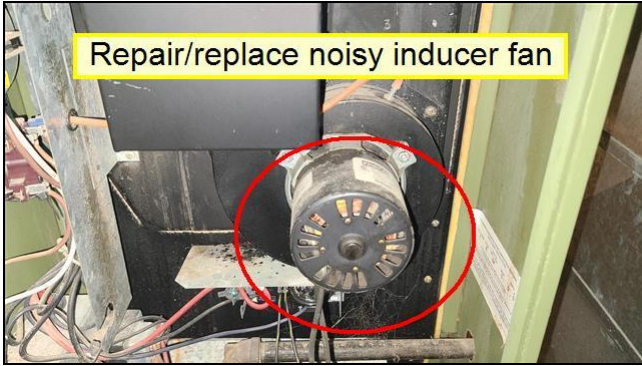
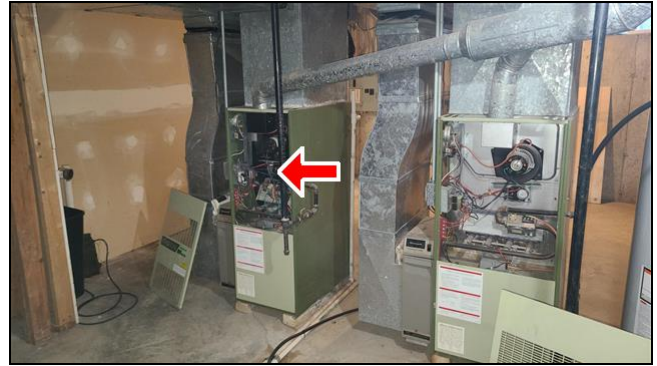
(2) The draft inducer motor was very noisy when the heat was operated. Service is needed. Contact a HVAC professional for correction and further evaluation of the furnace.

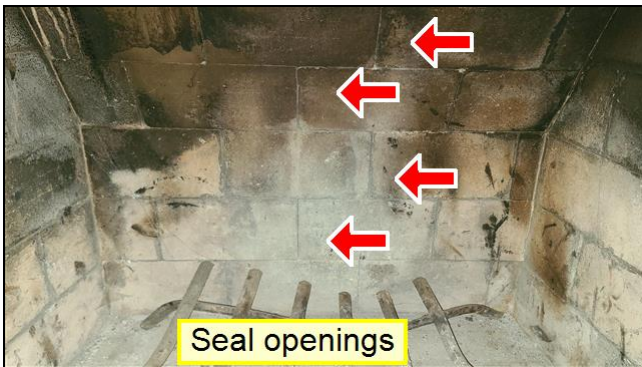
8.6 Item 1(Picture)

(2) There are cracks in the firebox. The bricks and mortar are cracking. This can allow flame, smoke and fumes outside of the controlled burn area. If not corrected, further damage may occur. Contact a fireplace company or chimney sweep for correction and further evaluation.

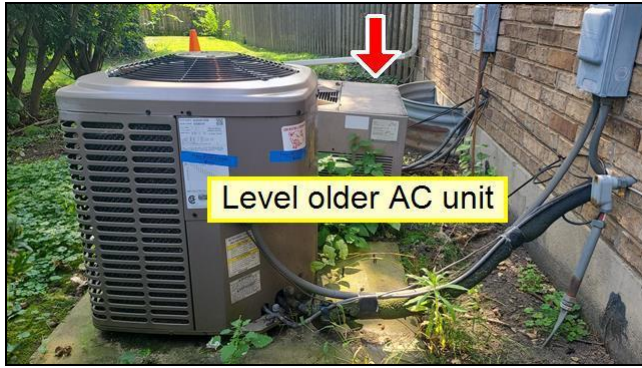
8.8 Item 5(Picture)

(3) One of the air conditioning units is not properly leveled. It is important that the AC unit is properly leveled to prevent bearings from failing prematurely. Contact a qualified person to properly level the unit.

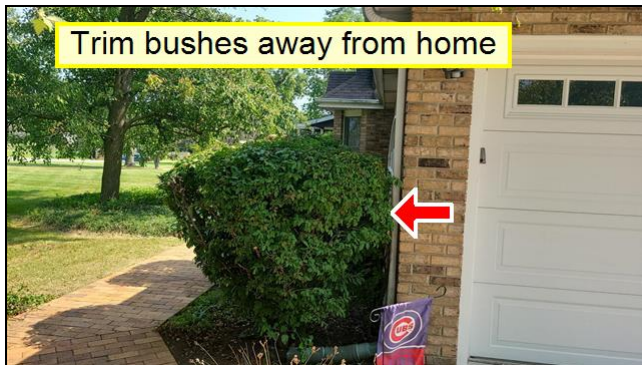
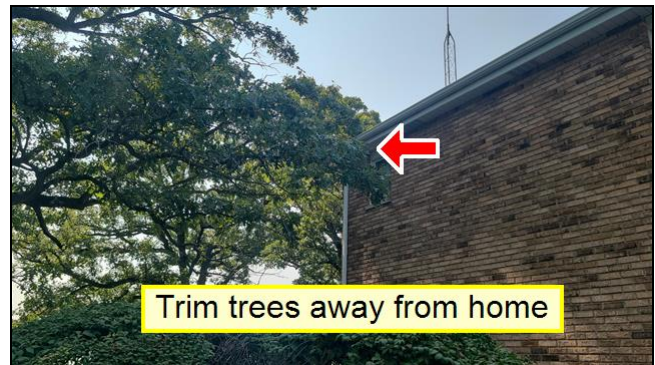
(1) There are trees and bushes in contact with the home. They should be trimmed or removed to prevent damage to the home. Contact a landscaping company to trim or remove all bushes and trees that are located too close to the home.

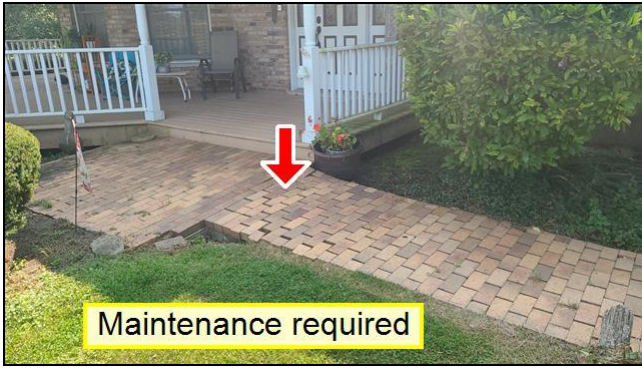
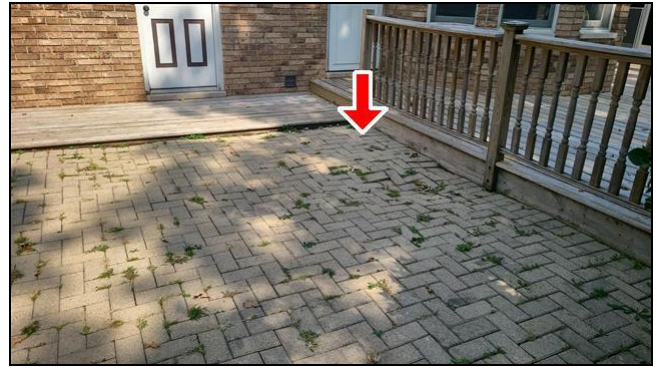
(1) The brick paver patio needs repair. Brick paver patios need periodic repair and maintenance to prevent damage. The algae must be removed from the joints, the brick power washed, new sand applied, and a new protective coating applied. Contact a landscaping company to perform this repair.

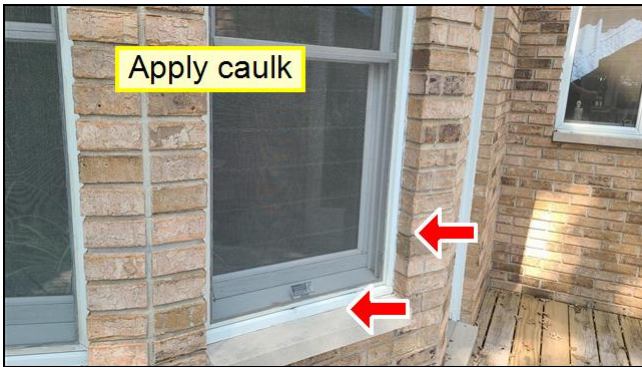
2.3 Item 1(Picture)

The caulk is failing on several of the exterior windows. If not replaced, water may penetrate into the home. Contact a qualified contractor to remove all old caulk and apply new.

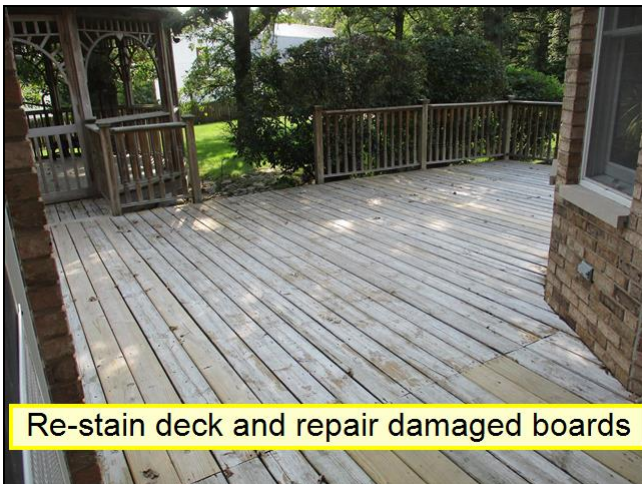
2.4 Item 4(Picture)

(3) The deck wood needs maintenance. I recommend re-staining the wood to prevent damage. Contact a qualified contractor to do so.

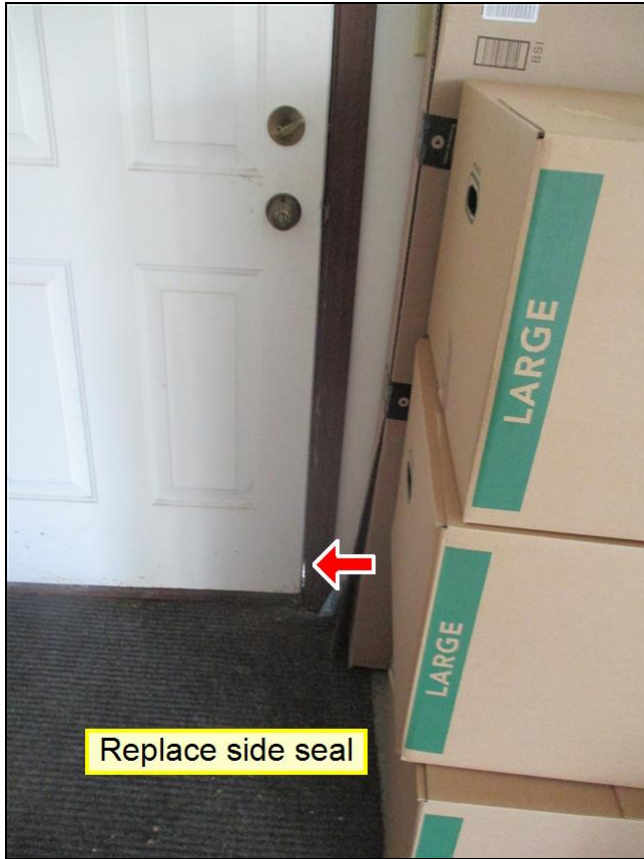
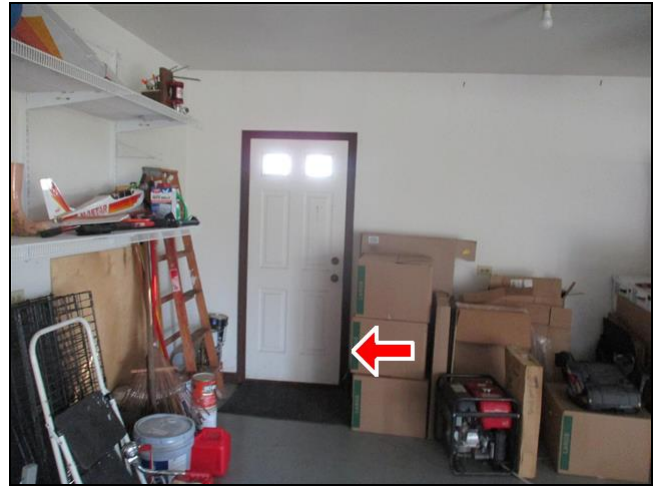
There is a gap on the side of the garage man door. If not sealed, insects, water, etc., may enter garage. Contact a qualified contractor for correction.

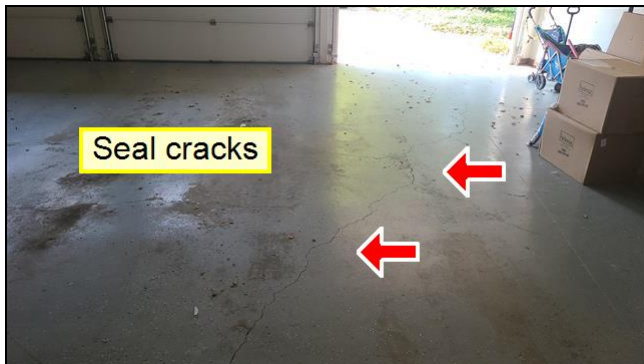
3.4 Item 1(Picture)

There were some cracks in the garage floor. These cracks are normal, but I recommend repair to prevent further damage. The cracks can be repaired with caulk or any other patching type material.

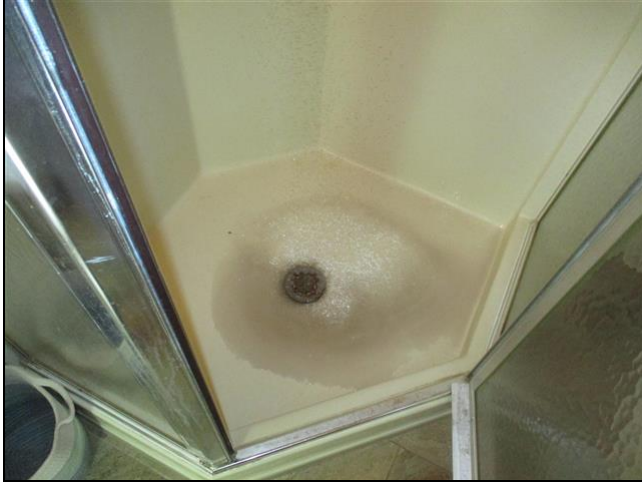
6.2 Item 2(Picture)

(2) The hot water was dirty when operated from fixtures. This is an indication that sediment is building up inside the tank. I recommend draining some sediment from the bottom of the tank. There is a water spigot present for this purpose. I also recommend installing an in-line filter.

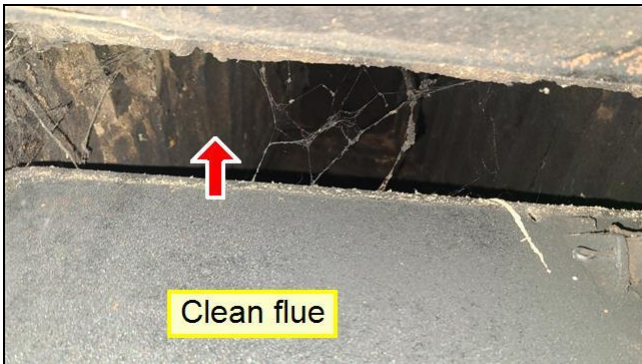
8.6 Item 2(Picture)

(3) There is a creosote buildup on the fireplace flue. This can cause a chimney fire, so it should be removed immediately. Contact a chimney sweep, to clean the chimney.
